**PRE-DEMOLITION ASSESSMENT REPORT
PRE-DEMOLITION SURVEYS AT
ARMED FORCES RESERVE CENTER,
JACKSON, MISSISSIPPI**

Contract No.: W912DY23P0033

**U.S. ARMY ENGINEERING & SUPPORT CENTER, HUNTSVILLE
CEHNC-CT
475 Quality Circle, NW
Huntsville, AL 35806**

Prepared By:
AMERICON, INC.
6795 E. Tennessee Avenue, Suite 657
Denver, CO 80224

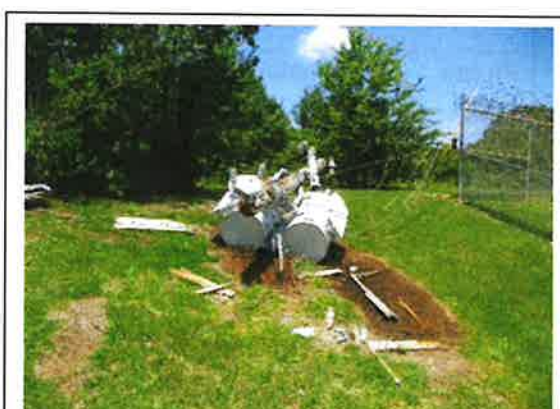
Transformers

Other: Brick chimney outside of building. Three formerly pole-mounted transformers were knocked down in a recent storm and are laying on the ground in the vicinity of the building.

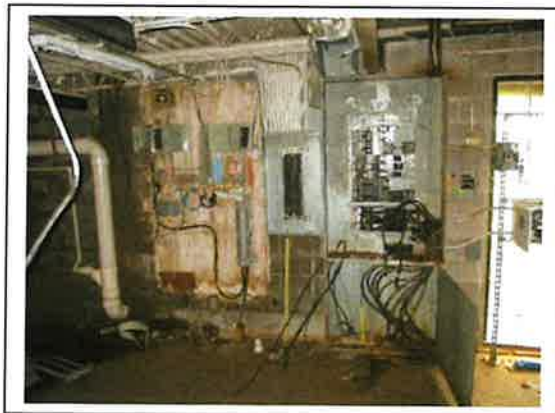
Building Interior Electrical Panels

2-ft Fluorescent Light Fixtures			0
2 Tubes Each Fixture			
1 PCB Ballast Each Fixture			
Electrical Panels/Switch Gear/Fuse Boxes		5 have been stripped	7
Emergency Lights with Battery(ies)			0
Exit Signs: Illuminated			10
Fire Extinguishers		Dry chemical	1
HVAC Units: Small Units		On roof	2
HVAC Units: Large Units		Ground mounted	3
Tank: AST		Location	0
Use:			
Capacity:			
Tank: UST/AST		Location	0
Use:			
Capacity:			
Thermostats			1
Water Coolers/Drinking Fountains			4
Water Heaters		Size	0

Several types of ORMs were identified in the structure. These materials should be removed and properly disposed of prior to demolition of this structure.

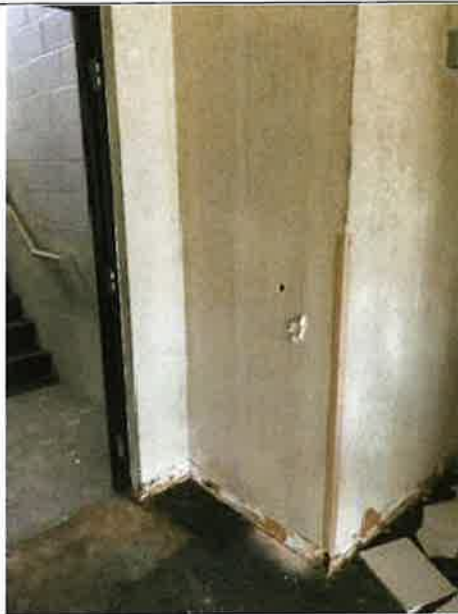
Sample 01 – Sheetrock/joint compound
foyer downstairs

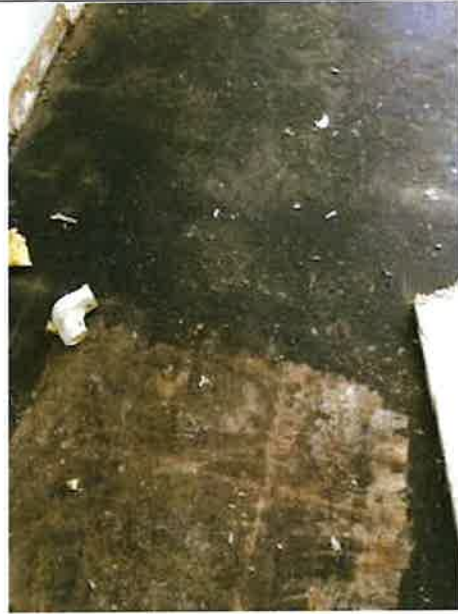
- Sample 03 – Black mastic residue (residual of a previous abatement) (estimated 16,000-18,000 sq. ft. of affected area)
Condition: Undamaged

Sample 03 – Black mastic – throughout the
building (some residual & some fully
applied)

I recommend that the floors be cleaned again by an MDEQ certified abatement contractor. There is residual mastic left from previous abatement and some areas of black mastic that don't appear to have been abated at all. If any of the identified asbestos materials are to be disturbed due to demolition and/ or renovation work performed, a MDEQ certified asbestos abatement contractor to properly abate the ACM.

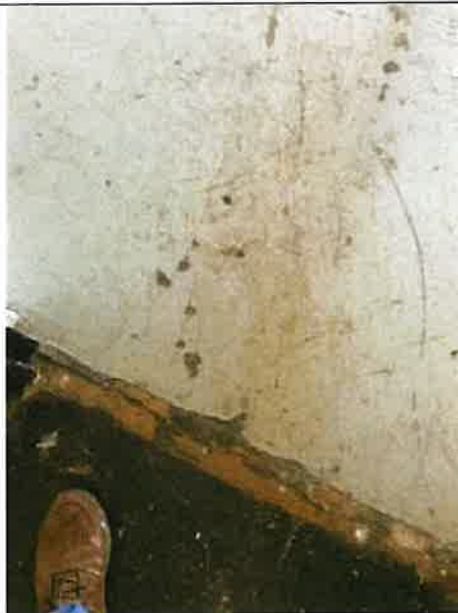
Sample 05 – staircase epoxy/paint

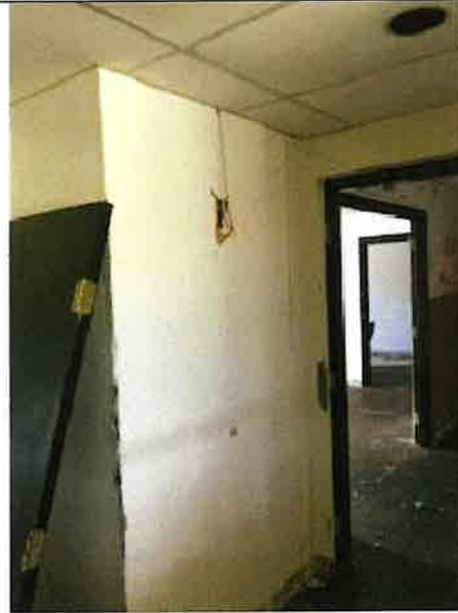
Sample 02 – sheetrock front office

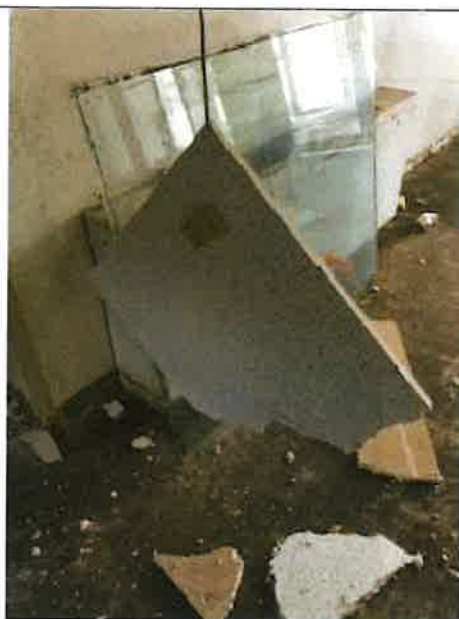
Sample 04 – 2x4 ceiling tile

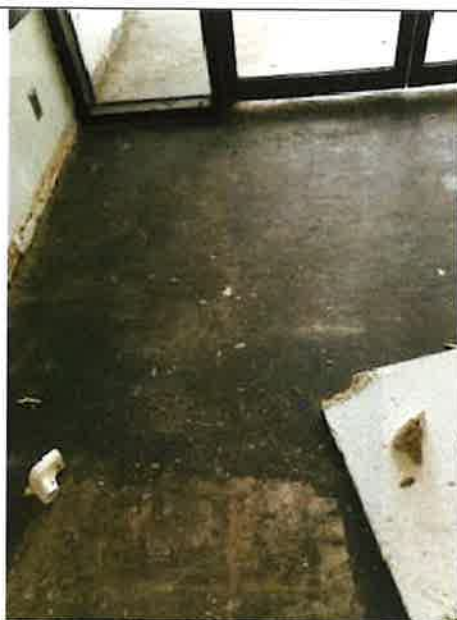
Sample 03 – Black mastic-front foyer

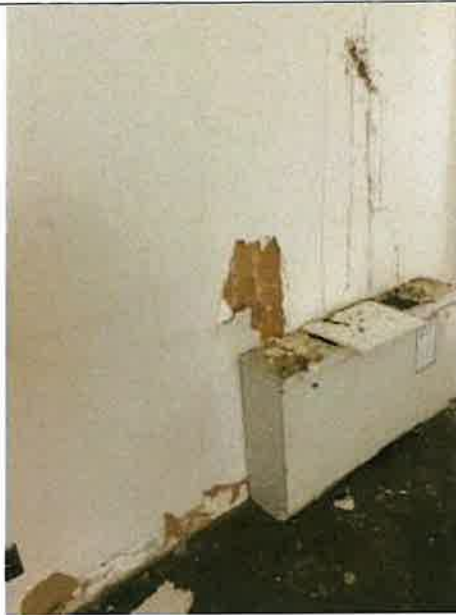
Sample 10-sheetrock upstairs

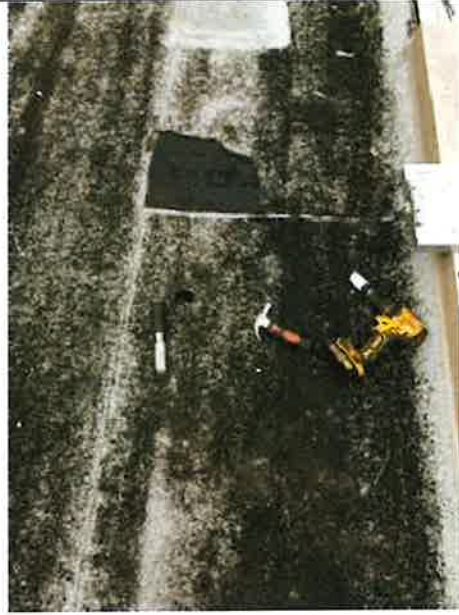
Sample 07 –shingle rolled roofing

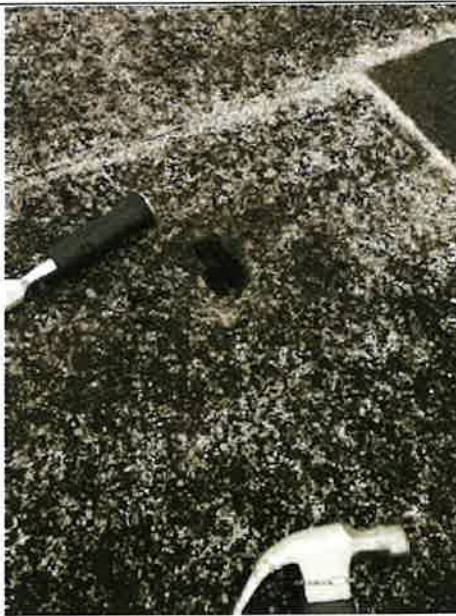
Sample 08 – layers underneath roofing

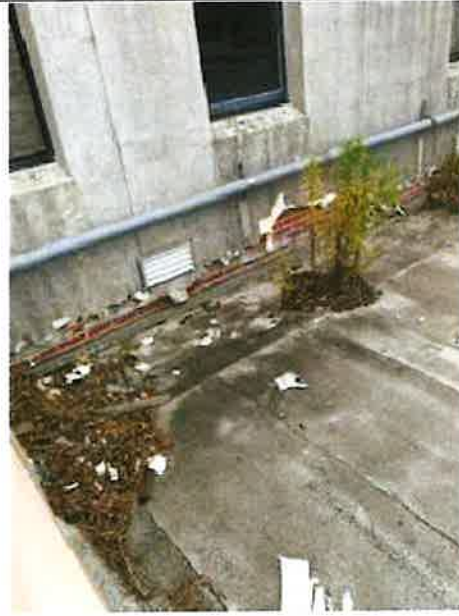
Sample 09 – Stucco/ Styrofoam – Exterior siding

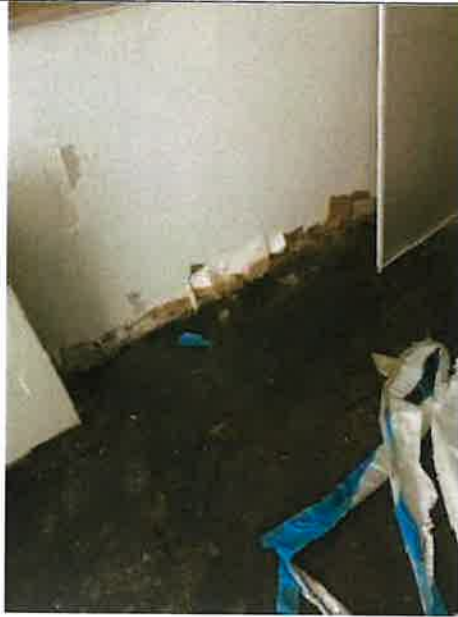
Black mastic – homogenous to 03
