MISSISSIPPI ASBESTOS DEMOLITION/RENOVATION NOTIFICATION FORM

Re: Addendum to scope pursuant to asbestos testing of material in facility

THALIA MARA HALL

CTEH Project Number: 044882

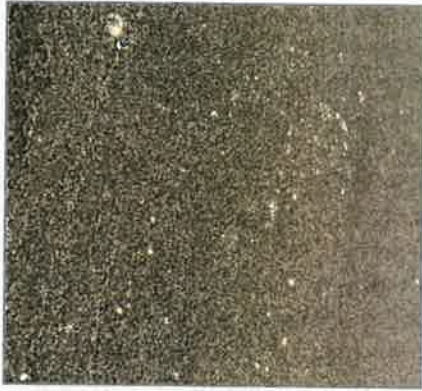
Photo 1

ACM found on carpet in the main auditorium. Suspected source is the beams above where suspected effluorescence is occurring from moisture intrusion

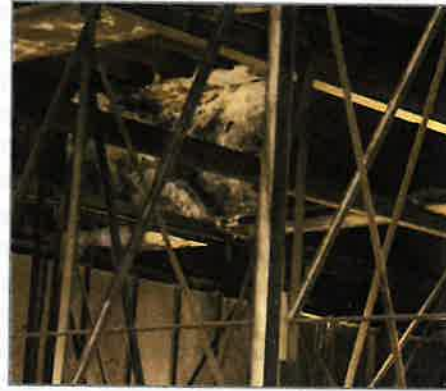
Photo 2

Effluorescence on fire proof coating ACM on beams above the main auditorium

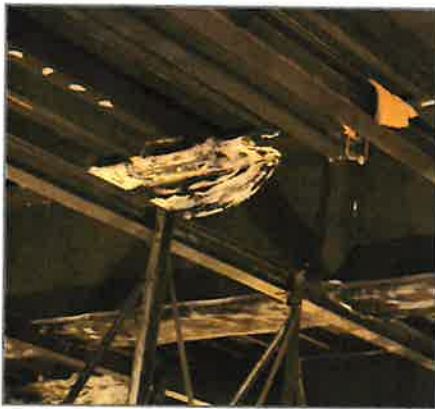
Photo 3

Main Auditorium fire proof coating exhibiting effluorescence and possibly acting a point source for falling materials

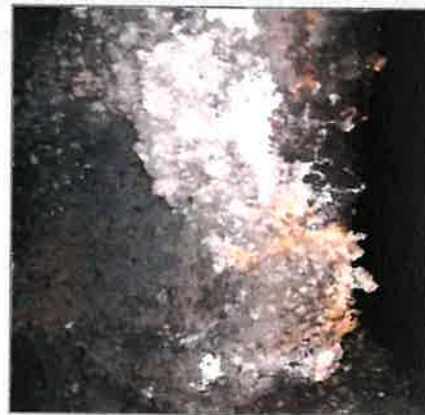
Photo 4

Borescope image of structurally diminished ACM from the fire proof coating effluorescence on the ceiling beams in the main auditorium

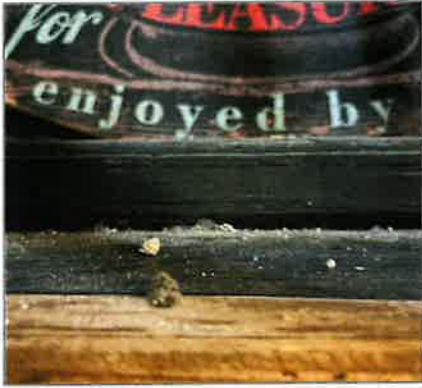
Photo 5

ACM falling from cross beams in stage area

2. Containment areas should be constructed for the walls occupied by cross beams with sprayed on coatings with ACM. This contained area should include the atmosphere occupied by the cross beams and the space on the floor directly below where beam coating materials have fallen. Materials which have dislodged and fallen to the stage surface must be removed. It is recommended that materials on the cross beams be encapsulated. Wrapping the ACM with an industry approved encapsulate material is preferred over a spray coating. It is hypothesized that spraying these materials could inadvertently dislodge more ACM.

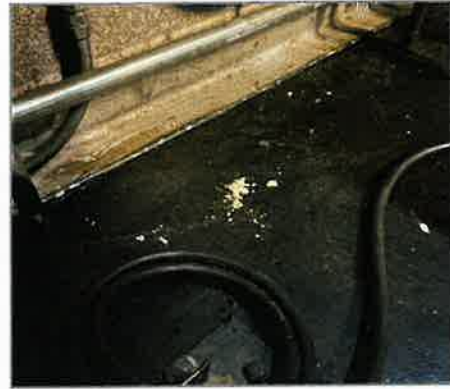
Photo 6

ACM falling from cross beam materials in stage area

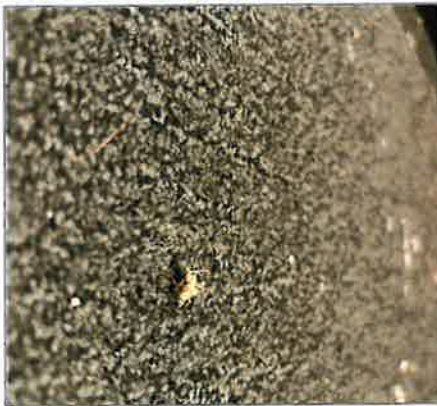
Photo 7

ACM on second floor balcony carpet

3. The carpet on the second-floor balcony seating area, along the west wall stairs (stage left) should be contained for ACM. The carpet is now recommended for abatement. The approximate abatement square footage of this area is ~650ft², including ~350ft² of carpet materials. The materials appear to be mostly intact in granular form on the carpet surface. Containment and negative pressure are recommended to prevent cross contamination to the rest of the auditorium.

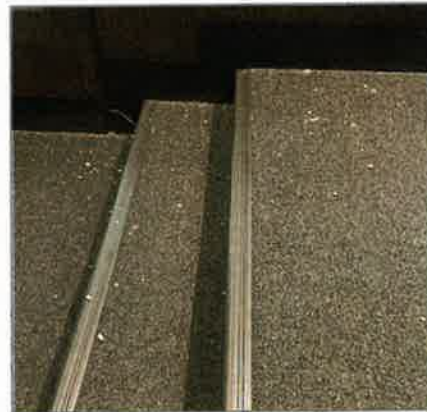
Photo 8

ACM on second floor balcony carpet

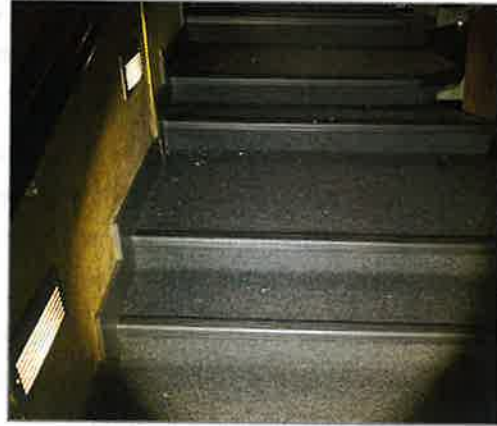
Photo 2

Visible debris on second floor west side of auditorium hall

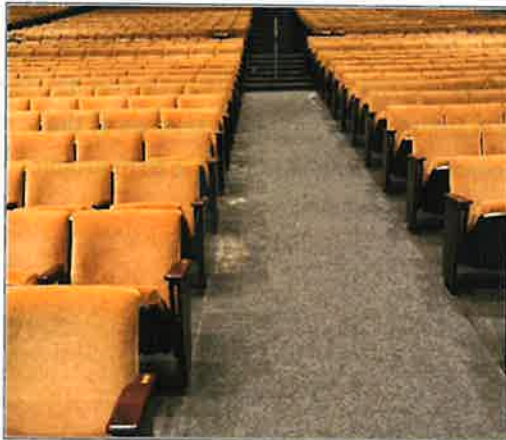
Photo 3

Microbial growth extending north in area of proposed carpet removal

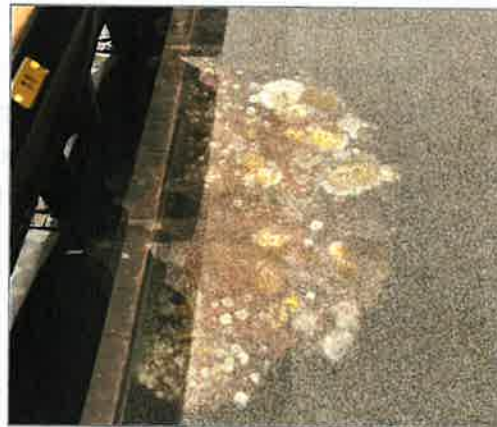
Photo 4

Multi species microbial growth directly in front of stage in area of proposed carpet removal

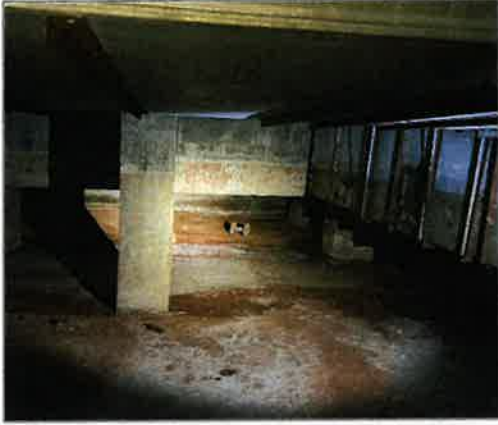
HVAC return duct work below structure and directly below main auditorium hall

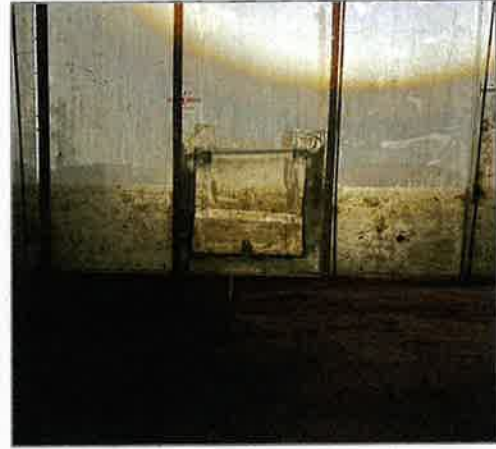
Photo 2

4. Further inspection of the HVAC systems revealed a crudely cut and unsealed access panel in the main return duct (beneath main structure) below the main auditorium hall. This duct work exhibited signs of possible previously flooding. There were water stains along the duct work, which were located in lowest point beneath the main structure.

HVAC return with hole cut into main return below main auditorium hall

1. The below structure main damaged return is recommended for cleaning and encapsulation with a contingency for removal and replacement of damaged areas. Replacement of damaged areas is recommended if HVAC contractor determines repair does not return the system to operational and air quality standards.

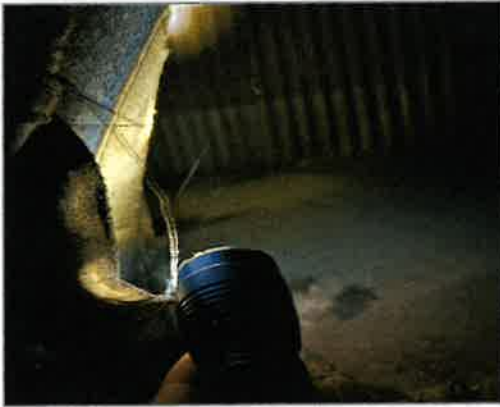
Photo

View of access hole cut into the HVAC return below main auditorium

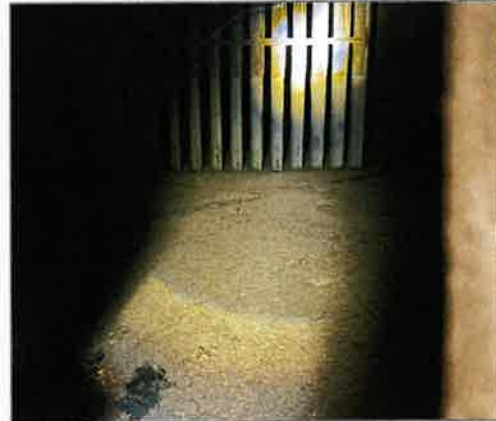
Photo

Second view point of hole cut into the HVAC return below main auditorium

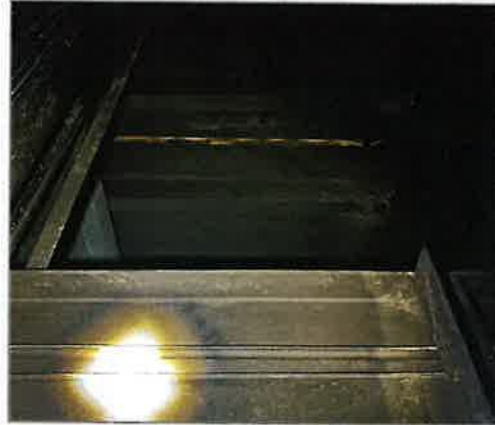
Photo 2

Looking up at ceiling seam inline with possible ceiling leak

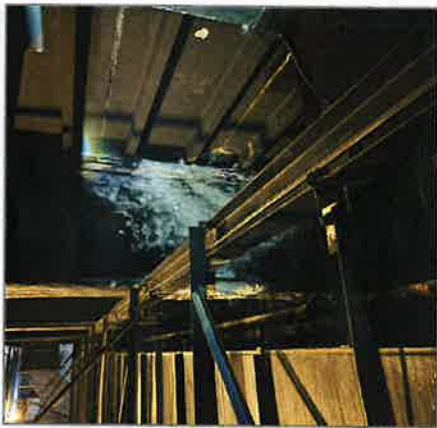
Photo 3

2. There was the visual presence of a roof leak on the west-northwest side of the structure, observed from the mezzanine. The leak was causing discoloration and crumbling of presumed ceiling insulation. Crumbling materials can be seen on the stairs of the second floor along west wall middle of seating rows. This can be another source of humidity and water ingress.

Possible roof leak on west-northwest side of building

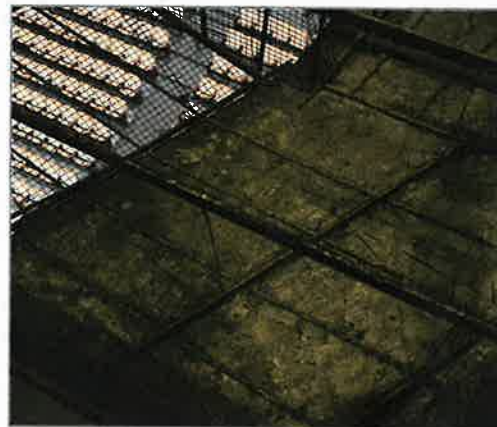
Photo 4

Second vantage point of main auditorium looking down from mezzanine. Pictured is the topside of acoustical tiles. There is dust but no sign of microbial biomass.

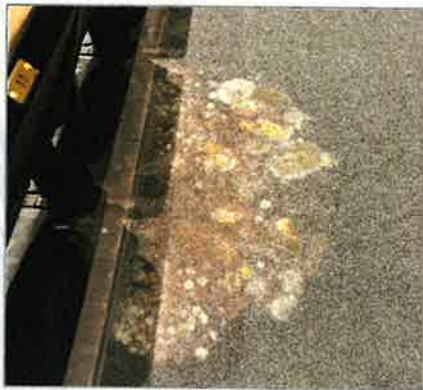
Photo 1

Fungal growth on carpet in front row directly in front of stage. Significant growth observed.

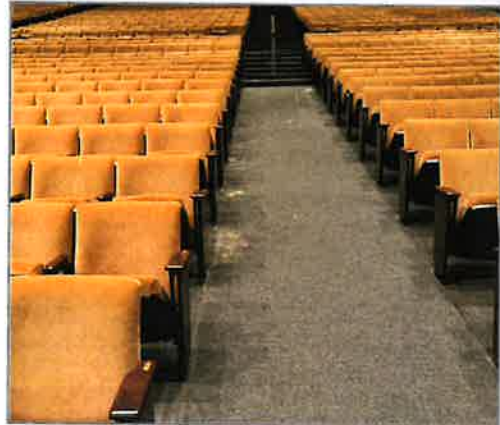
Photo 2

Facing North toward lobby from stage. Fungal growth extends up gradient to lobby doors.

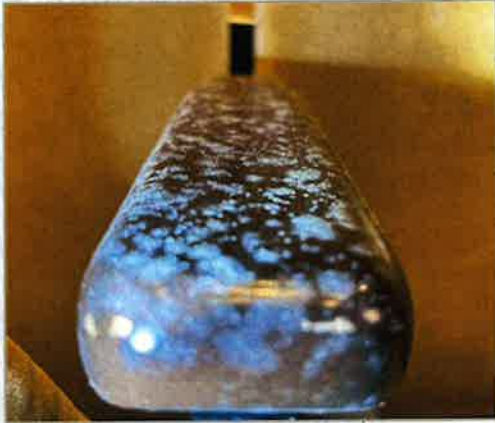
Photo 5

Representative armrest of fungal growth on first floor auditorium hard surfaces (wood)

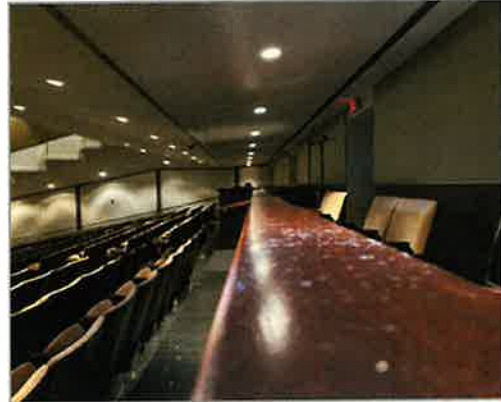
Photo 6

Directly East of sample location and sample# 5- fungal growth present on wood surfaces

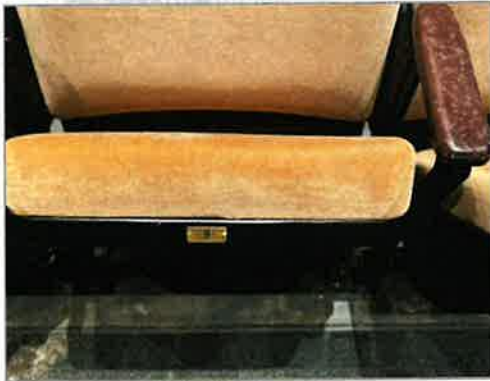
Photo 7

Fungal contamination of armrest but no visible on upholstery. Middle section close to stage.

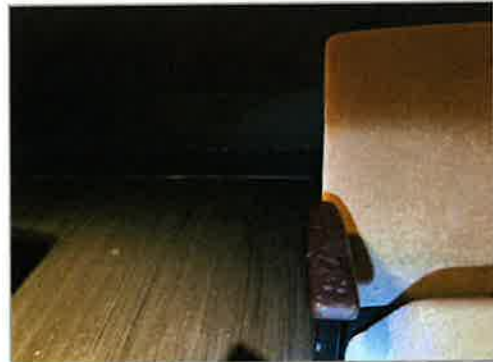
Photo 8

Fungal growth hard surfaces moving North from stage-still no visible upholstery contamination

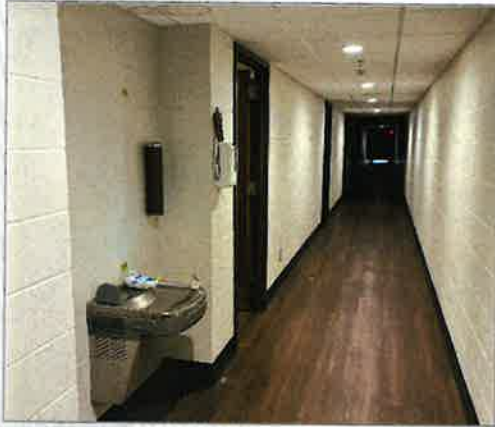
Photo 9

Sampling location and sample #8 next to water fountain. Visible stain on ceiling tile.

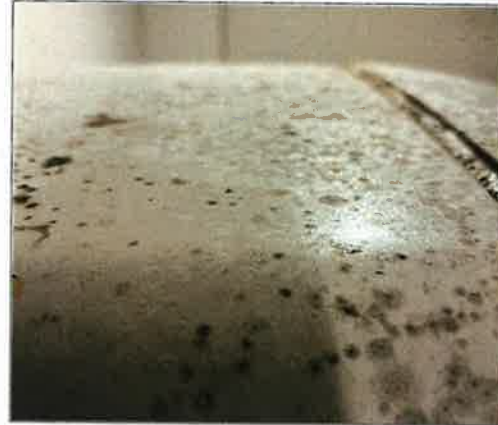
Photo 10

Facing East from photo #9. Same hallway. Visible surface contamination of painted metal on top of refrigerator.

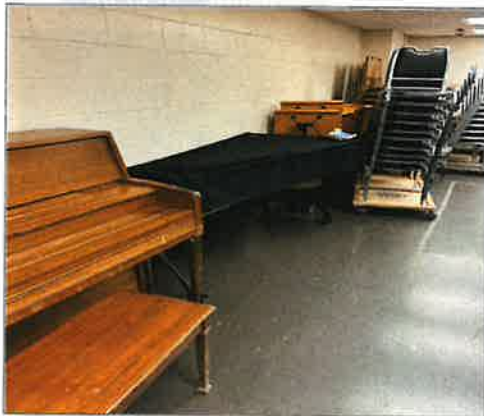
Photo 11

Sampling location and sample #9. Southeast basement storage. Surface growth on chairs and piano.

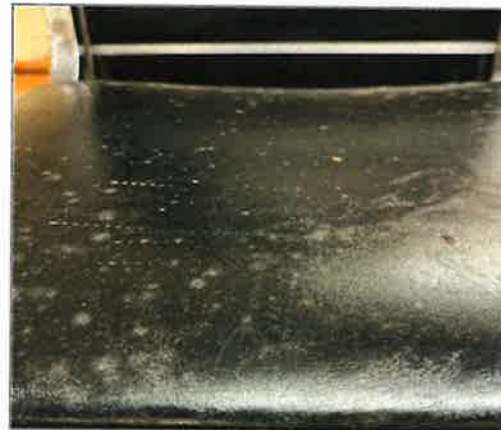
Photo 12

Chair surface from photo #11 location.

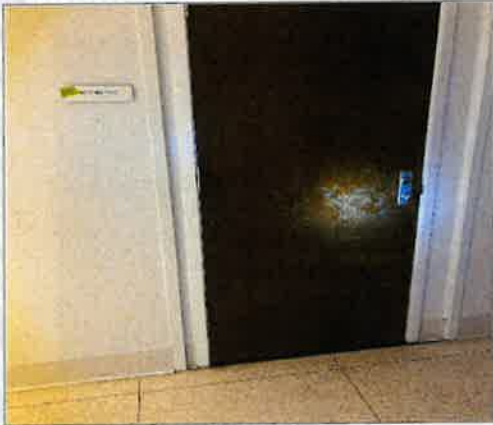
Photo 13

Ground floor lobby west of center of lobby and refreshment/couch seating area. Wooden door significantly contaminated. Room represents sampling site #11

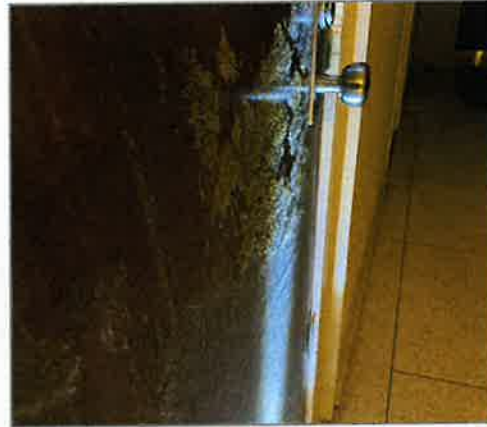
Photo 14

Same door from photo #13. Large spore mass on surface.

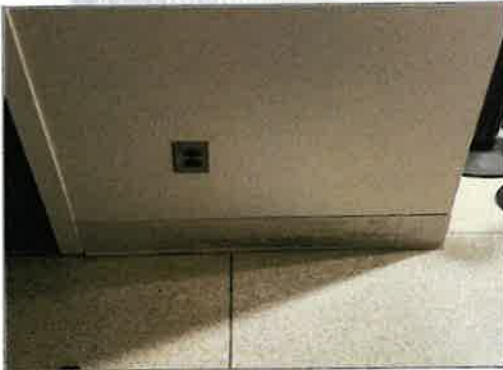
Photo 15

Facing North and accross from site #11 in photo 14. Dematiaceous fungal growth on sythetic base boards

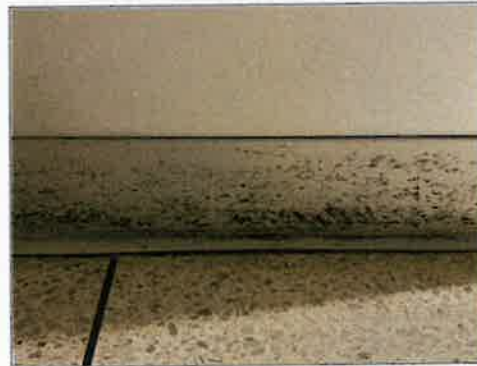
Photo 16

Close up of photo 15 for reference.

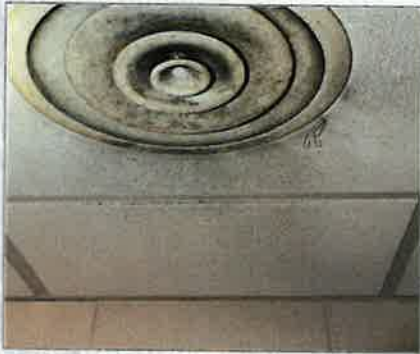
Photo 17

In room representing Sampling Site #11.
Mix of AMG and dust on supply diffuser.

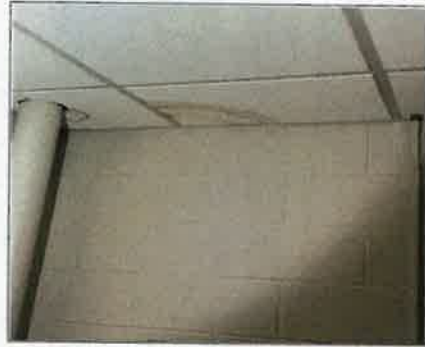
Photo 18

Ceiling tiles water stained and presumed
AMG in the same room as photo 11
representing Sampling site #11

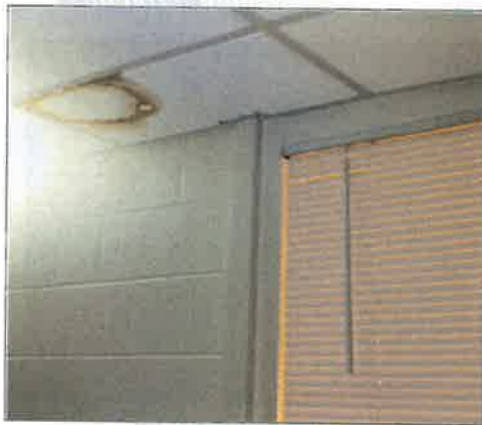
Photo 19

Sampling Site # 11 further indication of
moisture intrusion in this room from
ceiling tile stains. Significant odor.

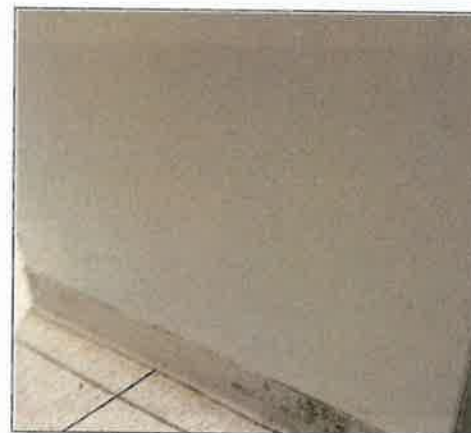
Photo 20

Hallway directly East of restricted room
Site #11- sythetic baseboards exhibiting
fungal growth from dematiacious
colonizers

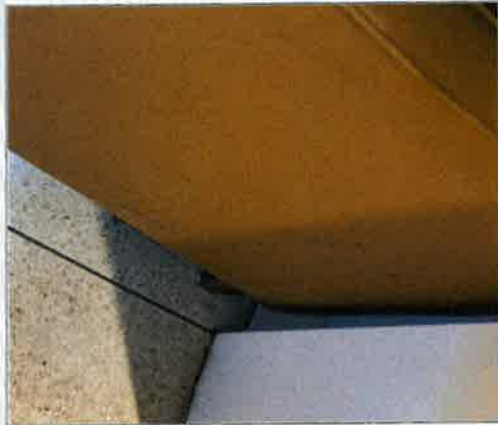
Photo 21

Ground floor lobby, East of highly impacted Site #11, pervasive colonization of couch surfaces with fungal growth

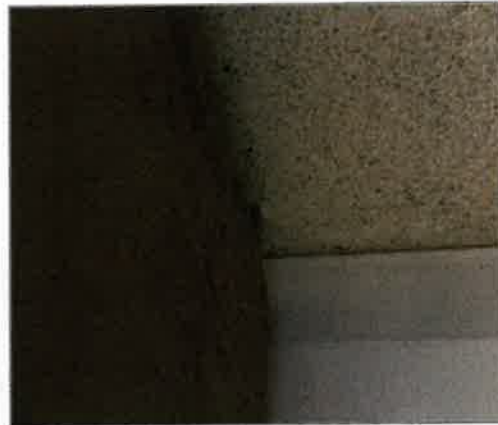
Photo 22

Ground floor lobby couch with additional fungal growth-different vantage point

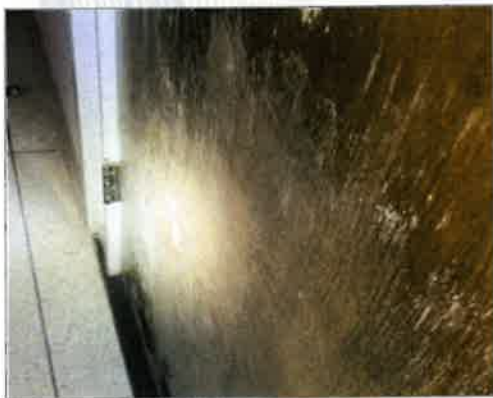
Photo 23

Sister room to Site #11, Ground floor lobby, East door. Significant fungal growth on wood door surface

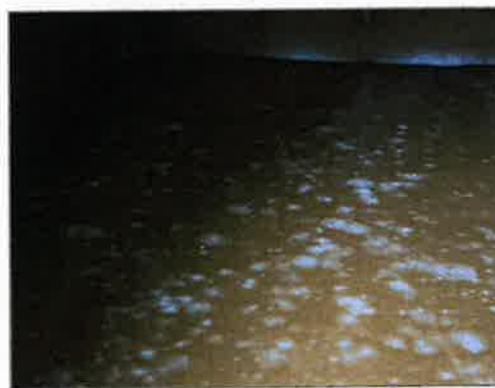
Photo 24

Moving East from photo 11 door, ground floor lobby. Chairs are contaminated with fungal structures.
