# ASBESTOS SURVEY

PROPOSED DOLLAR GENERAL - COLLINS, MS

1090 AND 1082 COLD SPRINGS ROAD  
COLLINS, MISSISSIPPI 39428

ECS PROJECT NO. 49:23809-A

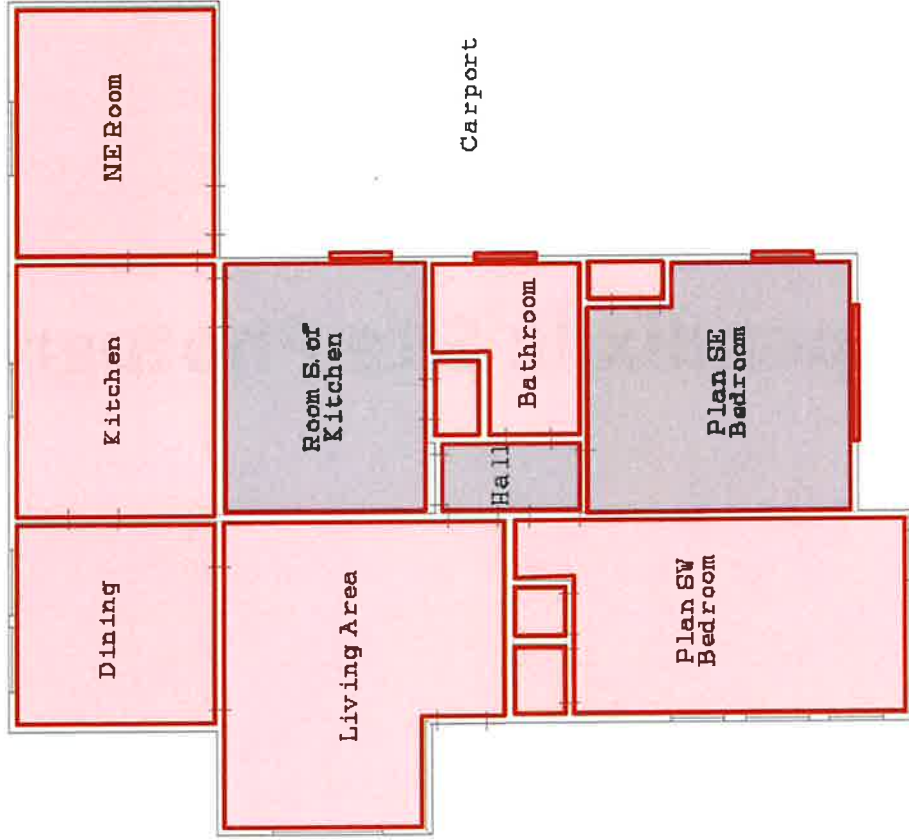
Figure 4

Extent of ACMs  
Proposed Dollar General Store  
1082 and 1090 Cold Springs Road  
Collins, Mississippi  
ECS Project No. 49-23809-A

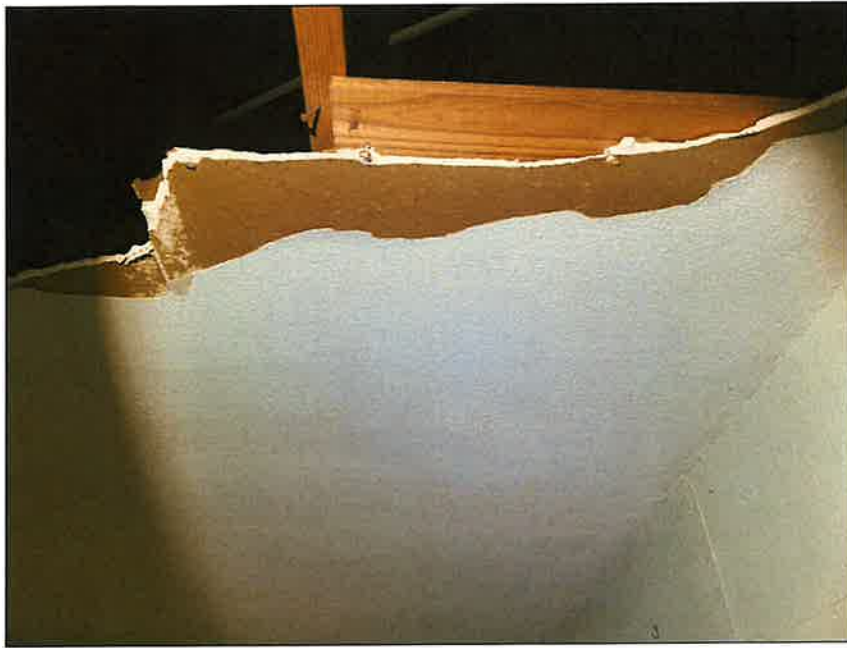
| Location | Material Description | Analytical Result | Category |
|--|---|--|---|
| Throughout Interior | White/off-white Ceiling Texture | 2% Chrysotile | Friable |

| Sample ID | Material Location | Material Description | Analytical Results | Category | Estimated Quantity |
|---|--|---|---|---|---|
| CTX1-1 through CTX1-5 | Ceiling throughout interior of structure | White/Off-white Ceiling Texture | 2% Chrysotile | Friable | 1,300 square feet |

9 - ACM ceiling texture (CTX1)

Federal, state, and local regulations require asbestos-containing materials be removed prior to disturbance by demolition operations. However, if the building is to be demolished, by regulation, Category I non-friable materials and in some instances Category II materials may remain in place during demolition under the following provisions: The Contractor must have appropriate training

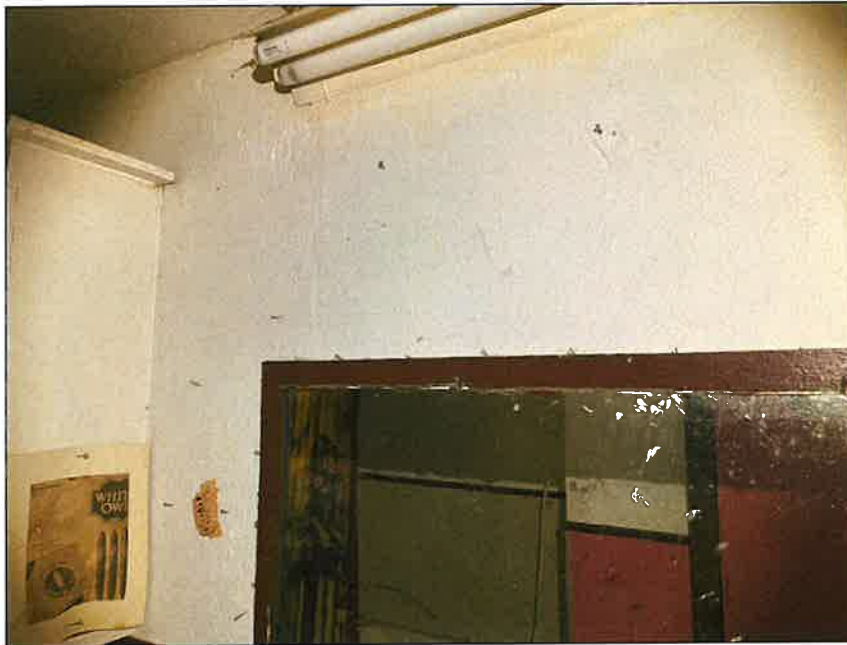
| Location | Material Description | Analytical Result | Category |
|--|---|--|---|
| Throughout Interior | White Joint Compound (applied as surfacing material to drywall) | 2% Chrysotile | Friable |

| Sample ID | Material Location | Material Description | Analytical Results | Category | Estimated Quantity |
|---|--|---|---|---|---|
| DW1-1 through DW1-5 | Walls throughout structure | Off-white Joint Compound (applied as surfacing) associated with drywall | Joint Compound - 2% Chrysotile<br>Drywall - None Detected | Friable | 4,500 square feet |

10 - ACM joint compound associated with drywall (applied as surfacing material) (DW1)

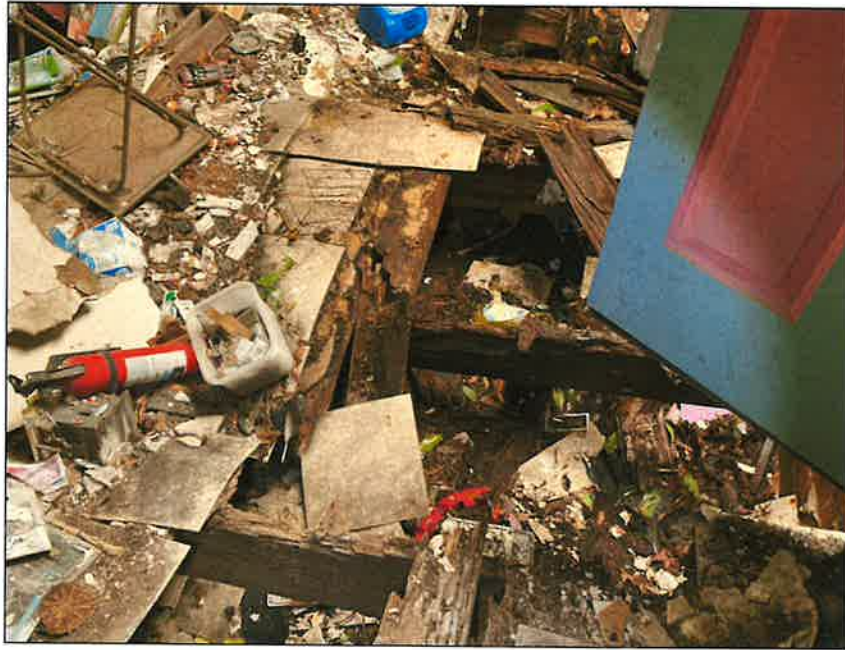
| Sample ID | Material Location | Material Description | Analytical Results | Category | Estimated Quantity |
|---|---|---|---|---|--|
| FL1-1, FL1-2 | Kitchen and Plan NE Room | 12" x 12" Off-white Floor Tile and associated Yellow Mastic | None Detected (ND) | Not Applicable (NA) | NA |

11 - Non-ACM 12" x 12" off-white floor tile and associated mastic (FL1)

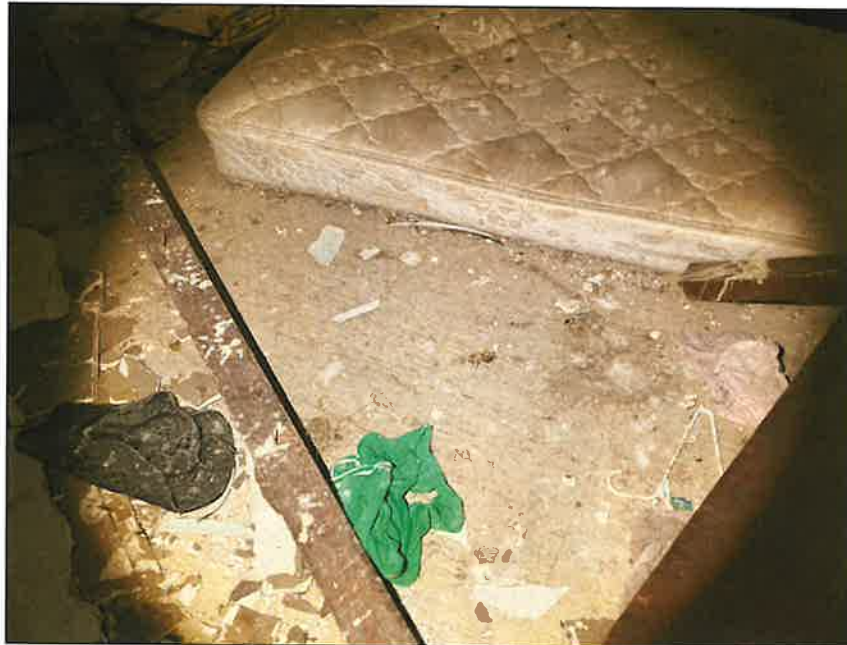
| Location | Material Description | Analytical Result | Category |
|--|---|--|---|
| Room Plan South of Kitchen, Hallway, and Plan SE Bedroom | 12" x 12" Off-white Floor Tile (thin) and associated Black Mastic | Floor Tile - 2% Chrysotile<br>Black Mastic - 2% Chrysotile | Category I<br>Non-Friable |

| Sample ID | Material Location | Material Description | Analytical Results | Category | Estimated Quantity |
|---|---|---|---|---|--|
| F2-1, FL2-2 | Room Plans of Kitchen, Hallway, and Plan SE Bedroom | 12" x 12" Off-white Floor Tile (thin) and associated Black Mastic | Floor Tile - 2% Chrysotile Black Mastic - 2% Chrysotile Black Felt Paper - ND | Category I Non-Friable | 375 square feet |

12 - ACM 12" x 12" off-white floor tile and ACM black mastic (FL2)

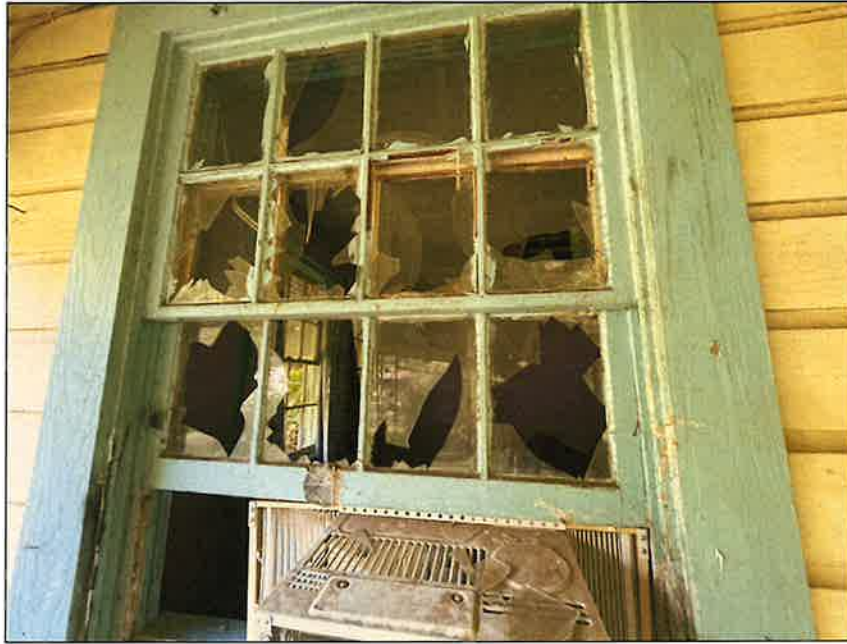
| Location | Material Description | Analytical Result | Category |
|--|---|--|---|
| Windows along Plan Eastern and Plan Southern Elevations | Beige Glazing | 2% Chrysotile | Category II<br>Non-Friable |

| Sample ID | Material Location | Material Description | Analytical Results | Category | Estimated Quantity |
|---|---|---|---|---|--|
| GLZ1-1, GLZ1-2 | Exterior windows | Beige Glazing | 2% Chrysotile | Category II Non-Friable | 30 linear feet (limited to windows along plan east and south elevations) |

13 - ACM window glazing (GLZ1)

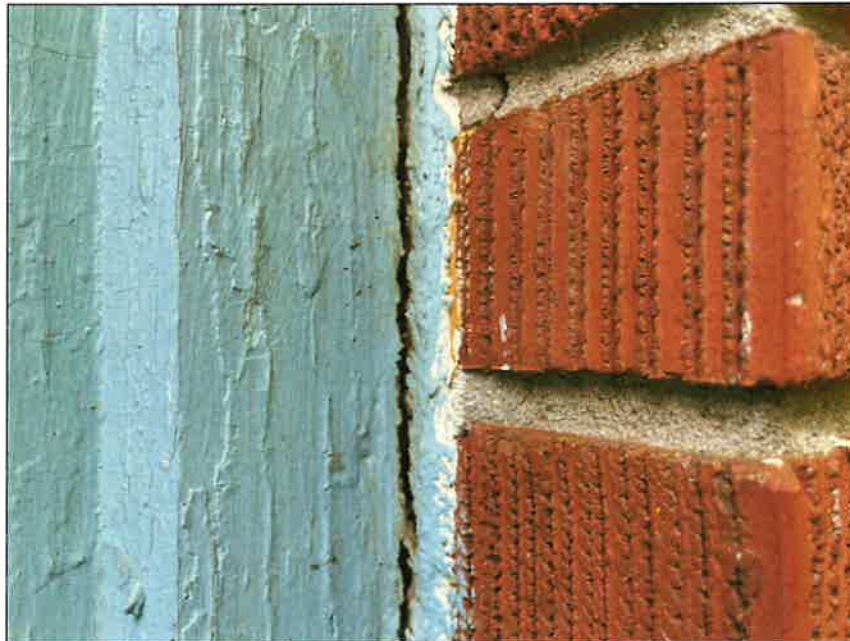
| Sample ID | Material Location | Material Description | Analytical Results | Category | Estimated Quantity |
|---|---|---|---|---|--|
| CLK1-1, CLK1-2 | Exterior between window frames and walls | Blue/White Caulking | ND | NA | NA |

14 - Non-ACM building caulk (CLK1)

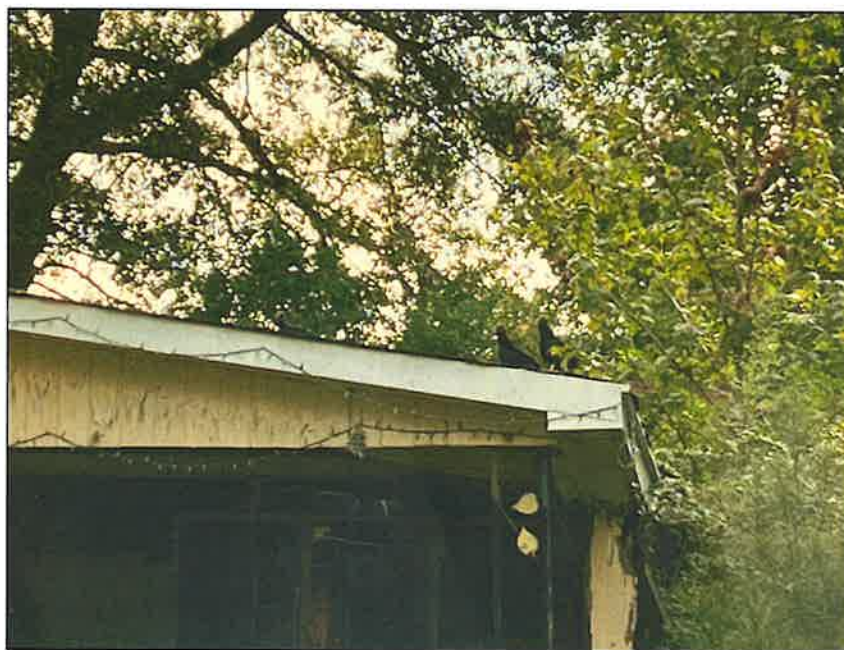
| Sample ID | Material Location | Material Description | Analytical Results | Category | Estimated Quantity |
|---|---|---|---|---|--|
| RF1-1, RF1-2 | Roof | Brown/Black Roofing Shingles and Black Felt Paper | ND | NA | NA |

15 - Non-ACM roofing materials (RF1)

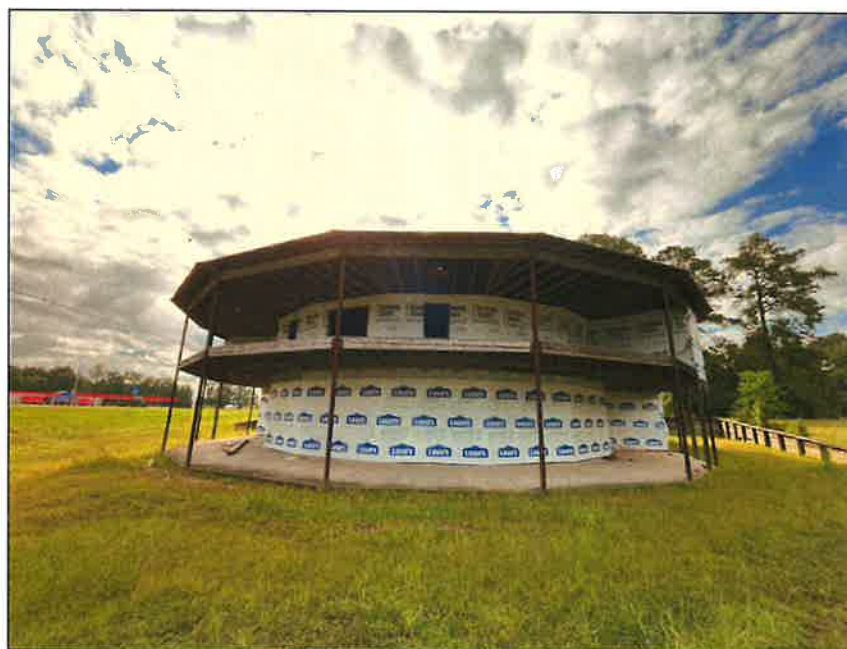
| Sample ID | Material Location | Material Description | Analytical Results | Category | Estimated Quantity |
|---|---|---|---|---|---|
| RF1-1, RF1-2 | Roof | Black Roofing Shingles and Black Felt Paper | ND | NA | N |

16 - Exterior of 1090 Cold Springs Road, and non-ACM roofing materials (RF1)

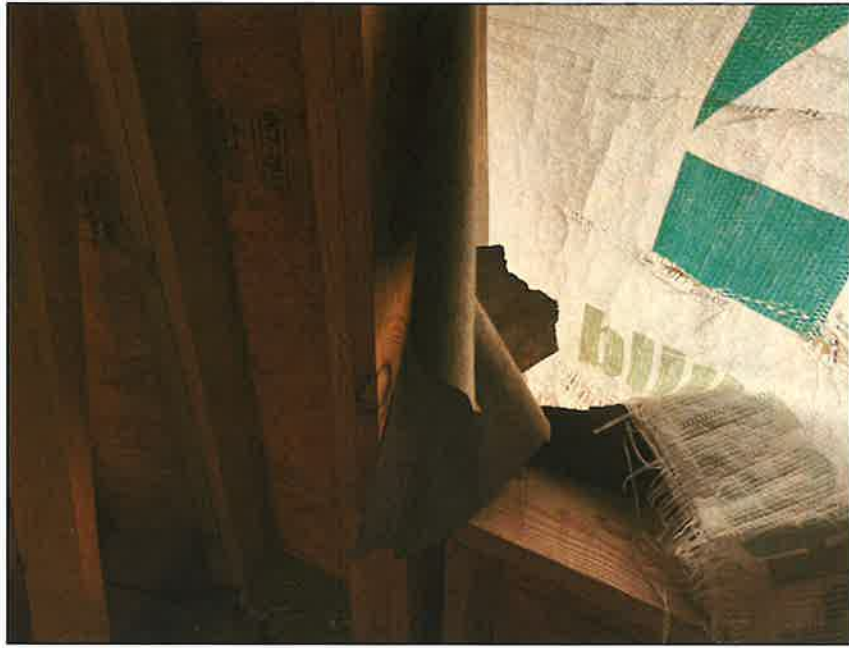
| Sample ID | Material Location | Material Description | Analytical Results | Category | Estimated Quantity |
|---|---|---|---|---|--|
| VB1-1, VB1-2 | Exterior | Black Vapor Barrier | ND | NA | NA |

19 - Non-ACM vapor barrier (VB1)
