NESHAP ASBESTOS-CONTAINING MATERIALS SURVEY REPORT

**Merit Health River Region, West Campus
Site Specific Asbestos Survey
1111 North Frontage Rd.
Vicksburg, MS 39180**

GHP Project No. 230046.01

**Survey Date: July 8-11, 2024
Final Report Date: July 30, 2024**

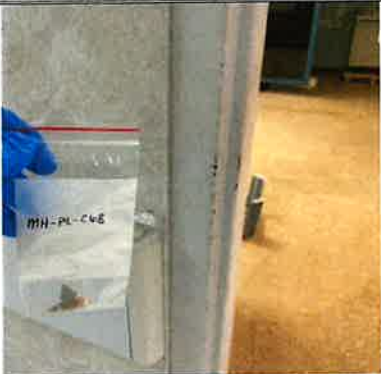
None Detected	White Wall Plaster
D

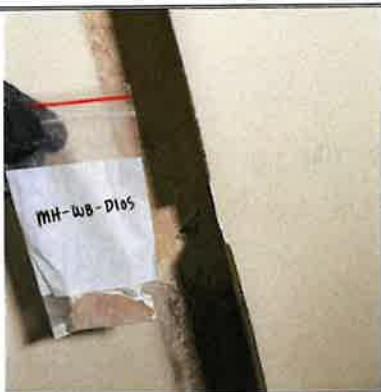
None Detected	Wallboard, Tape & Mud
E

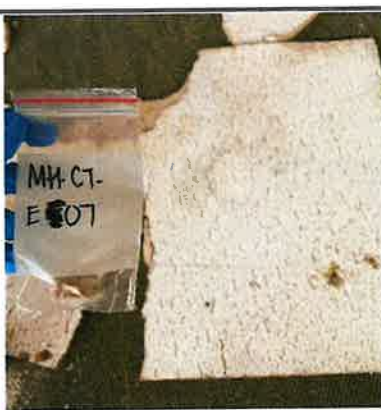
None Detected	2' x 4' Fissure Ceiling Tile

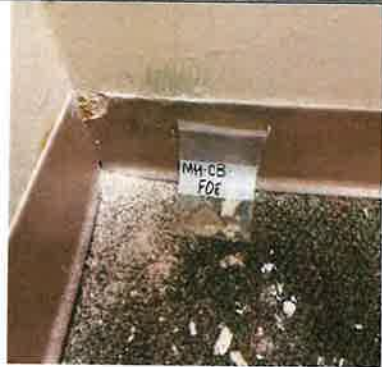
None Detected	Beige/Gray Cove Base & Yellow Mastic
G

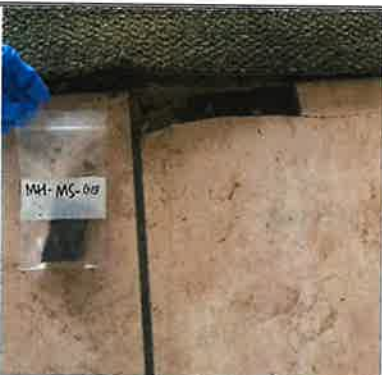
NAD - Tile 5% Chrysotile - Mastic	12" x 12" Beige Ceramic Floor Tile & Grout with Mastic
H

Based on the site investigation and sample results, GHP would recommend that any regulated materials identified within this report be removed and disposed by properly licensed and trained personnel based prior to any demolition or development of the site/facility.

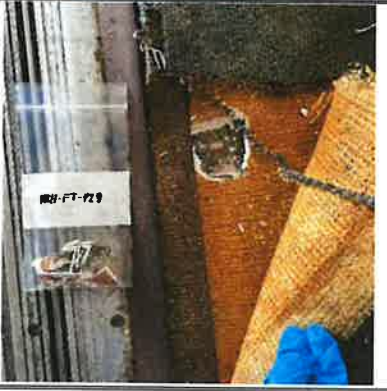
2% Chrysotile – Bottom Tile 5% Chrysotile - Mastic	12" x 12" Beige Vinyl Floor Tile (Under Carpet)

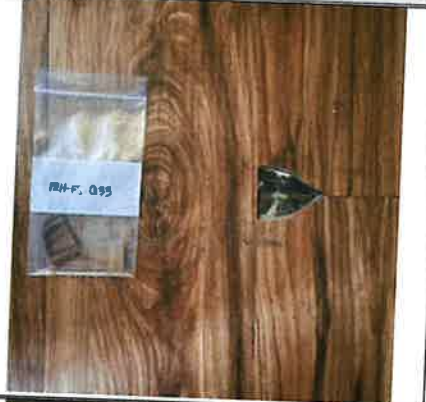
<p>NAD – Floor Sheeting 2-3% Chrysotile – Mastic</p>	<p>Light & Dark Wood Pattern Floor Sheeting</p>
R	 	<p>None Detected</p>	<p>White Automatic Door Frame Caulking</p>
S

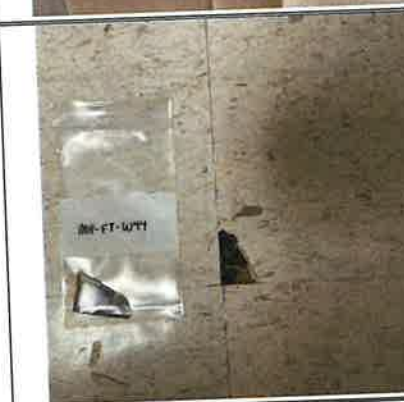
<p>NAD – Tile 5% Chrysotile - Mastic</p>	<p>12" x 12" White/Gray/Brown Vinyl Floor Tile</p>
X

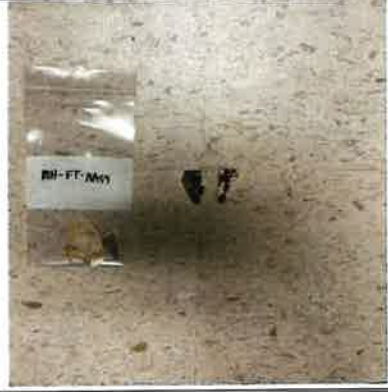
<p style="text-align: center;">NAD – Tile 3% Chrysotile – Mastic</p>	<p style="text-align: center;">12" x 12" Beige w/ Brown Fleck Vinyl Floor Tile</p>

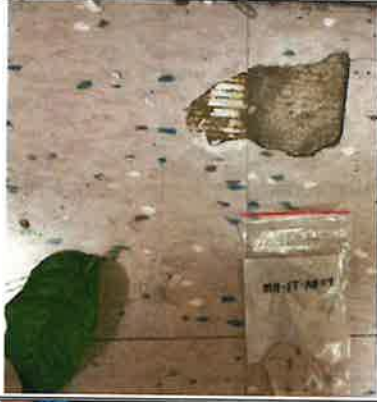
<p>2% Chrysotile – Tile 5% Chrysotile – Mastic</p>	<p>12" x 12" Pink Speckled Vinyl Floor Tile</p>
AC

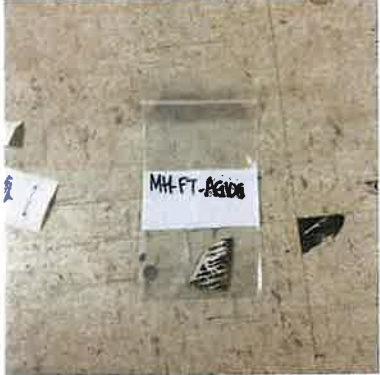
<p>2% Chrysotile – Tile 5% Chrysotile – Mastic</p>	<p>12" x 12" Cream Vinyl Floor Tile with Brown Specks</p>
AH

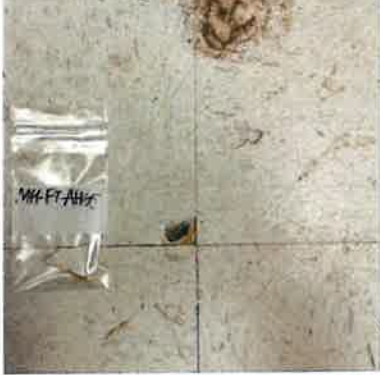
<p>NAD – Top Tile 2% Chrysotile – Bottom Tile 5% Chrysotile – Mastic</p>	<p>12" x 12" Cream Vinyl Floor Tile with Grey Flecks</p>
AI

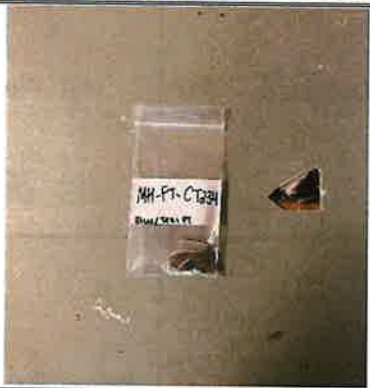
<p style="color: red;">NAD – Tile 2% Chrysotile Mastic</p>	<p style="color: red;">12" x 12" Teal Vinyl Floor Tile</p>
CU

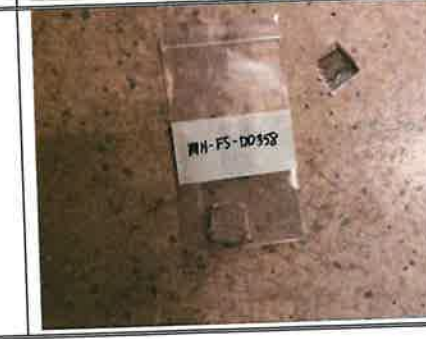
<p style="color: red;">NAD – Linoleum 2% Chrysotile – Tile 5% Chrysotile – Mastic</p>	<p style="color: red;">White Floor Sheetting with Blue Specks</p>

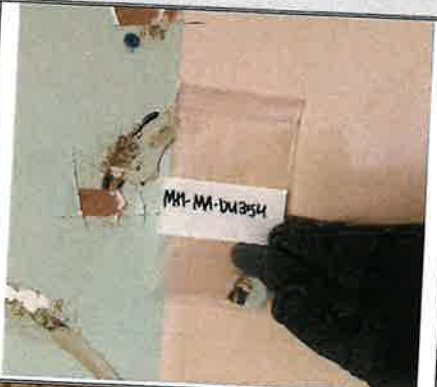
<p>10% Chrysotile</p>	<p>Black Mirror Mastic</p>
DV
