# MISSISSIPPI ASBESTOS DEMOLITION/RENOVATION NOTIFICATION FORM

**CNIC  
DEMO OF VARIOUS FACILITIES  
NAS Meridian, MS**

**Specifications – Volume 2  
Hazmat Reports  
Final Submittal**

## Asbestos and Lead-Based Paint Survey Naval Air Station Meridian Building 158 Meridian, Mississippi

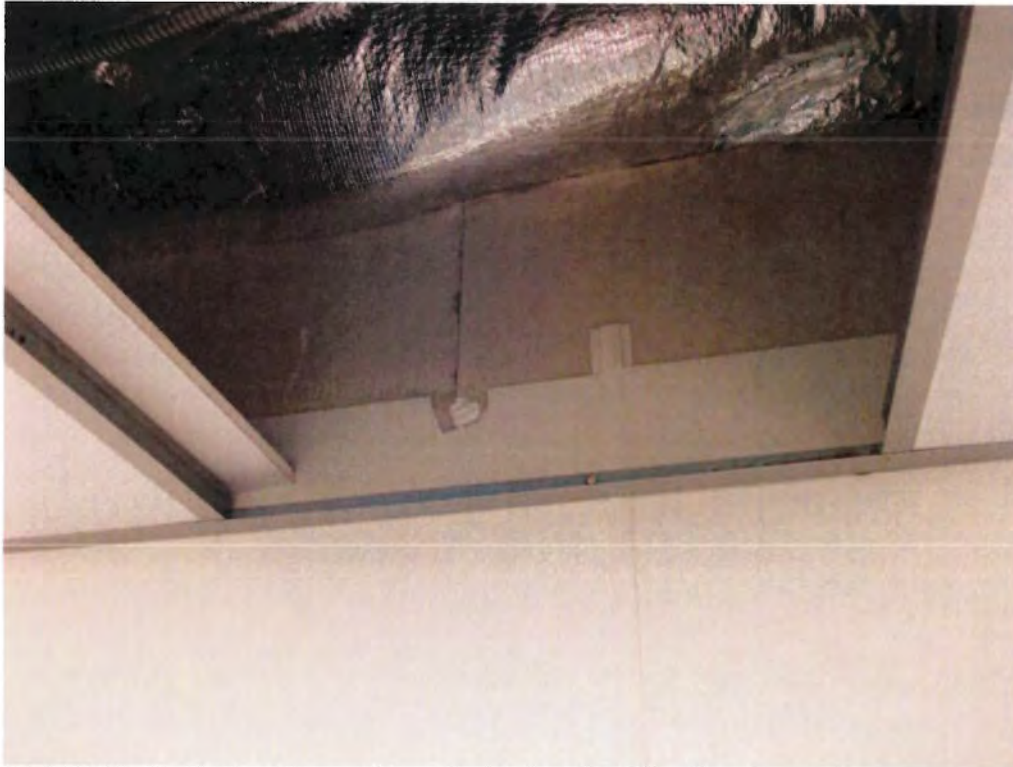
HSA 158-01: Plastic Panel Covered Drywall with Associated Tan Glue. Sample A.

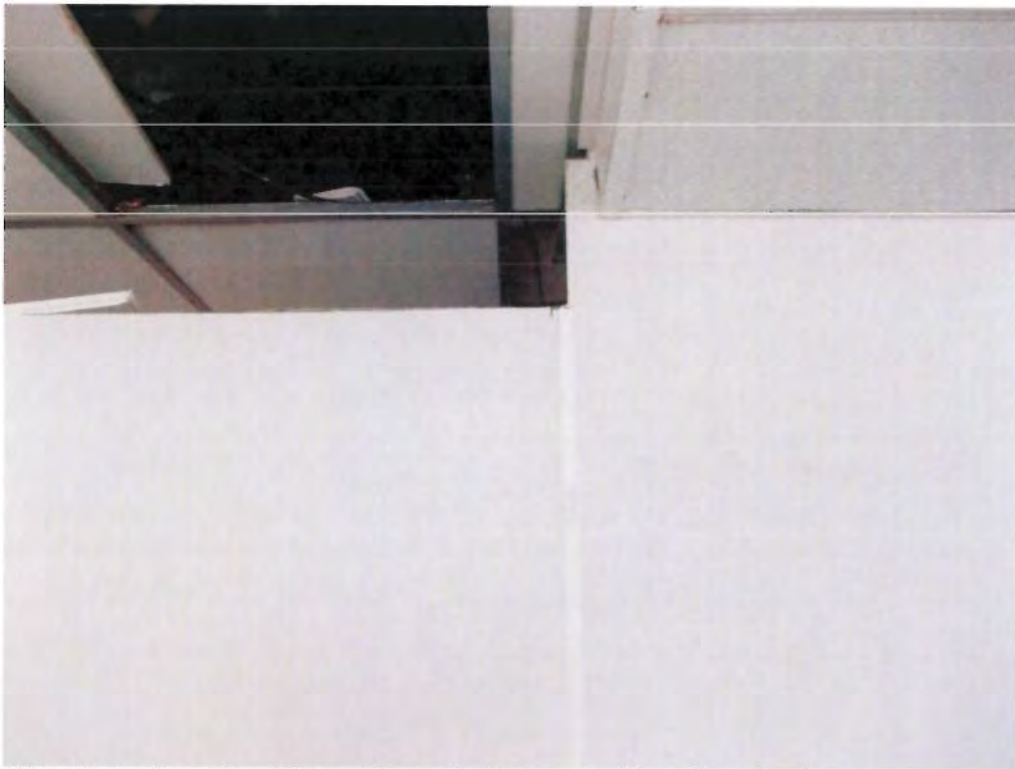
HSA 158-01: Plastic Panel Covered Drywall with Associated Tan Glue. Sample B.

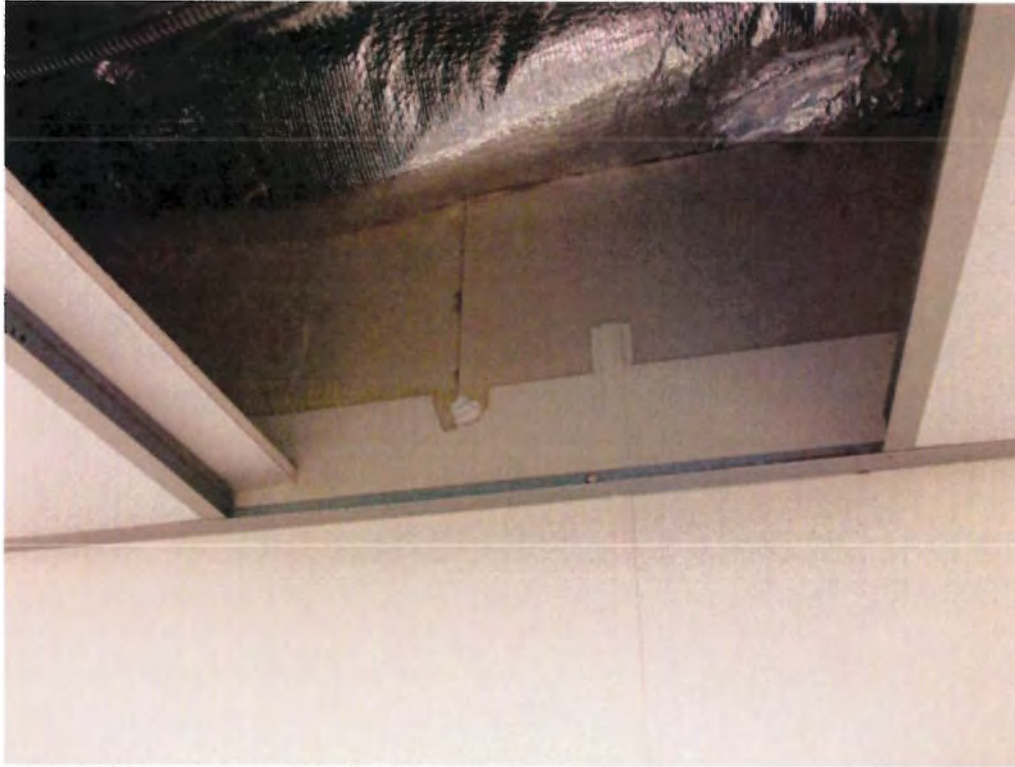
HSA 158-02: 2' x 2' Drywall Ceiling Panel. Sample A.

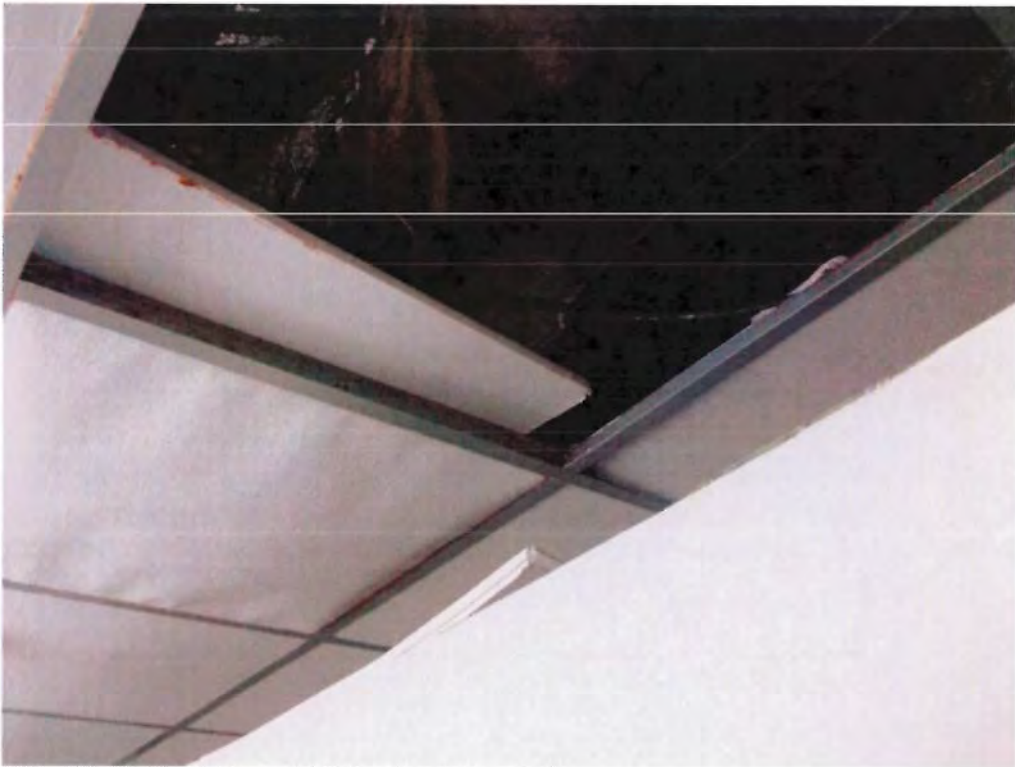
HSA 158-02: 2' x 2' Drywall Ceiling Panel. Sample B.

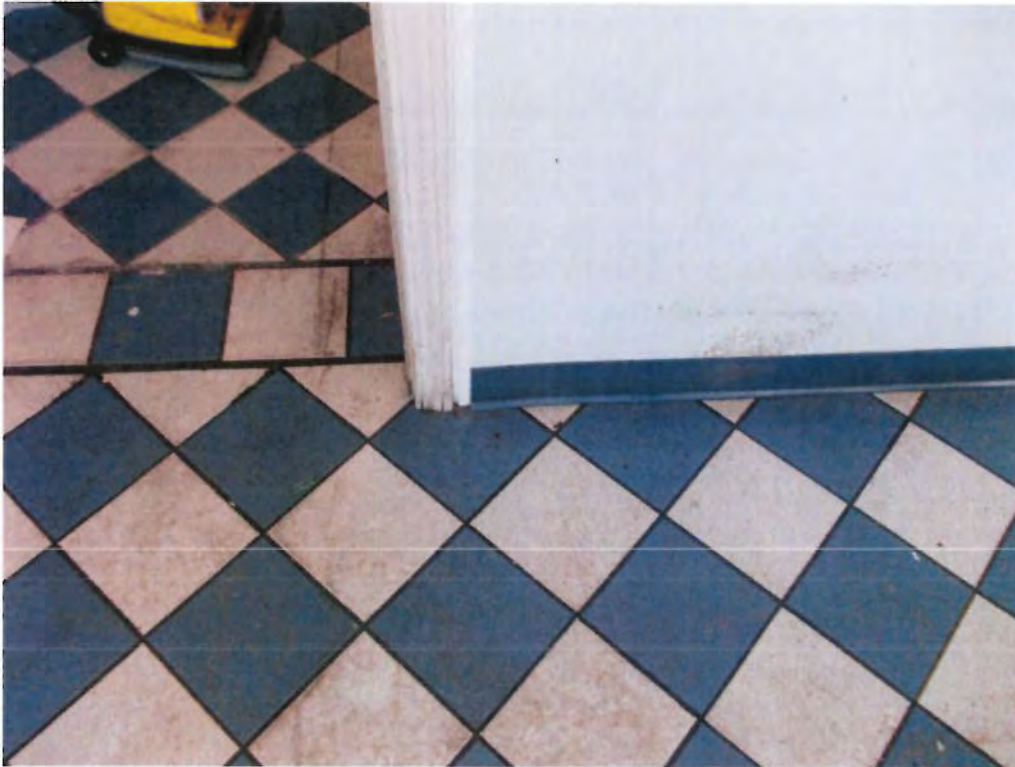
HSA 158-03: 4" Blue Cove Base and Associated Glue. Sample A.

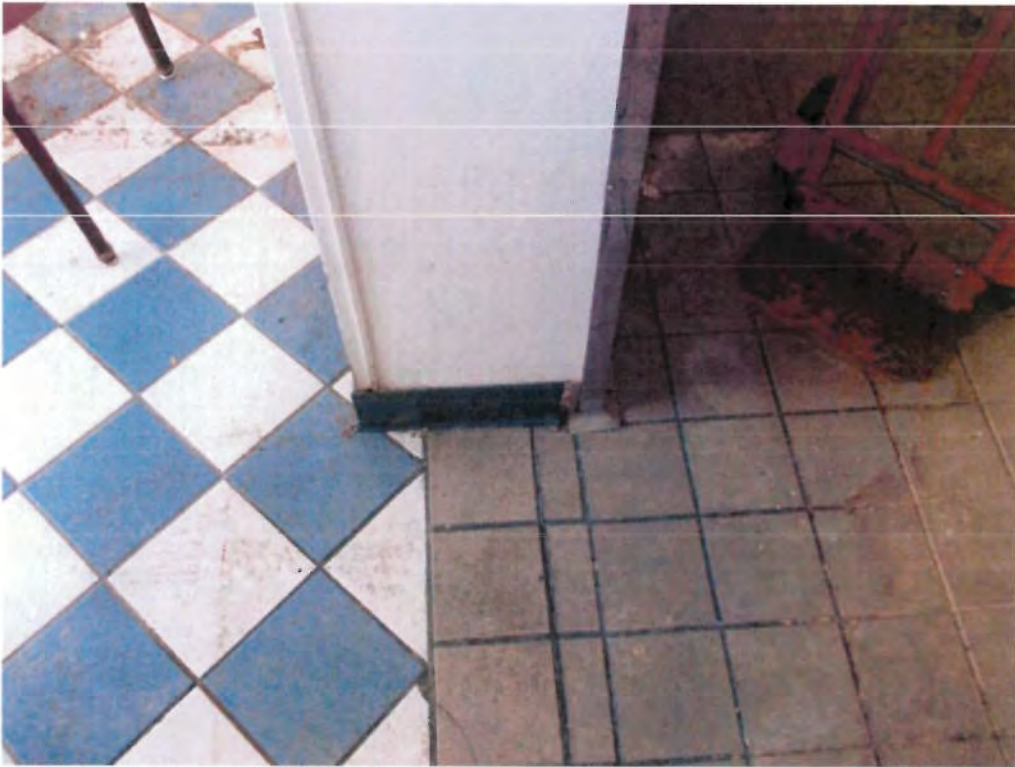
HSA 158-03: 4" Blue Cove Base and Associated Glue. Sample B.

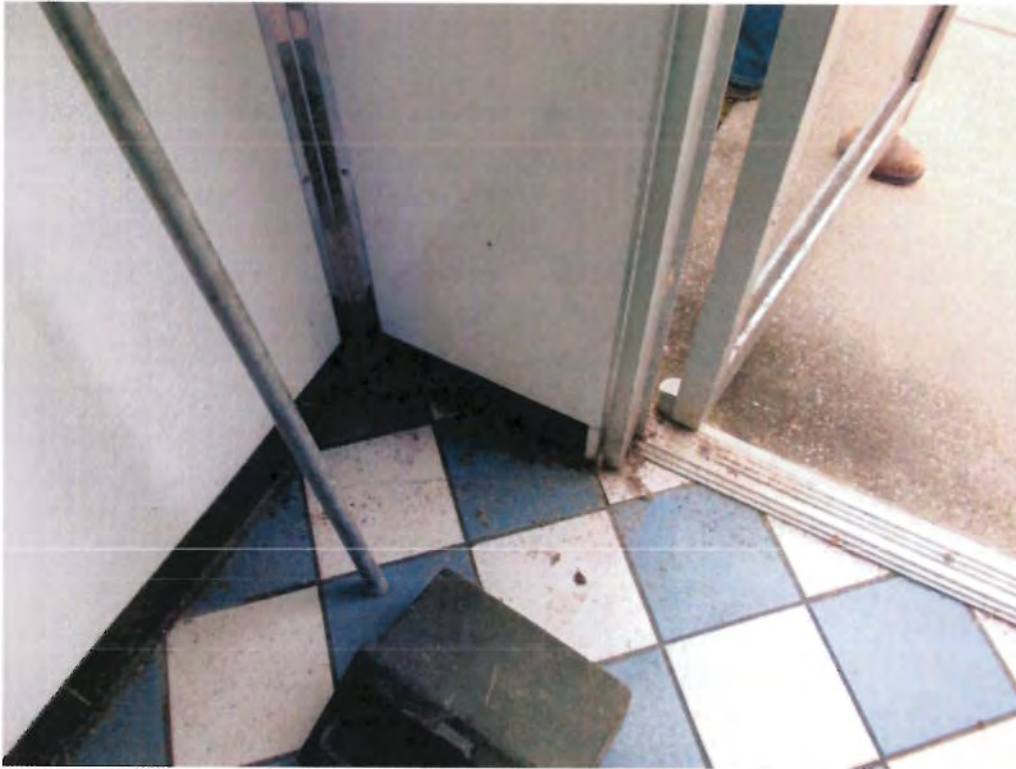
HSA 158-04: 4" Black Cove Base and Associated Glue. Sample A.

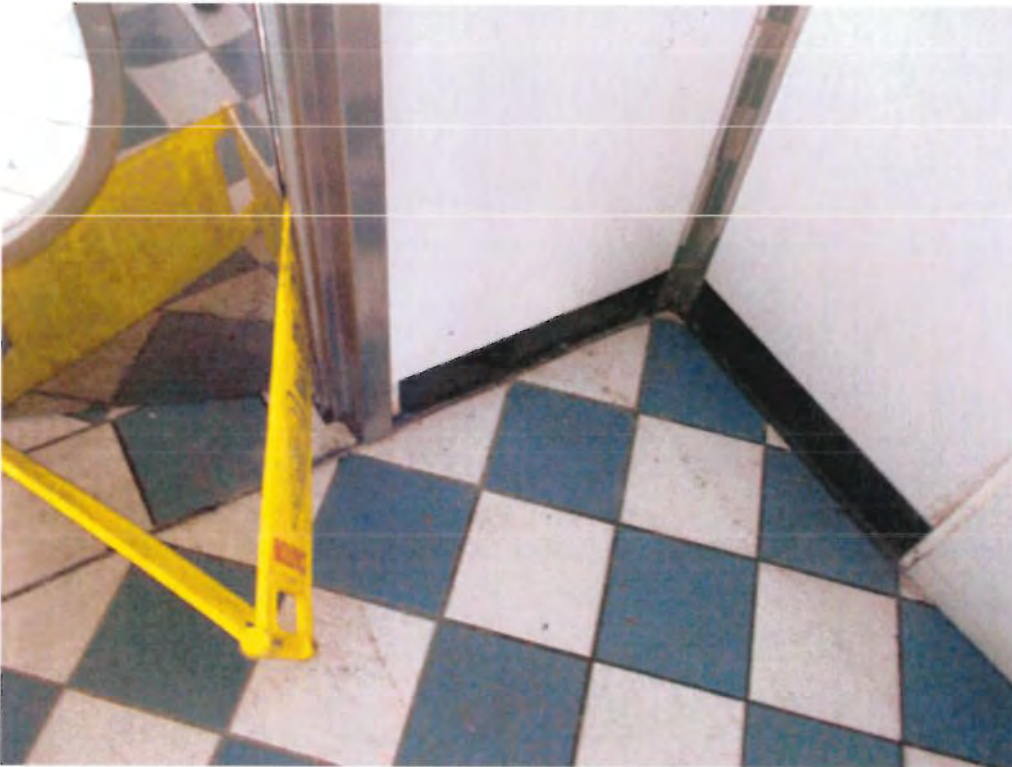
HSA 158-04: 4" Black Cove Base and Associated Glue. Sample B.

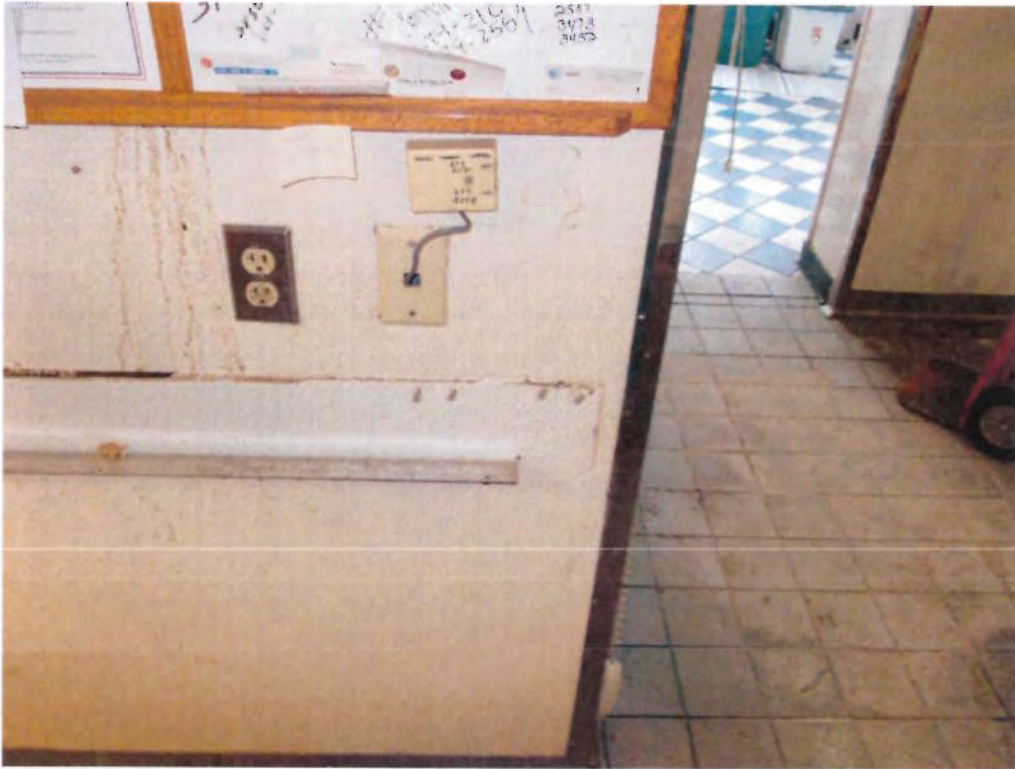
HSA 158-05: White Caulk. Sample A.

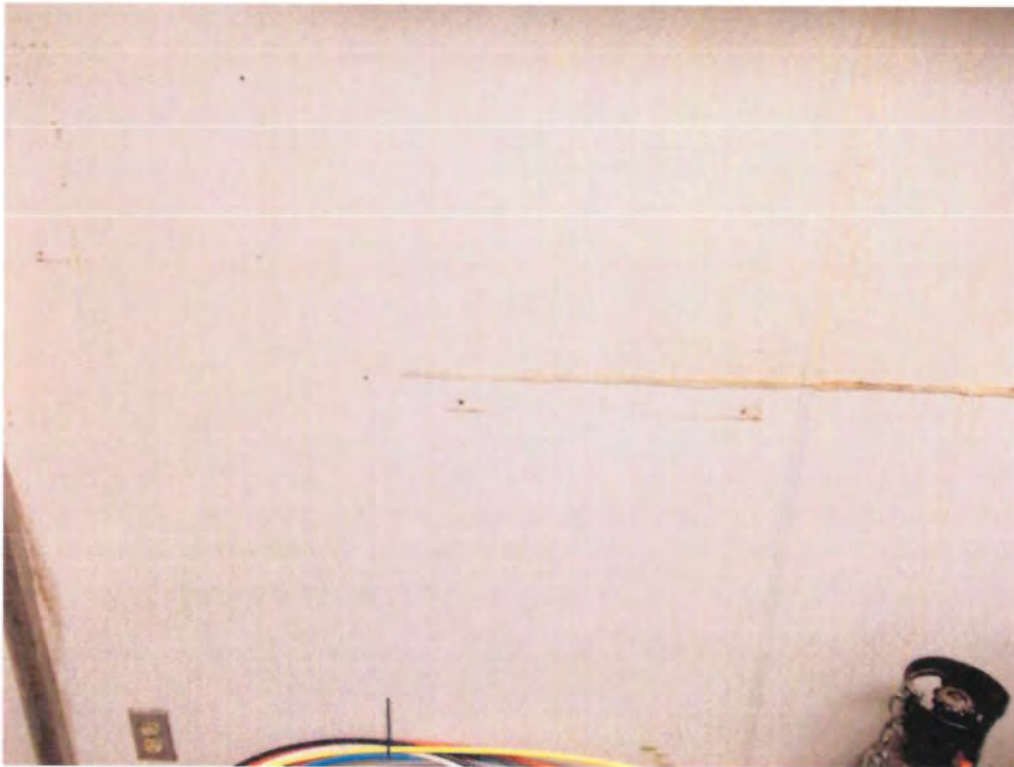
HSA 158-05: White Caulk. Sample B.

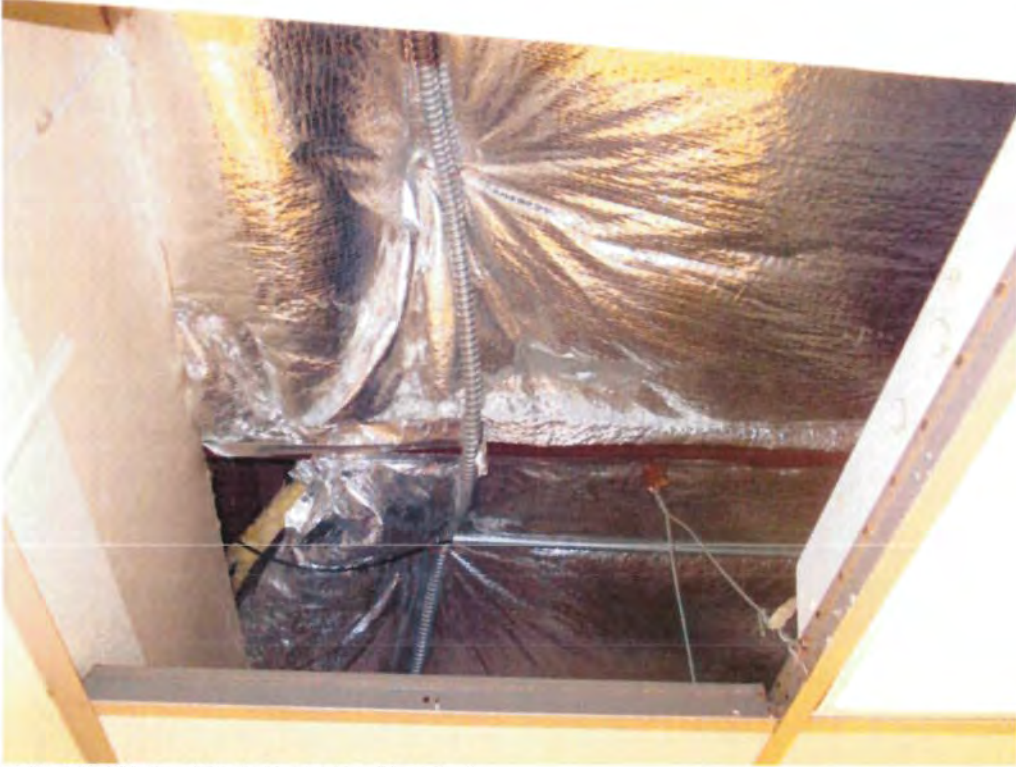
HSA 158-06: Roof Deck Insulation. Sample A.

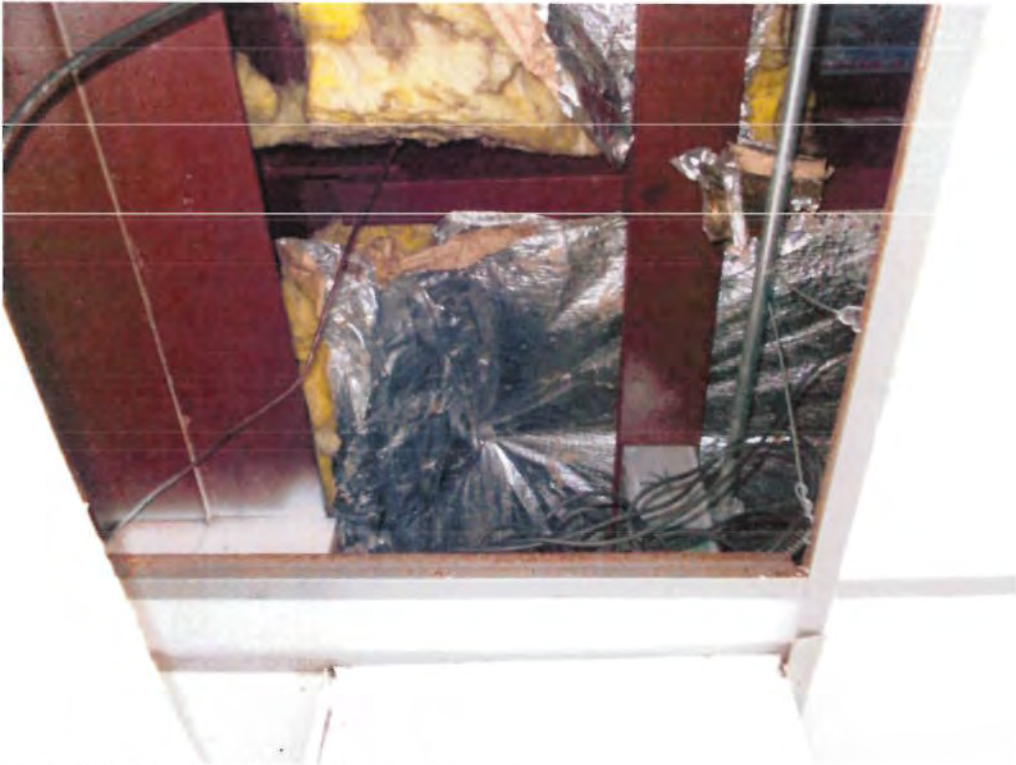
HSA 158-06: Roof Deck Insulation. Sample B.

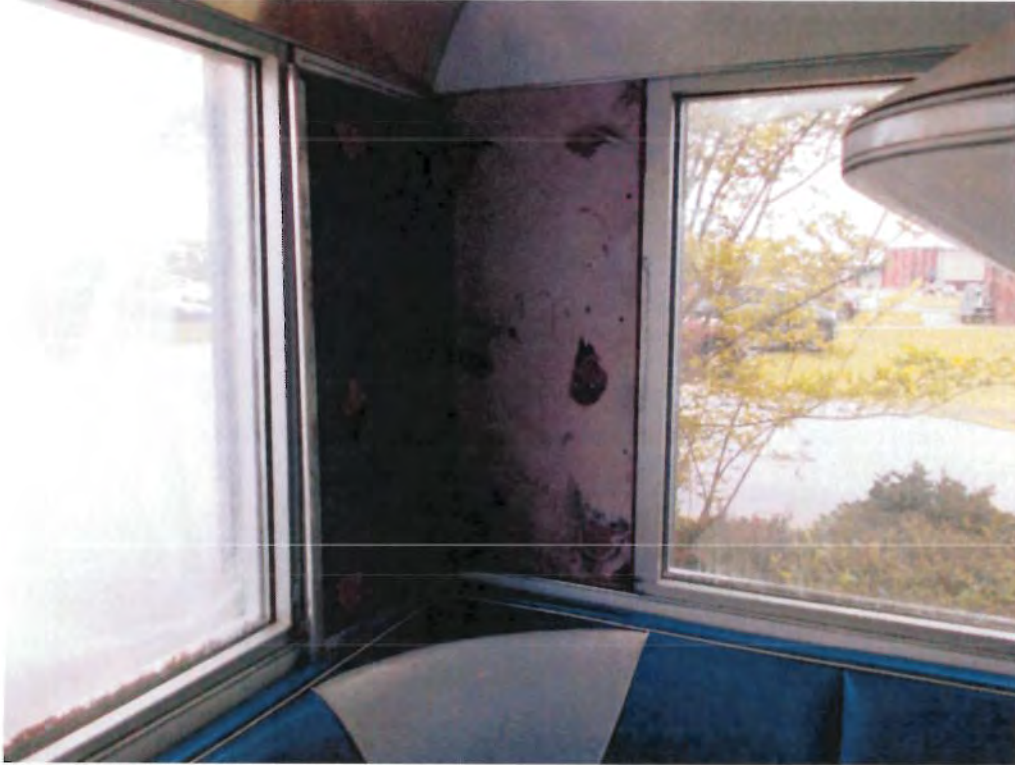
HSA 158-07: Black Glue Pods. Sample A.

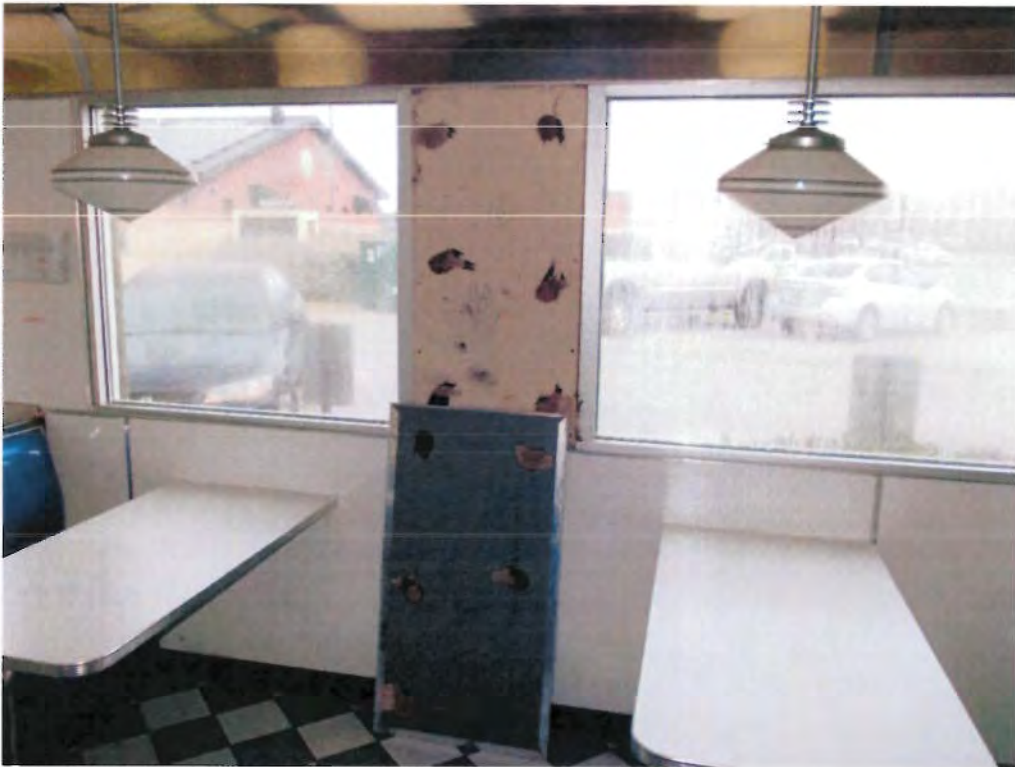
HSA 158-07: Black Glue Pods. Sample B.

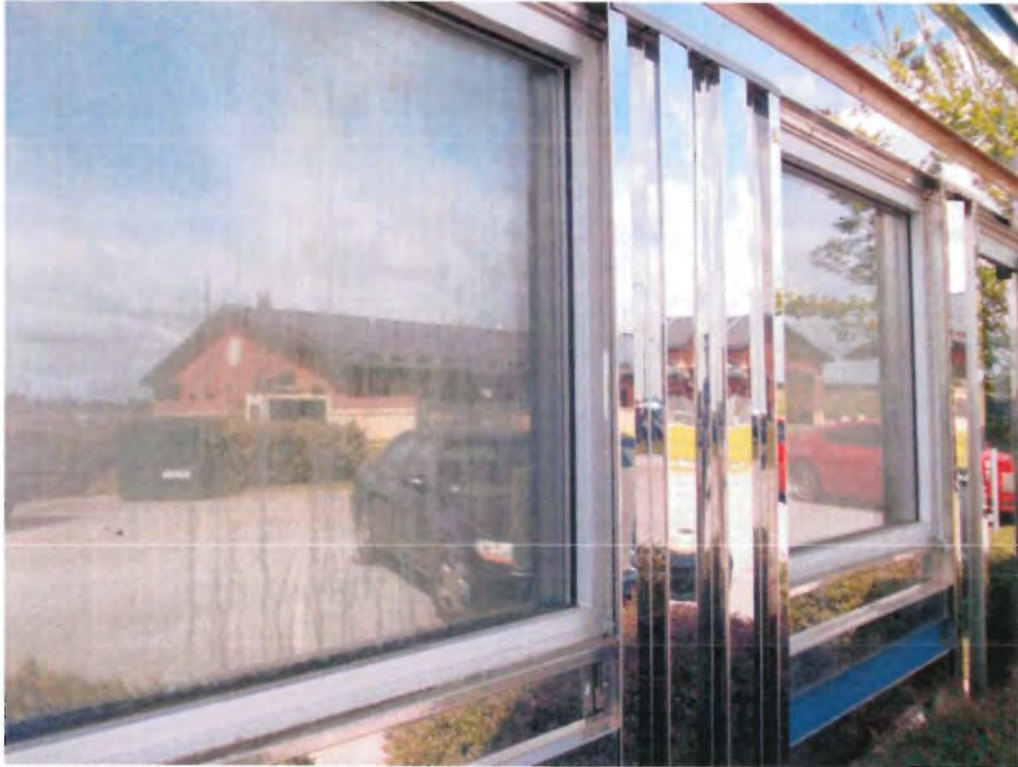
HSA 158-08: Grey Exterior Window and Door Frame Caulk. Sample A.

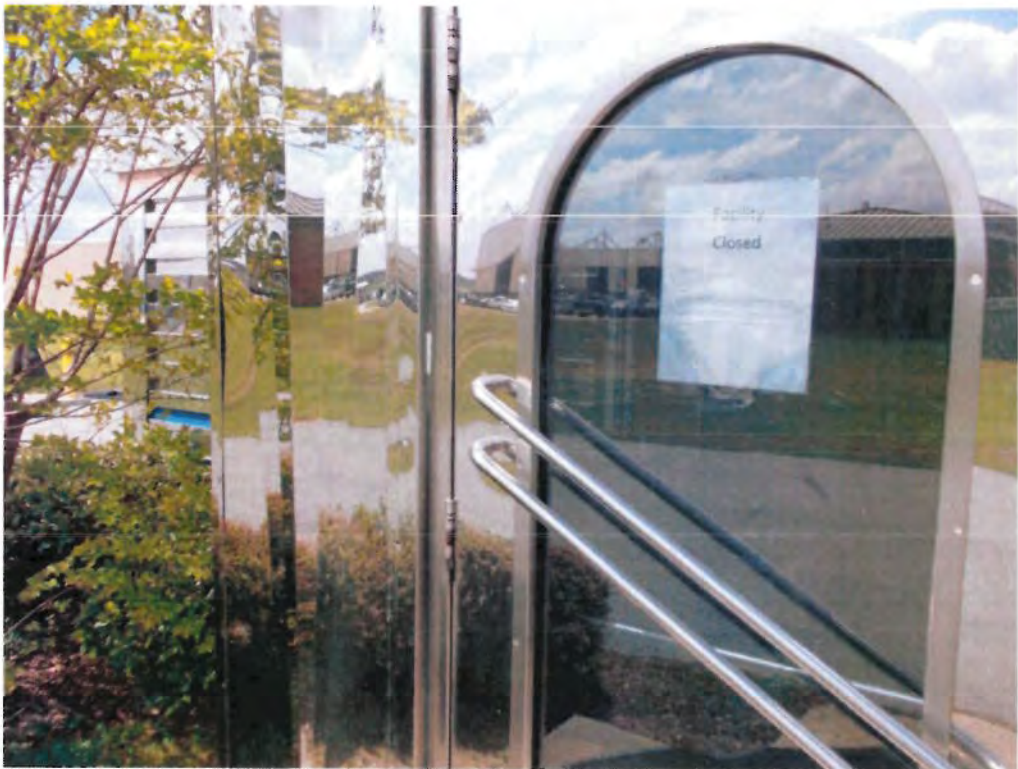
HSA 158-08: Grey Exterior Window and Door Frame Caulk. Sample B.

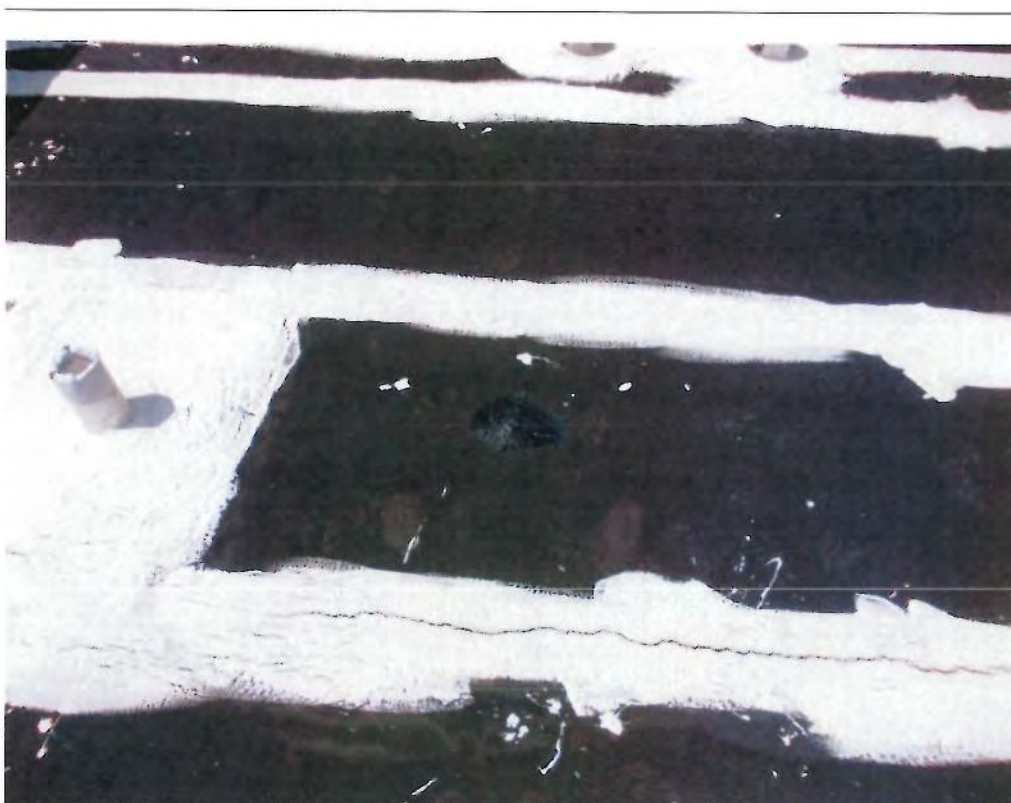
HSA 158-09: Roofing Materials. Sample A.

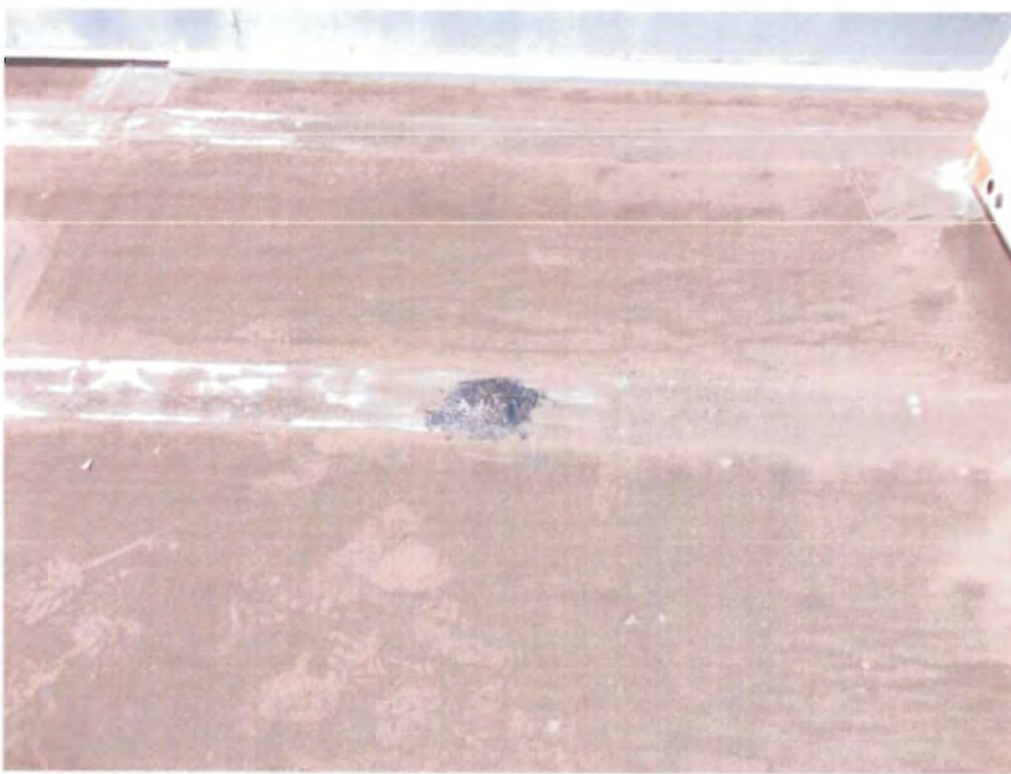
HSA 158-09: Roofing Materials. Sample B.

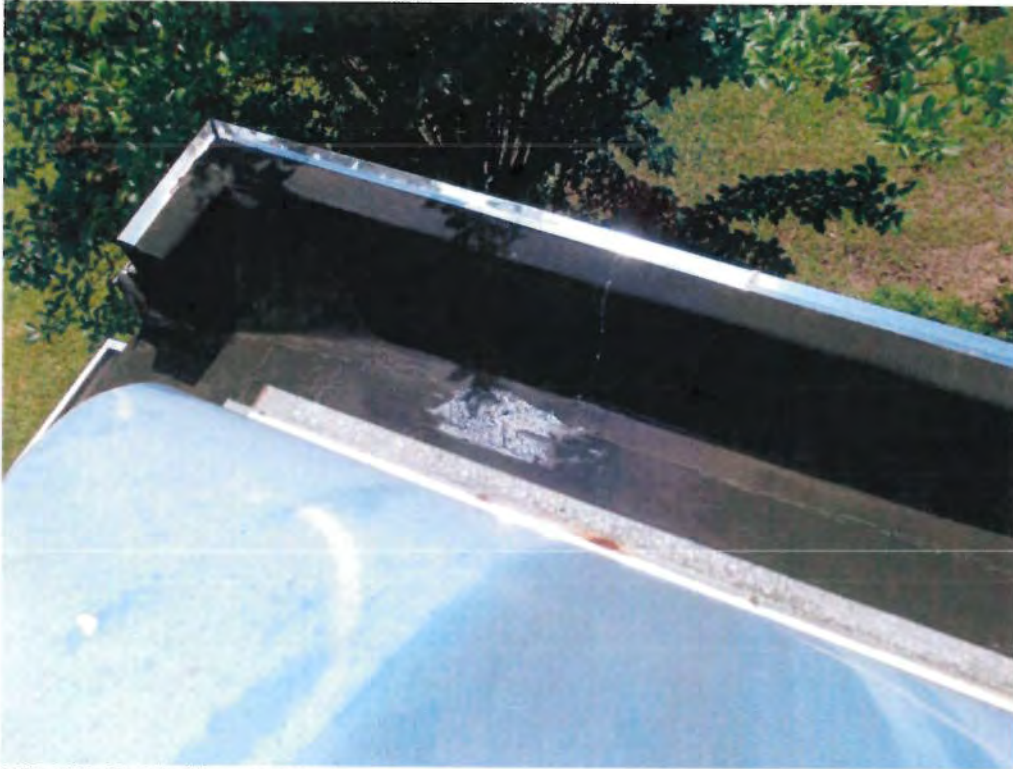
HSA 158-10: Flashing, Sample A.

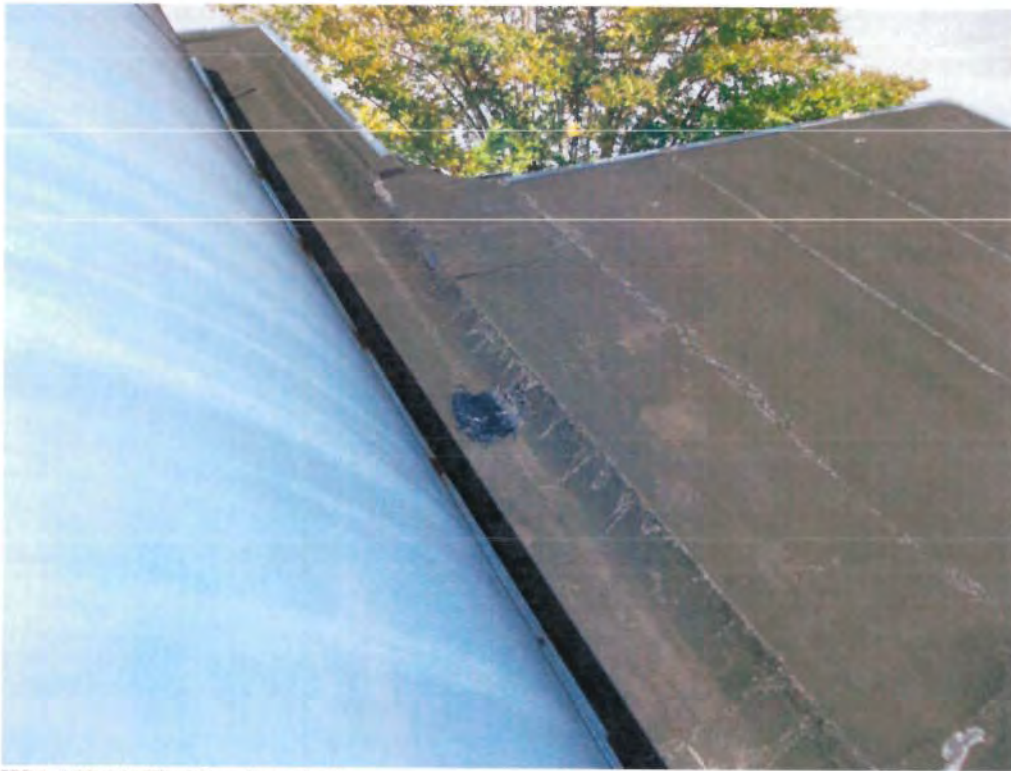
HSA 158-10: Flashing, Sample B.

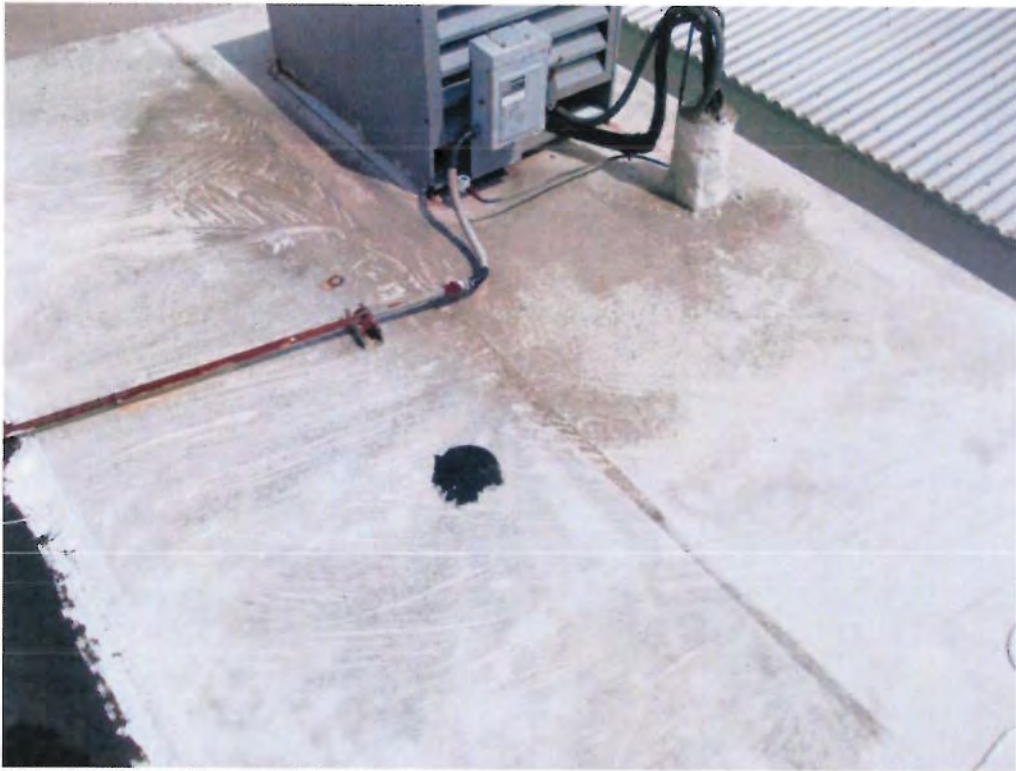
HSA 158-11: Roofing Materials. Sample A.

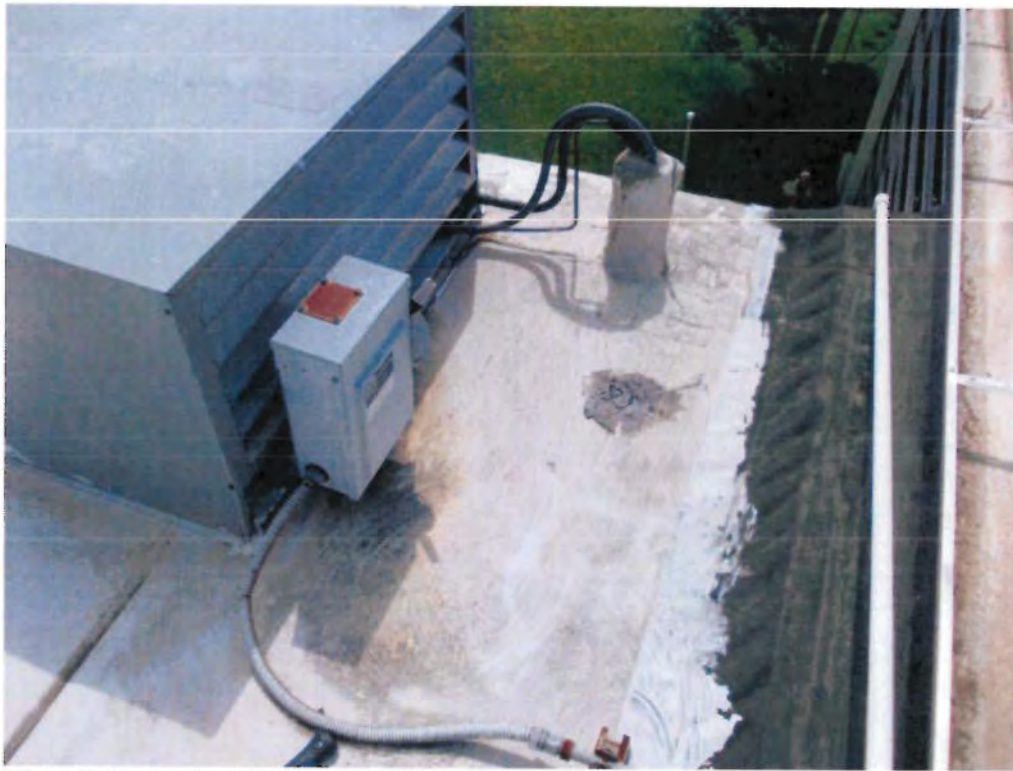
HSA 158-11: Roofing Materials. Sample B.
