MISSISSIPPI ASBESTOS DEMOLITION/RENOVATION NOTIFICATION FORM

**RE: Asbestos Inspection Services
Community Apartments
120 Gillis Circle
McComb, Mississippi**

**ASBESTOS-CONTAINING MATERIALS
INSPECTION REPORT**

**COMMUNITY APARTMENTS
120 GILLIS CIRCLE
McCOMB, MISSISSIPPI 39648**

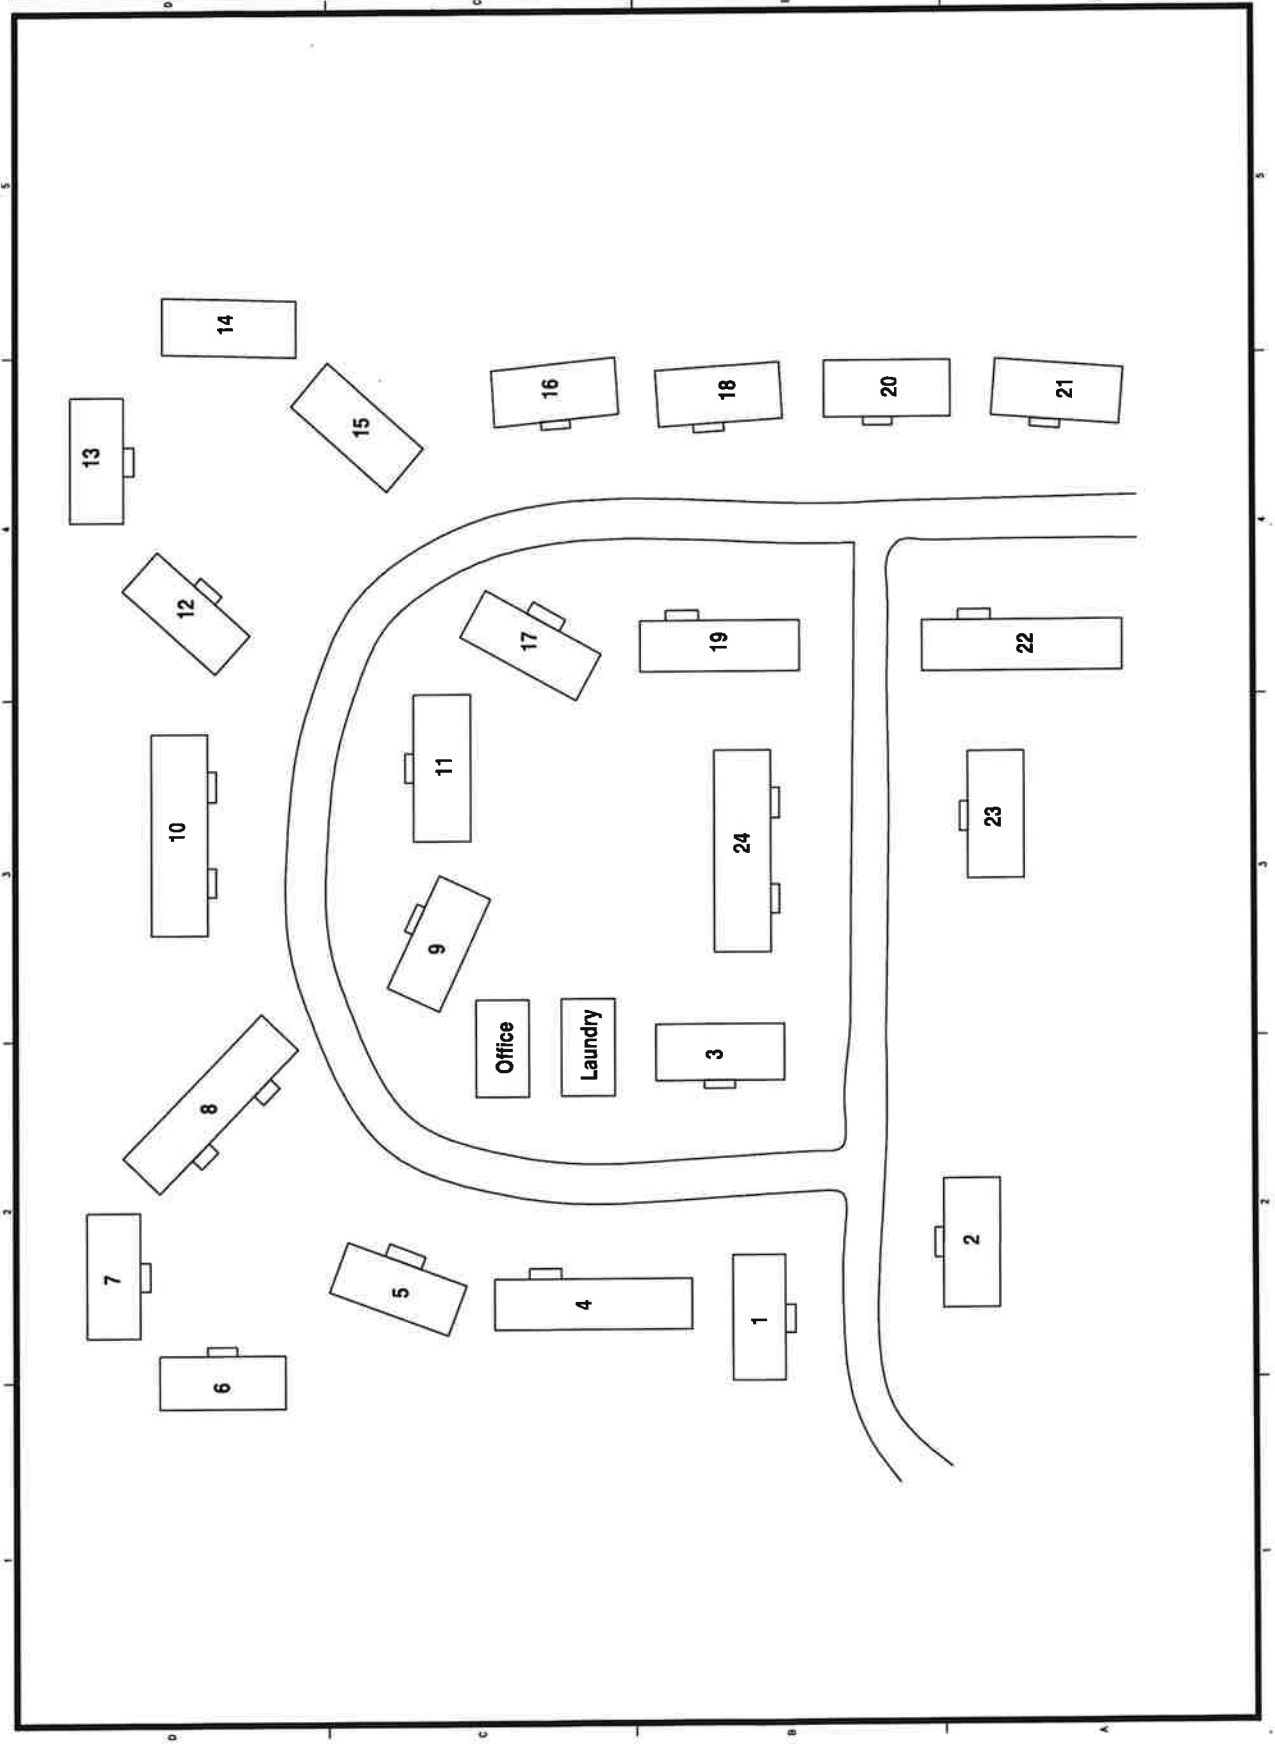
SHEET NUMBER:
 1

DESCRIPTION:
 Site Map

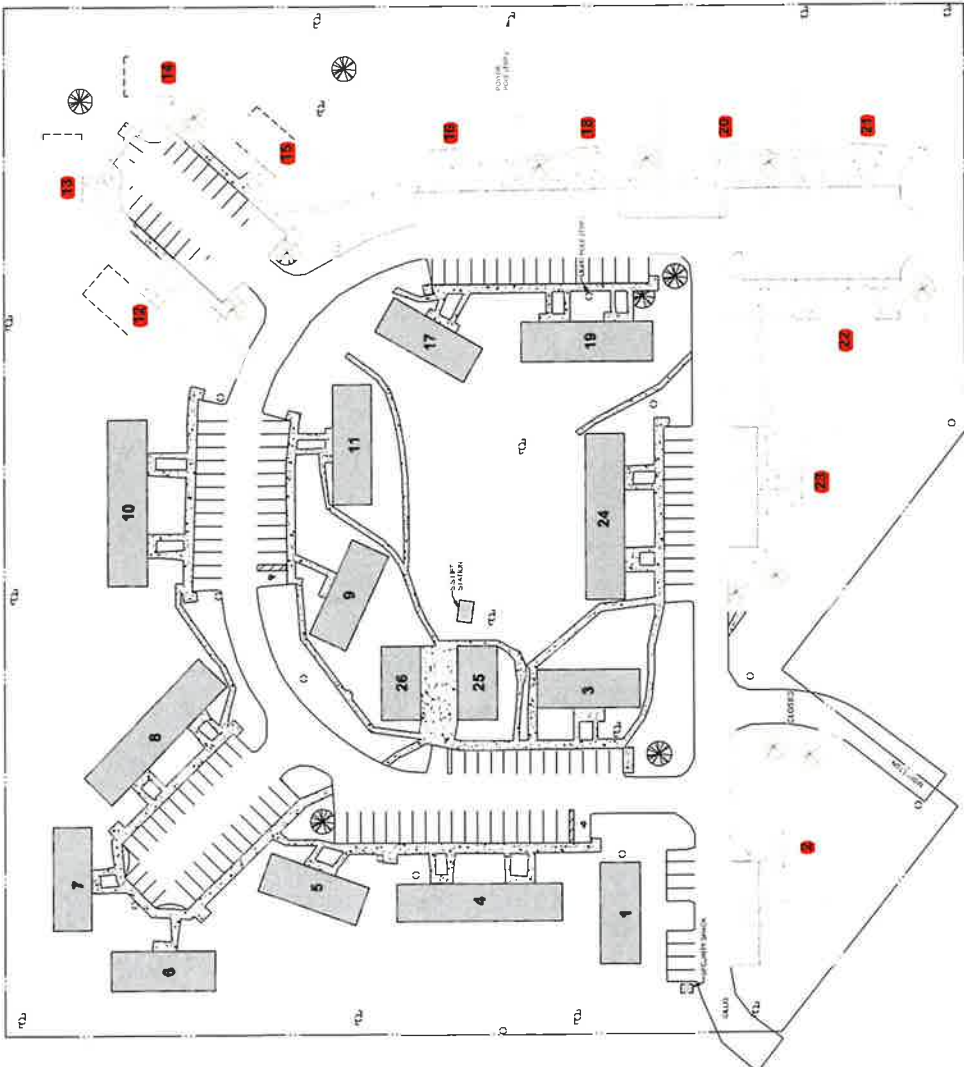
Building to be demolished (H)
