## MISSISSIPPI ASBESTOS DEMOLITION/RENOVATION NOTIFICATION FORM

Re: Asbestos Inspection, Lead-based Paint Sampling,  
and Hazardous Materials Evaluation  
Former Motel 6 Hotel  
4137 Interstate 20 Frontage Road  
Vicksburg, Mississippi

Re: Asbestos Inspection, Lead-based Paint Sampling,  
and Hazardous Materials Evaluation  
Former Battlefield Museum  
4139 Interstate 20 Frontage Road  
Vicksburg, Mississippi

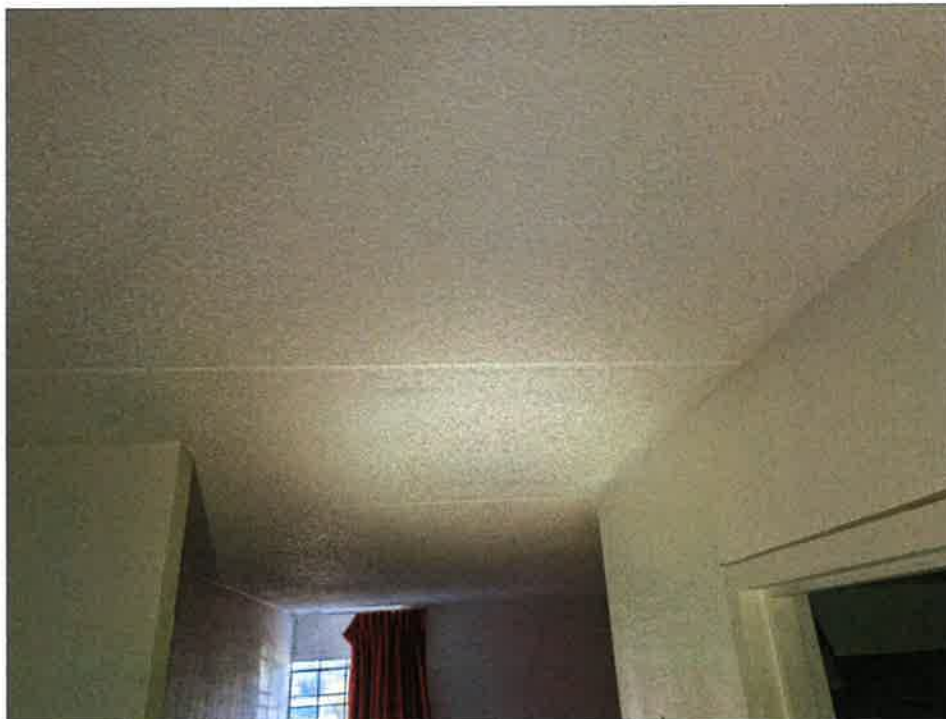
**Photo 2:** Asbestos-containing spray-applied ceiling texture

1. The asbestos inspection identified friable and Category 1 non-friable ACMs. The friable ACMs consist of approximately 54,000 square feet of spray-applied ceiling texture and approximately 3,500 square feet of joint compound. The Category 1 non-friable ACMs consist of approximately 5,500 square feet of black mastic below plank vinyl flooring in the banquet hall and vinyl floor tile in the communications room adjoining the office, and approximately 30,000 square feet of gray sheet vinyl flooring in the laundry room and guest rooms. Friable ACMs and non-friable ACM that would likely become friable during demolition are considered regulated asbestos-containing material (RACM) and should be removed prior to building demolition. Asbestos abatement must be performed by a certified asbestos abatement contractor in a manner prescribed by EPA 40 CFR Part 61, Subpart M, and OSHA 29 CFR 1926.1101. Regulations require that written notification be submitted to the Mississippi Department of Environmental Quality at least 10 working days prior to commencement of RACM abatement activities. Non-friable non-regulated ACMs may be left in place during demolition; however, demolition wastes would require disposal at a landfill approved for asbestos disposal.

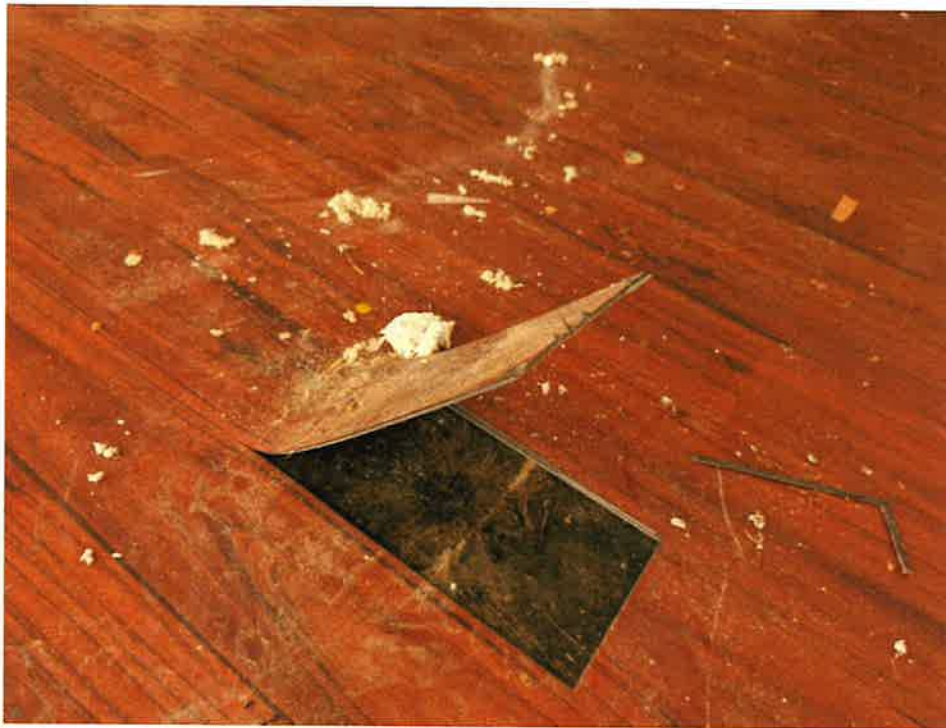
**Photo 3:** Asbestos-containing black mastic below banquet hall flooring

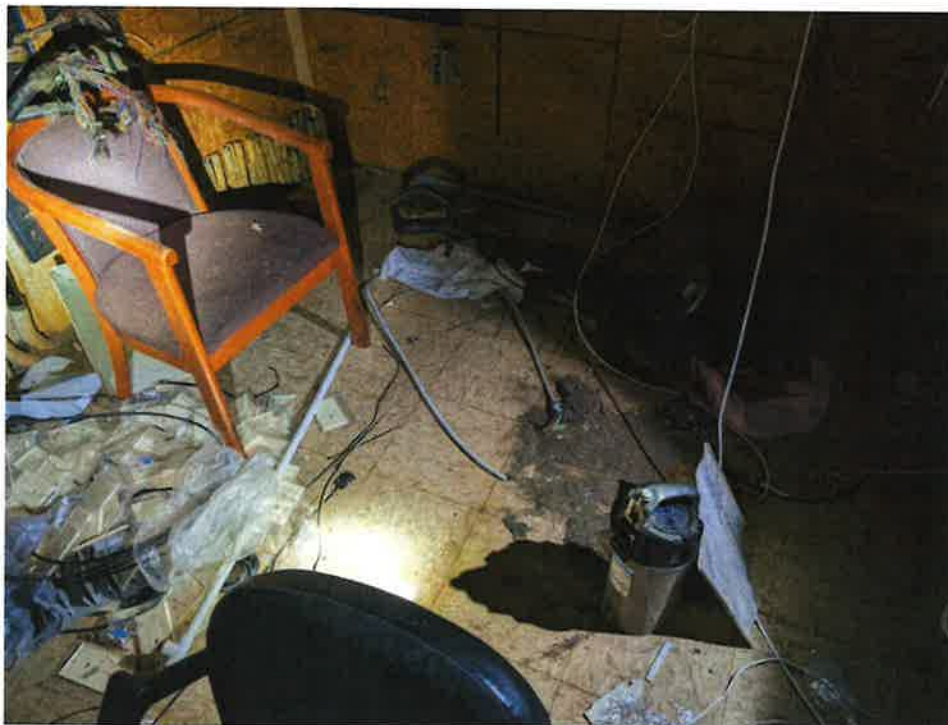
**Photo 4:** Asbestos-containing black mastic below communications room flooring

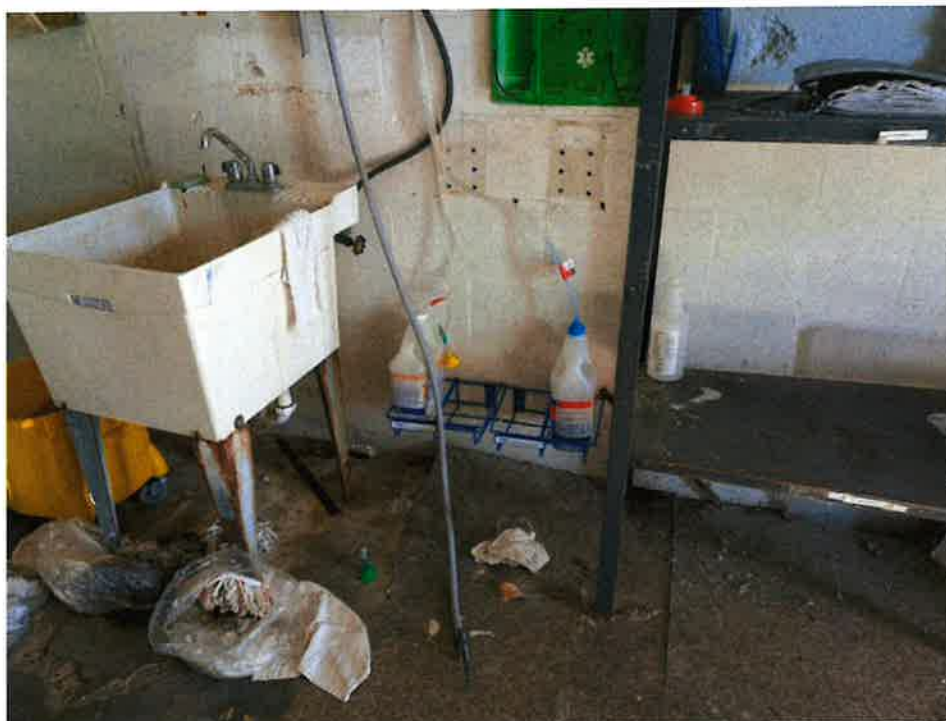
**Photo 5:** Asbestos-containing sheet vinyl flooring and soap containers in laundry room

5. KLG observed two one-gallon bleach containers and one- and five-gallon paint containers in guest rooms, soap containers in the laundry room, one 32-ounce drain cleaner container in the communications room, and one asphalt primer five-gallon container near the kitchen rear door. These containers, as well any similar containers in rooms not accessed during this evaluation, should be removed for proper disposal prior to building demolition.

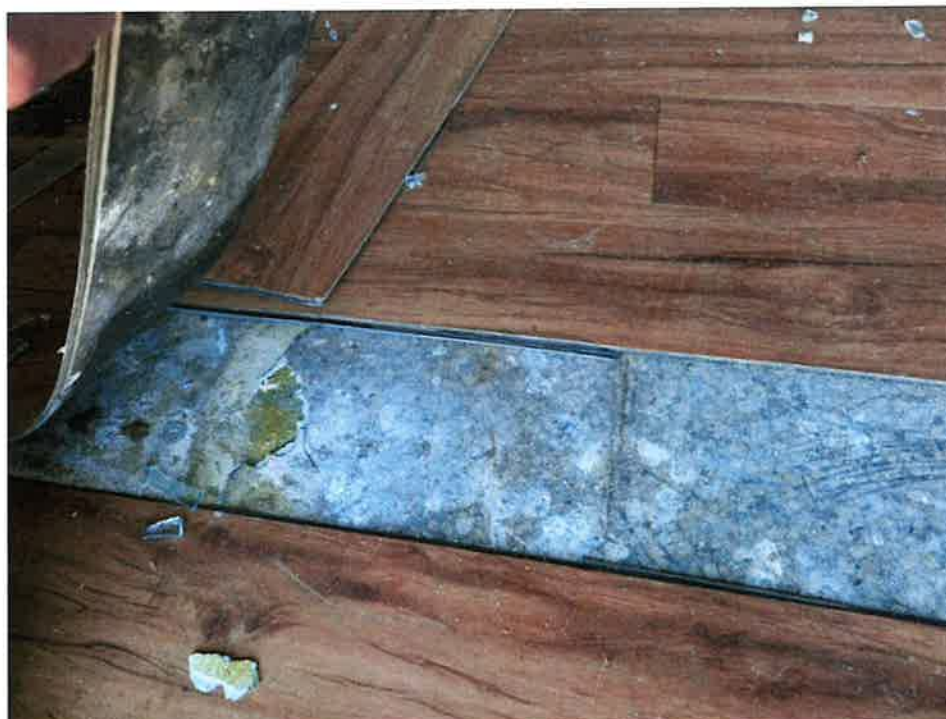
\* This flooring appears to be the original flooring, which based on an inspection of representative guest rooms, has been removed in some areas and left in place in other areas with newer flooring overlain.

**Photo 6:** Asbestos-containing sheet vinyl flooring under plank vinyl flooring in Room 128

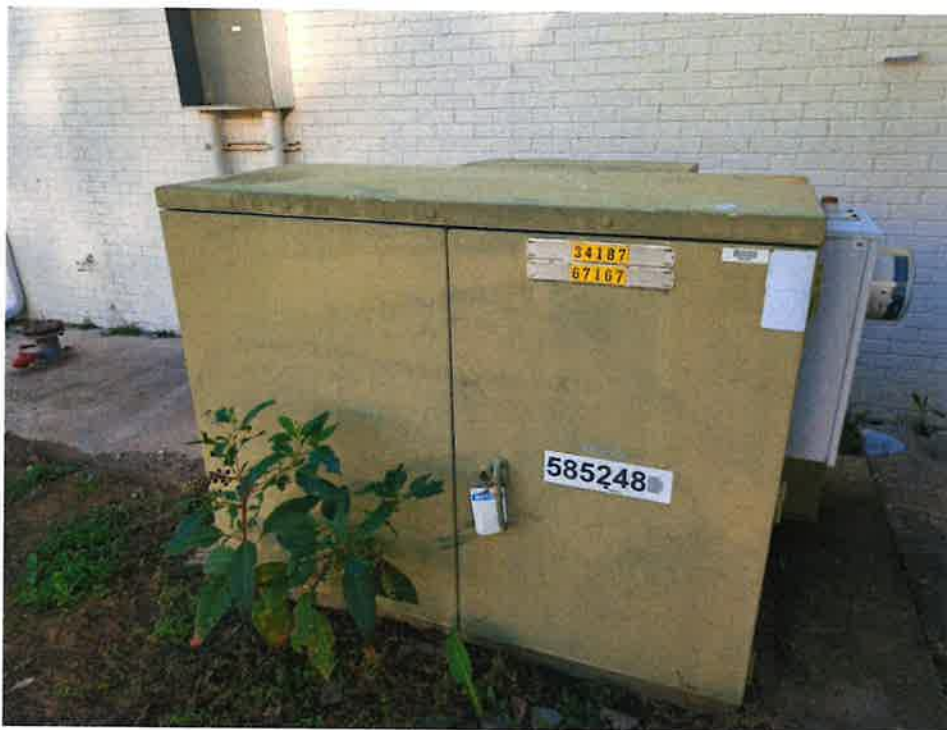
- Electricity is supplied to the site building by one pad-mounted transformer located north of the site building. The transformer was not labeled as to polychlorinated biphenyl (PCB) content and was in good condition with no visible leaks or corrosion.
- Lighting in the building consists of fluorescent fixtures and bulbs and fixtures with light-emitting diode (LED) bulbs. Some fluorescent ballasts were labelled as non-PCB containing, while other ballasts were not labelled as to PCB content. Loose fluorescent bulbs were observed in the kitchen and restaurant area. Boxed fluorescent bulbs were observed in the hotel hall.

**Photo 7:** Pad-mounted transformer on north side of building

8. One pad-mounted transformer is located north of the site building. The transformer is not labeled as to PCB content. Transformers installed prior to 1977 may be PCB containing while transformers installed after 1977 are unlikely to be PCB containing; however, sampling is required to determine the PCB content. The transformer should be decommissioned in accordance with applicable regulations prior to building demolition.

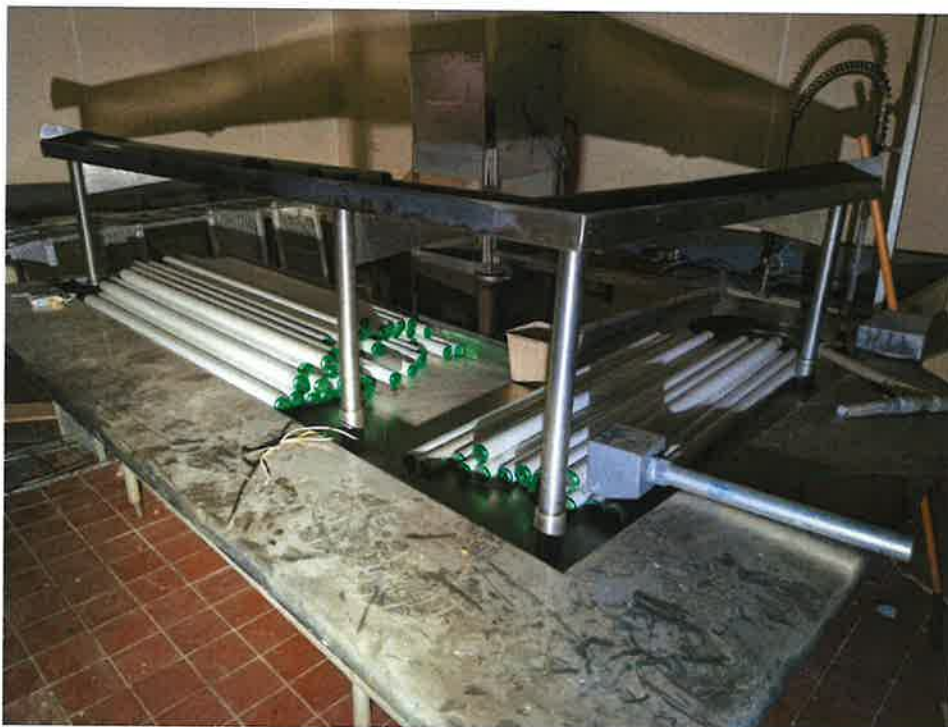
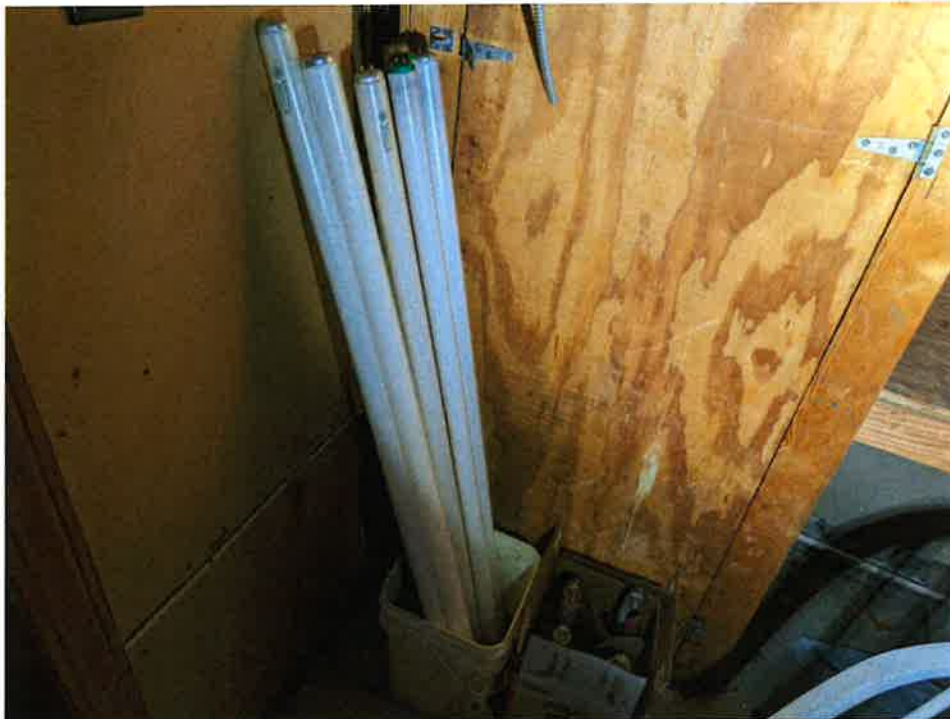
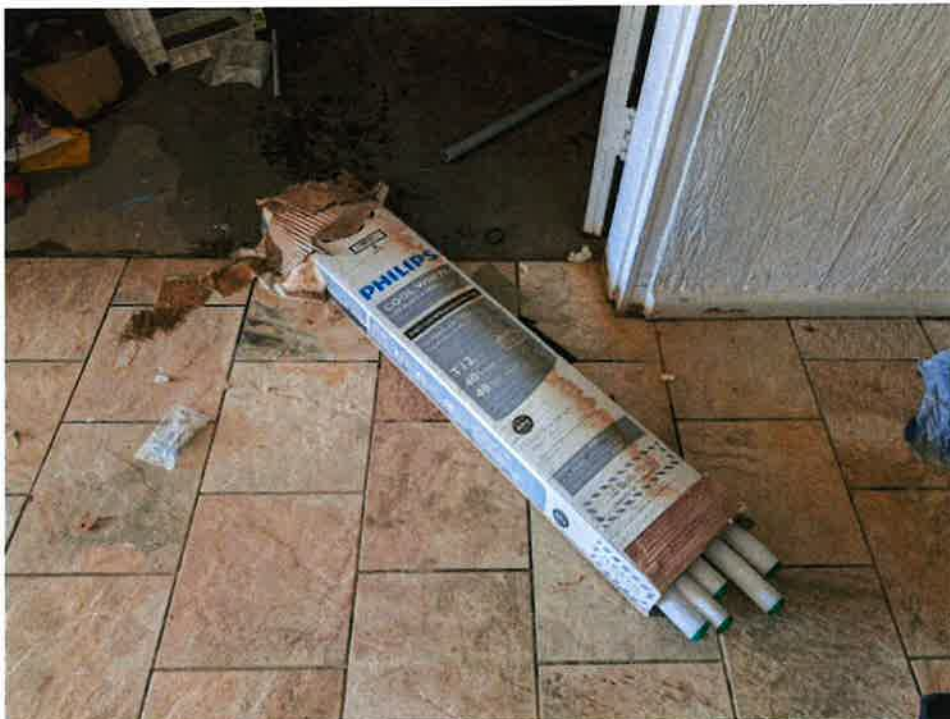
**Photo 8:** Fluorescent bulbs in kitchen

**Photo 9:** Fluorescent bulbs in service area

**Photo 10:** Fluorescent bulbs in hall

3. Fluorescent bulbs should be removed prior to demolition and sent to an approved lamp recycler as universal wastes. LED bulbs should also be considered for recycling. Some fluorescent ballasts were labelled as non-PCB containing, while other ballasts were not labeled as to PCB content. Fluorescent ballasts not marked as PCB-free, or ballasts without a date code showing a manufacture date after 1979, should be assumed to be PCB-containing and be disposed of accordingly.

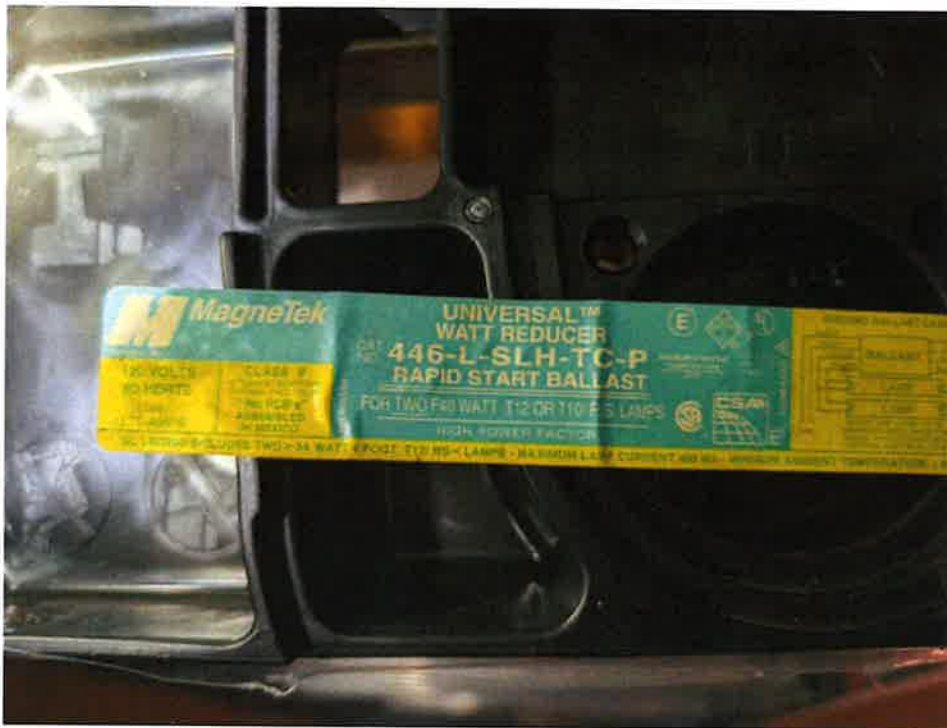
**Photo 11:** Fluorescent ballast labelled as non-PCB

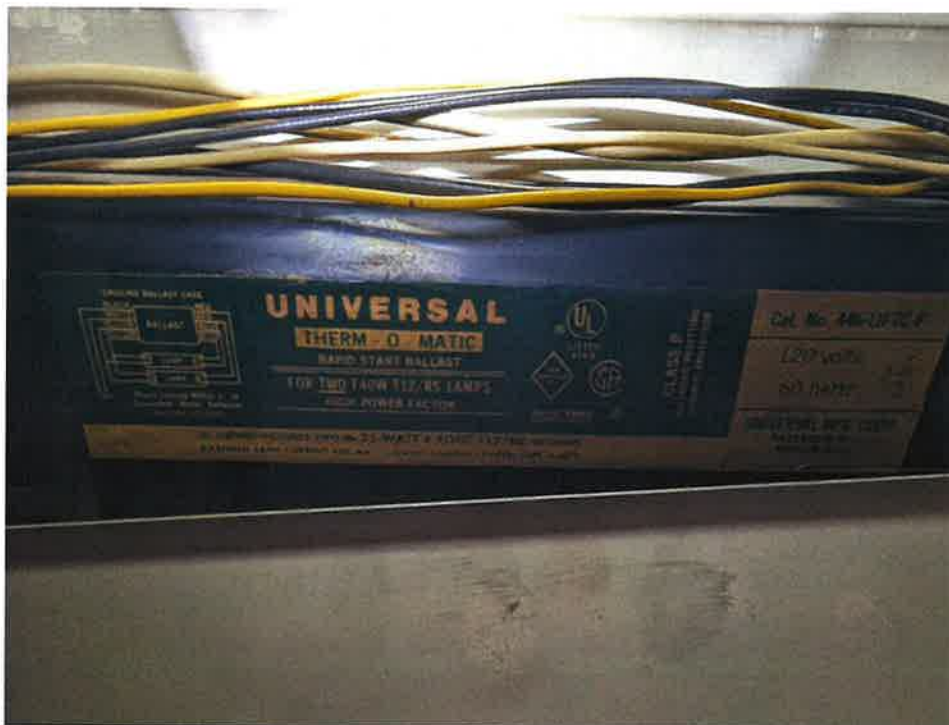
**Photo 12:** Unlabeled fluorescent ballast

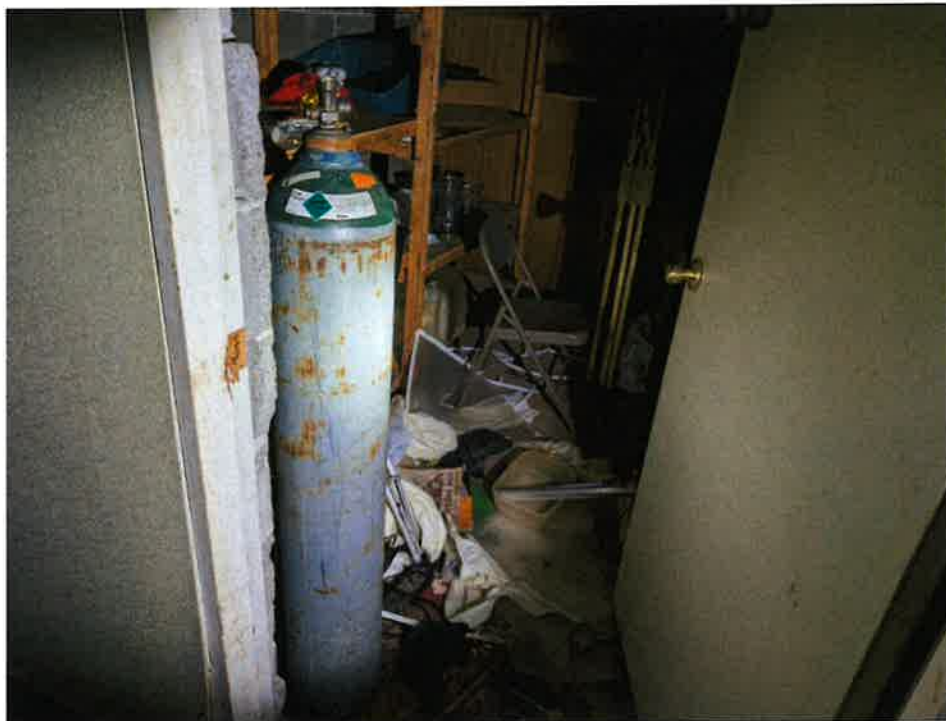
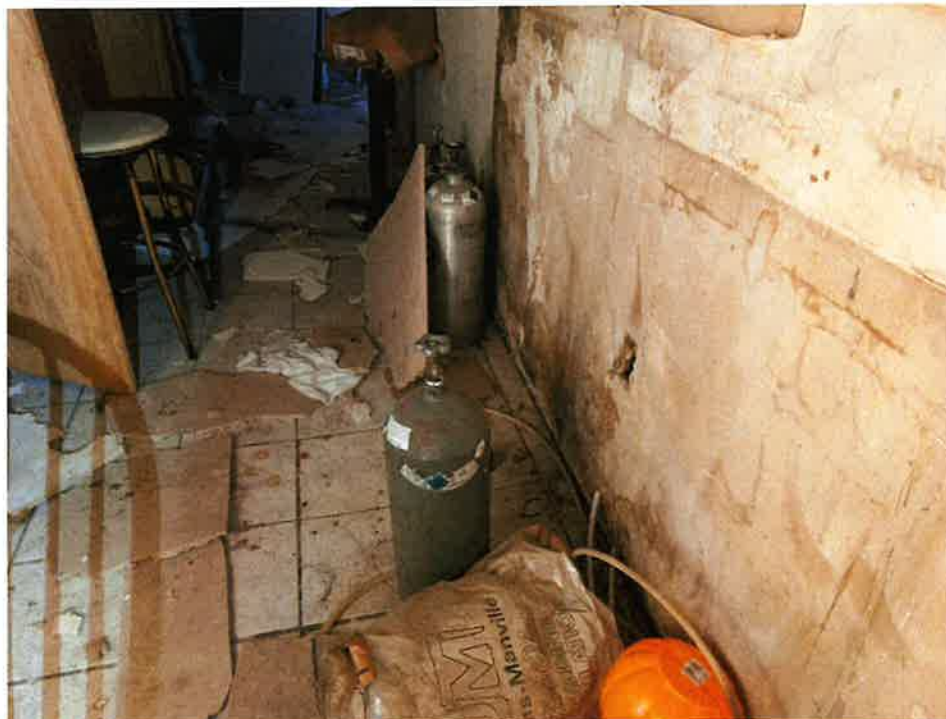
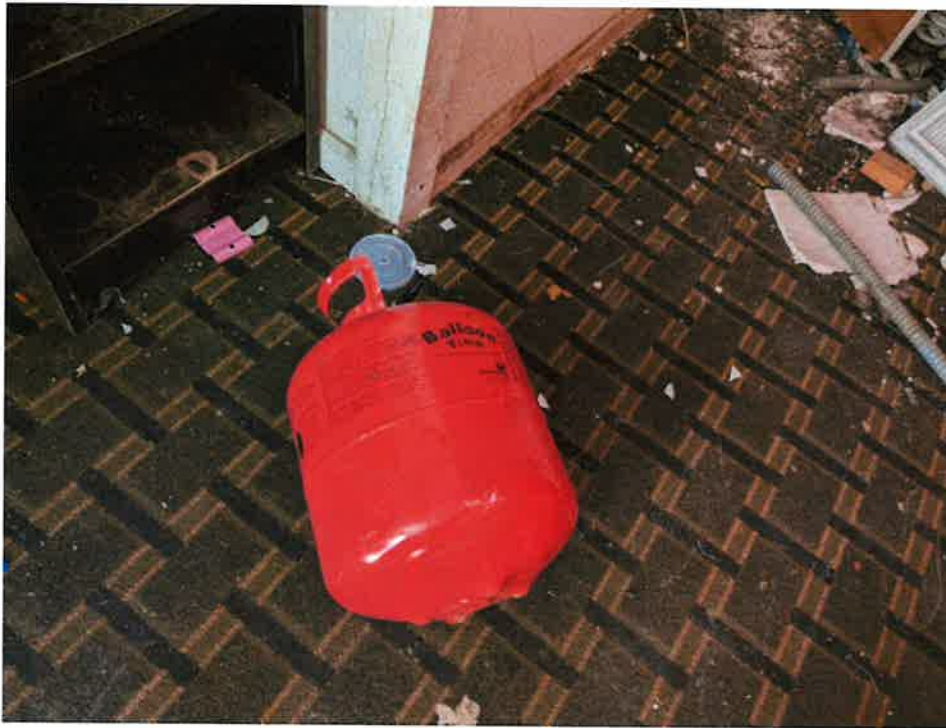
- KLG observed three carbon dioxide cylinders and one helium cylinder in the kitchen area and one helium cylinder in Room 165.
- KLG observed one mercury-containing thermostat was observed on the north wall of the banquet hall.

**Photo 13:** Helium cylinder in kitchen

**Photo 14:** Carbon dioxide cylinders in kitchen

**Photo 15:** Helium cylinder in Room 165

7. KLG observed three carbon dioxide and one helium cylinders in the kitchen area and one helium cylinder in Room 165. The compressed gas cylinders should be removed for proper disposal prior to demolition.

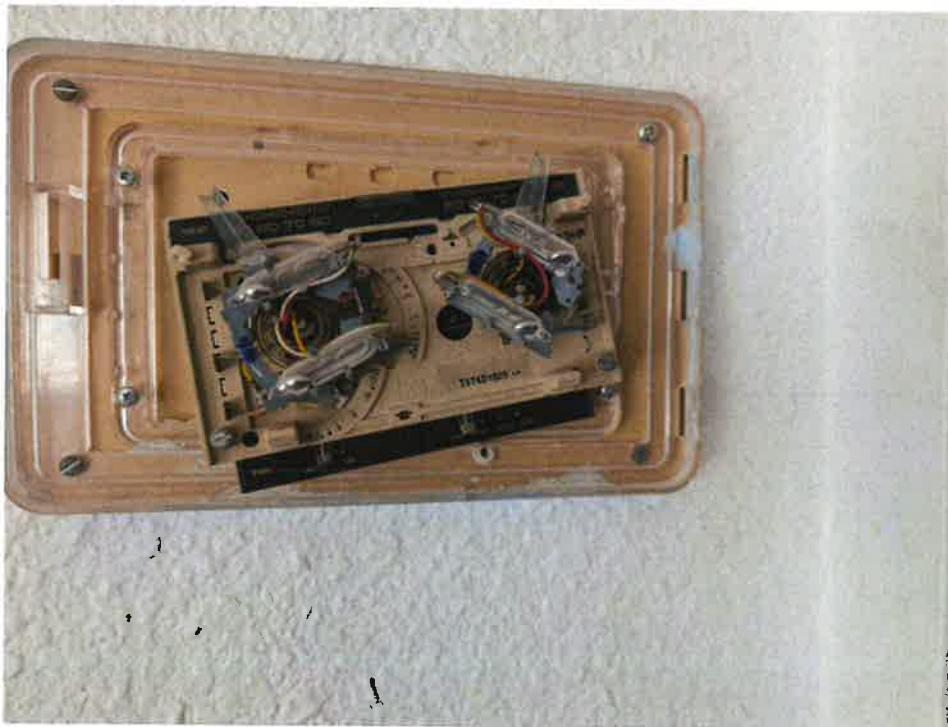
**Photo 16:** Mercury containing thermostat in banquet hall

9. The mercury-containing thermostat located on the north wall of the banquet hall should be removed intact and properly disposed prior to building demolition.

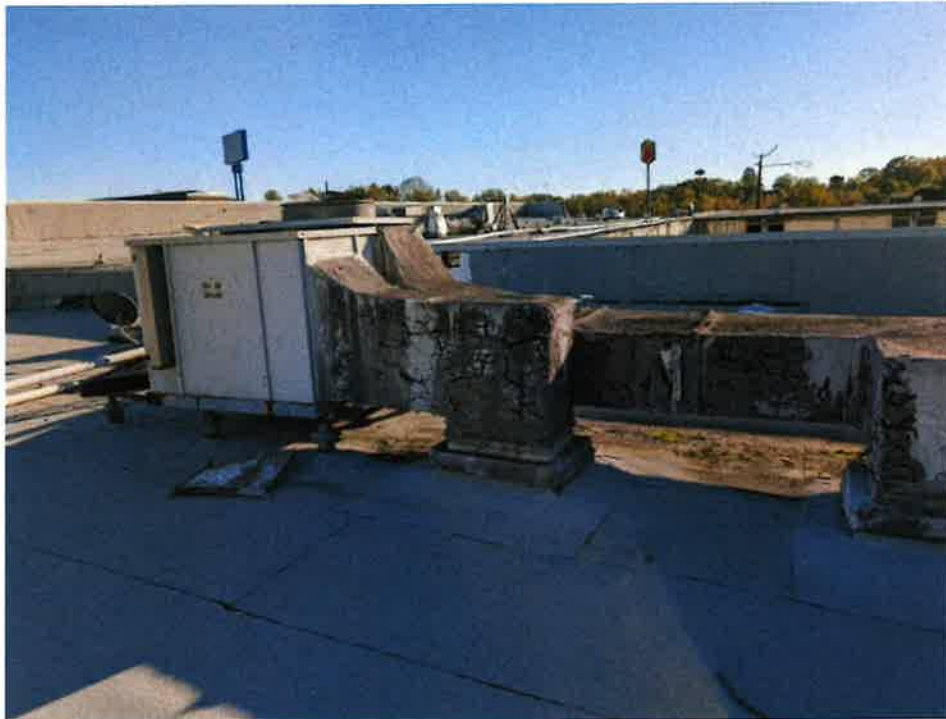
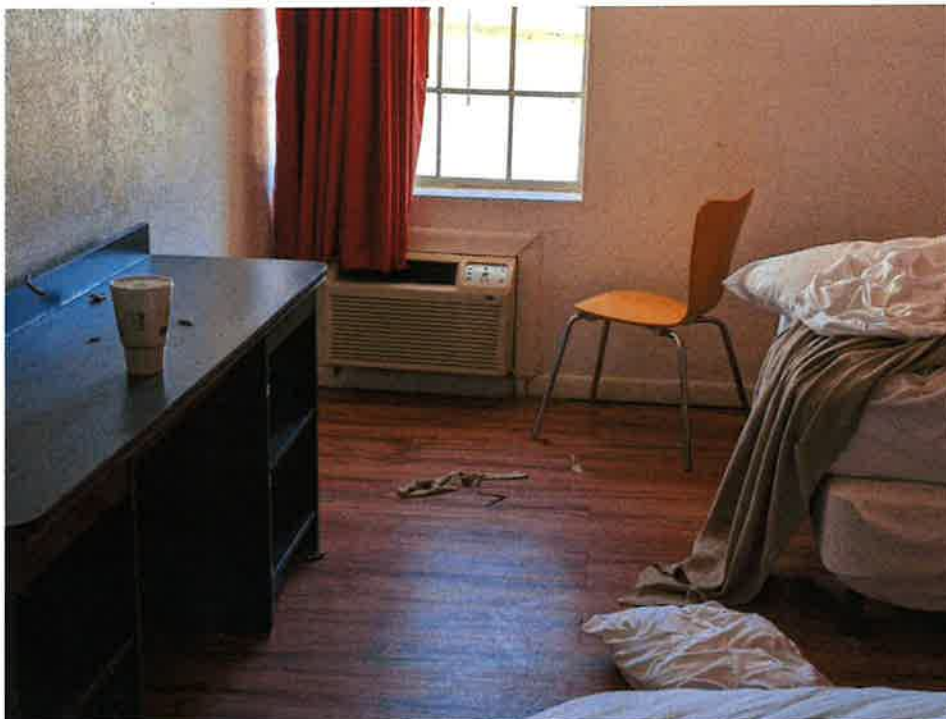
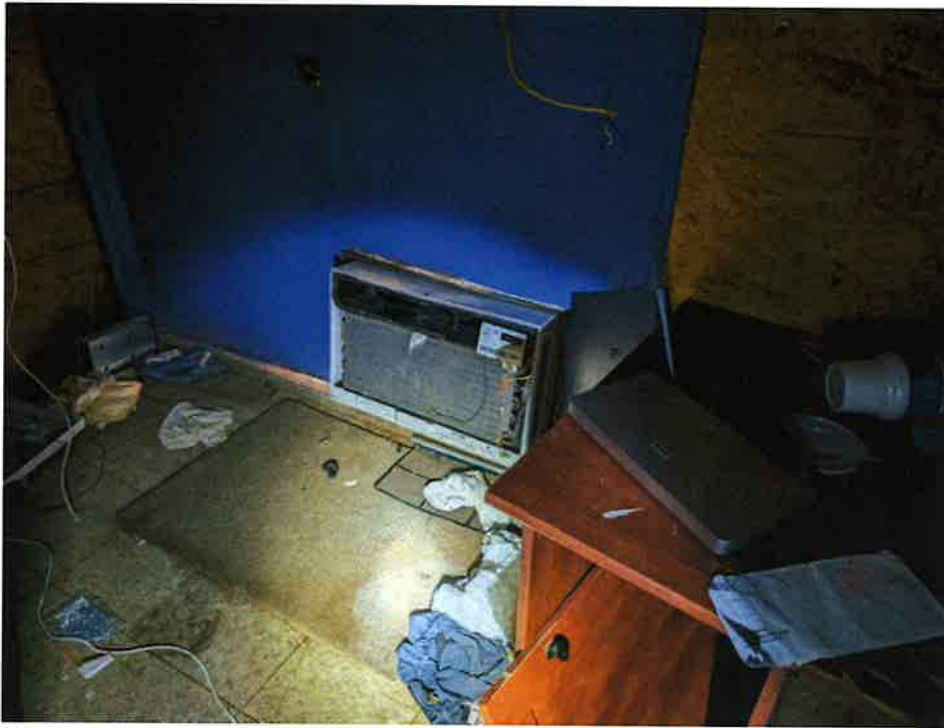
- Package heating ventilating, and air conditioning (HVAC) units were observed on the roof above the restaurant. Packaged terminal air conditioner (PTAC) units and window units were observed in the guest rooms. One window air conditioning unit was observed in the communications room adjoining the front desk. Refrigerators were observed in storage areas and guest rooms. A walk-in refrigerator was observed in the kitchen area.

**Photo 17:** Representative rooftop package HVAC unit

**Photo 18:** Representative window HVAC unit in guest room

**Photo 19:** Window HVAC unit in communications room

4. Section 608 of the Clean Air Act (40 CFR Part 82, Subpart F) prohibits the intentional venting of ozone-depleting substances used as refrigerants into the atmosphere while maintaining, servicing, repairing, or disposing of air conditioning or refrigeration equipment. Refrigerants used in the package HVAC units, window units, PTAC units, guest room refrigerators, and the walk-in refrigerator should be recovered prior to equipment disposal.

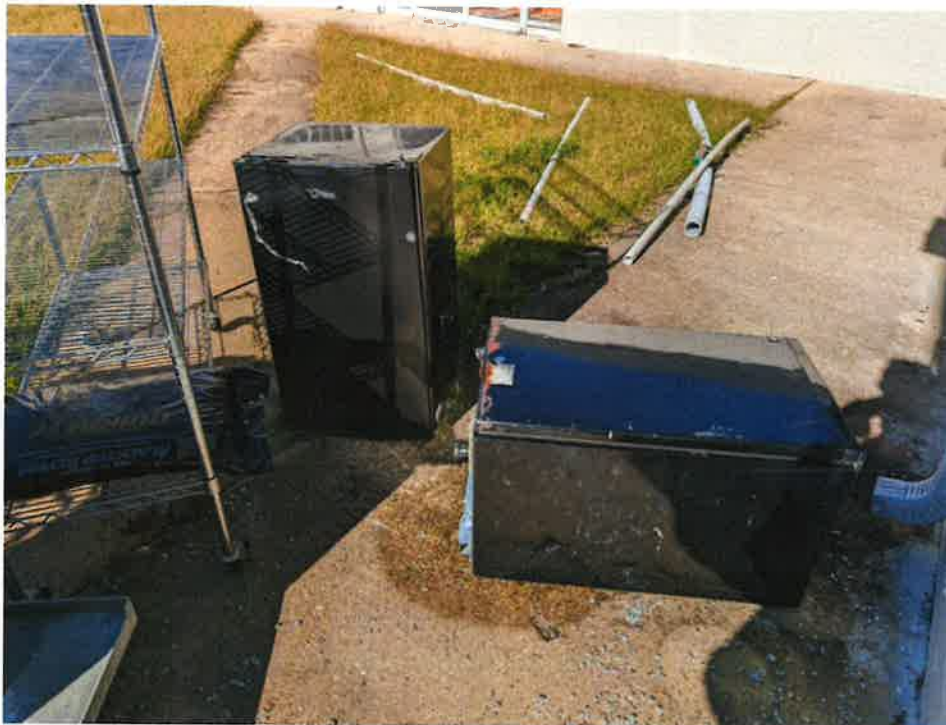
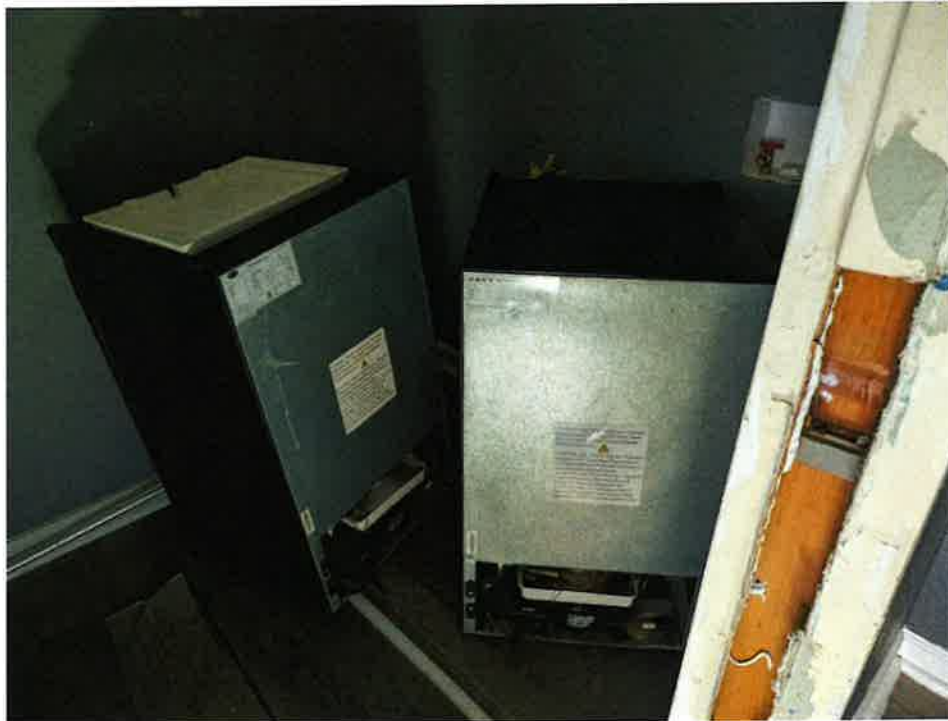
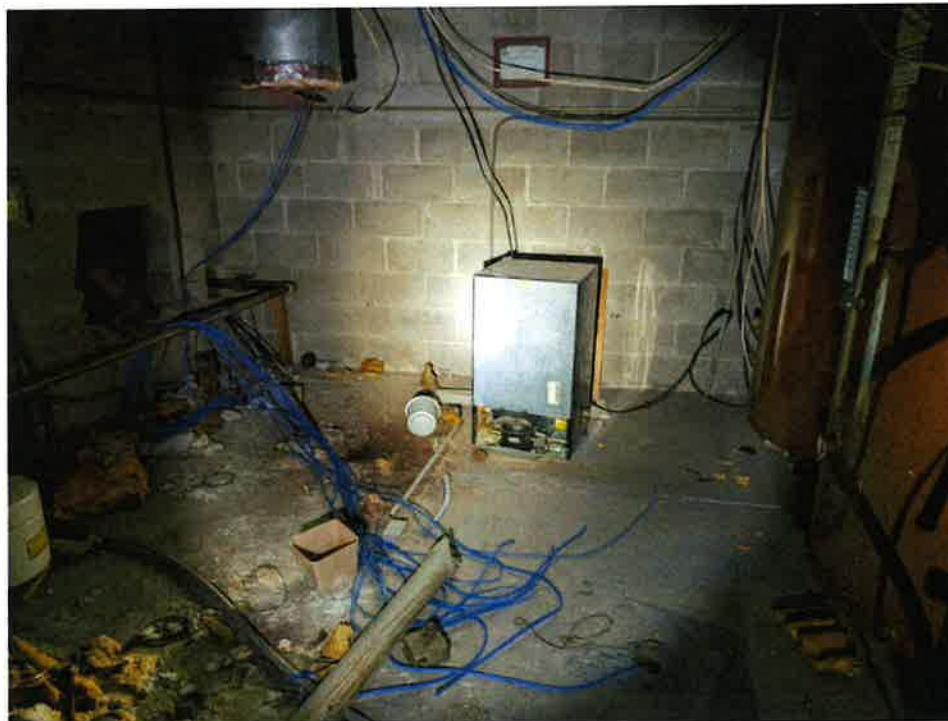
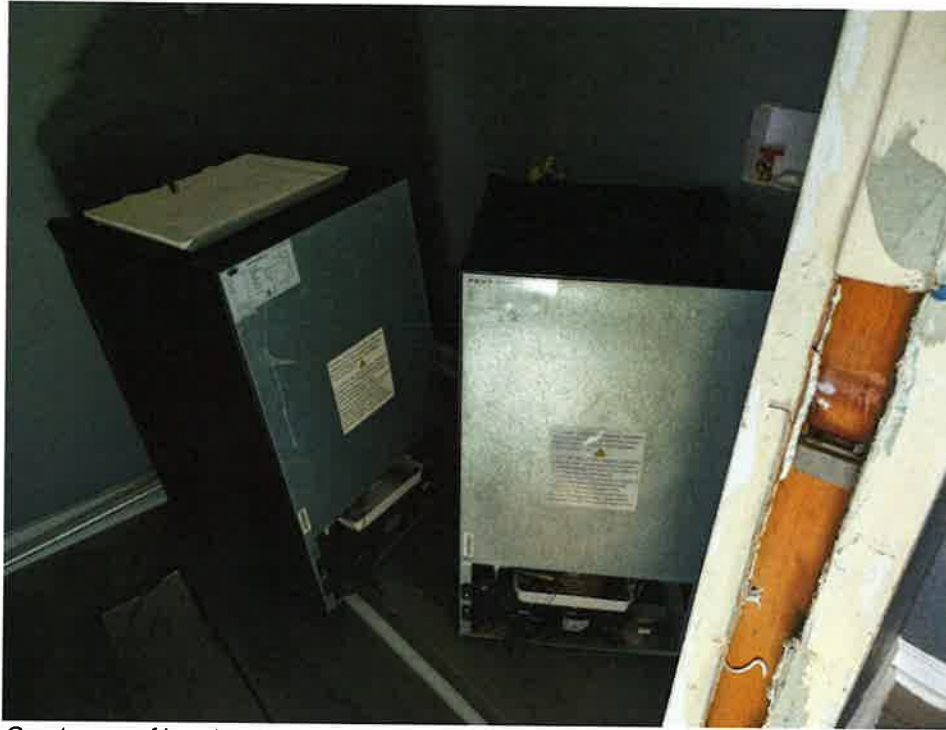
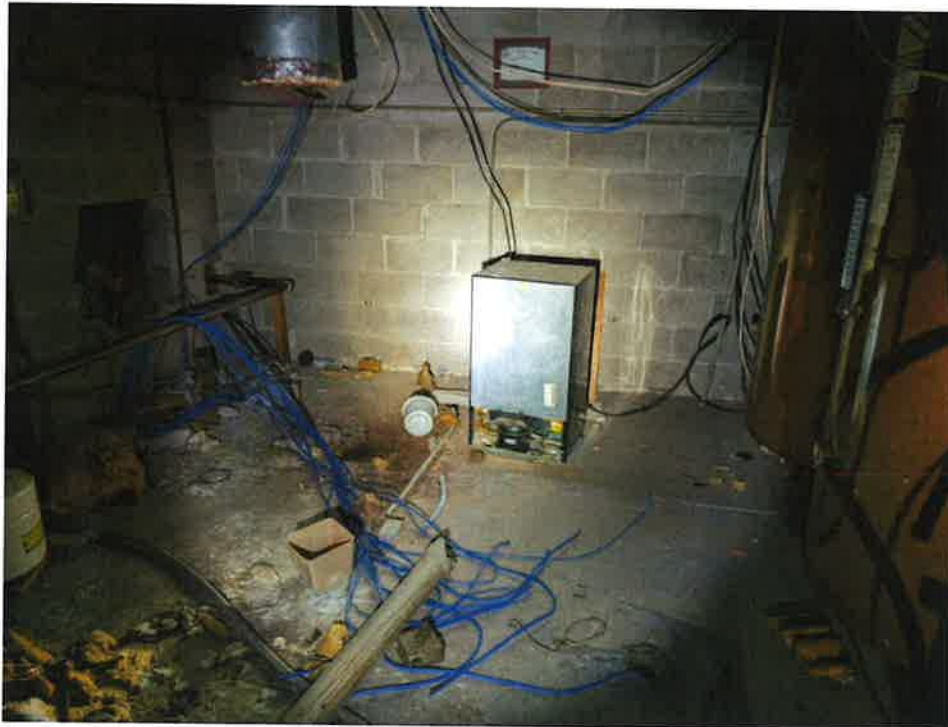
**Photo 20:** Guest room refrigerators

**Photo 21:** Guest room refrigerators

**Photo 22:** Guest room refrigerator

**Photo 23:** Guest room refrigerators

**Photo 24:** Guest room refrigerator

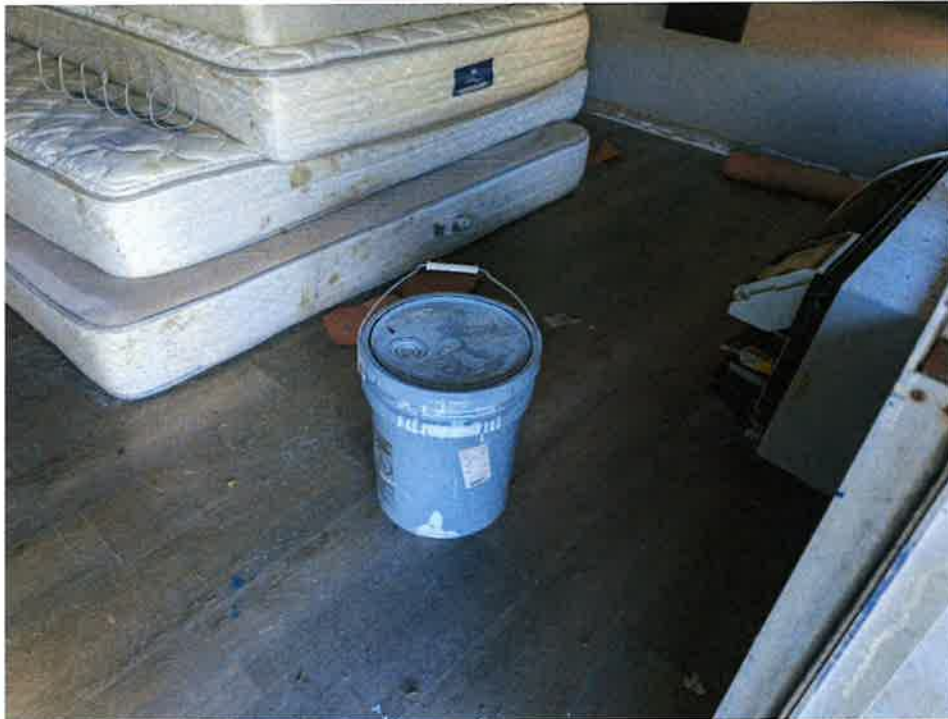
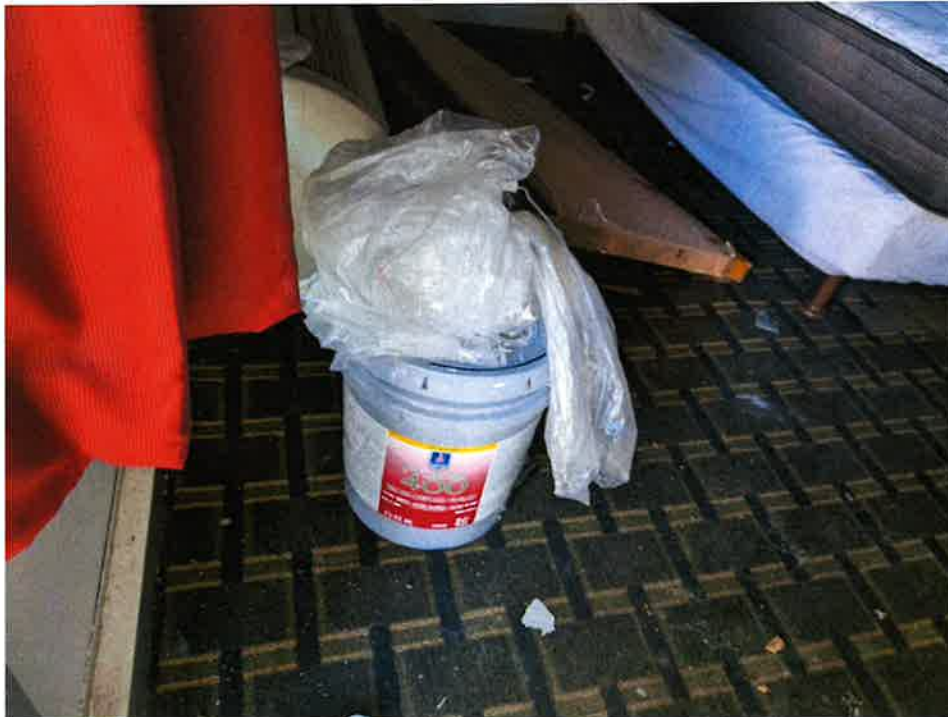
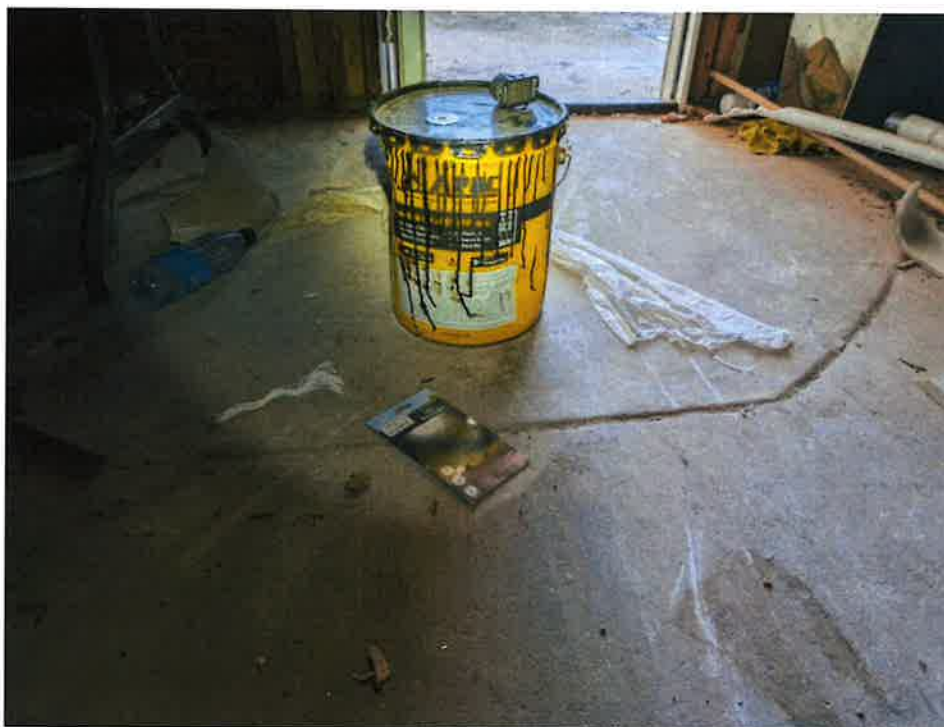
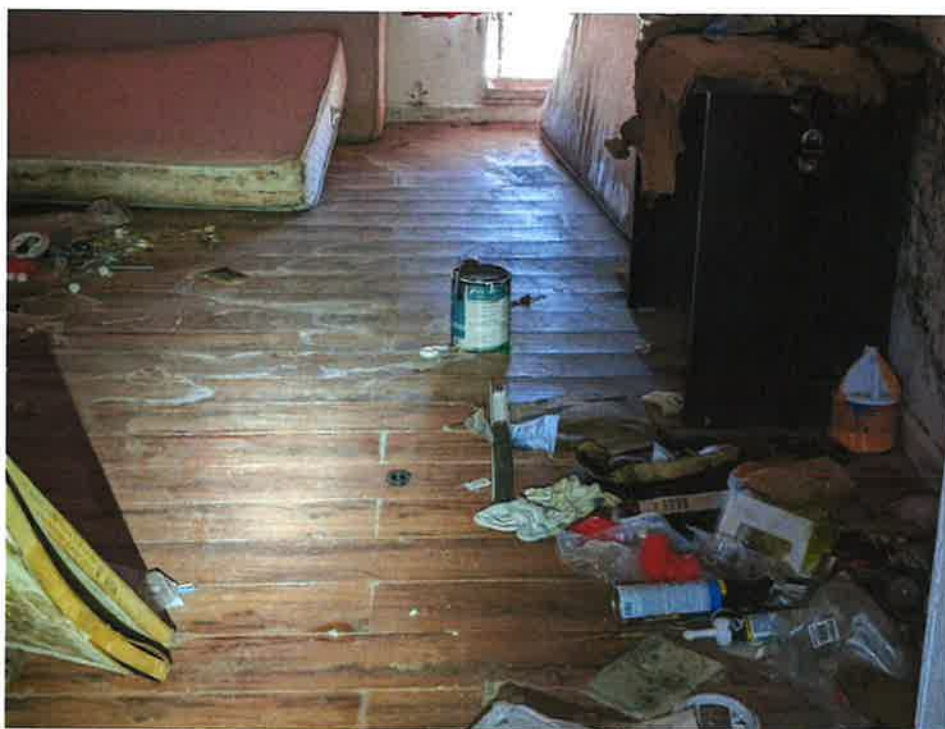
- KLG observed two one-gallon bleach containers and one- and five-gallon paint containers in guest rooms, soap containers in the laundry room, one 32-ounce drain cleaner container in the communications room, and one asphalt primer five-gallon container in the kitchen storage room.

**Photo 25:** Paint container in Room 138

**Photo 26:** Paint container in Room 240

**Photo 27:** Asphalt primer container near kitchen rear door

**Photo 28:** Bleach and paint containers in guest room

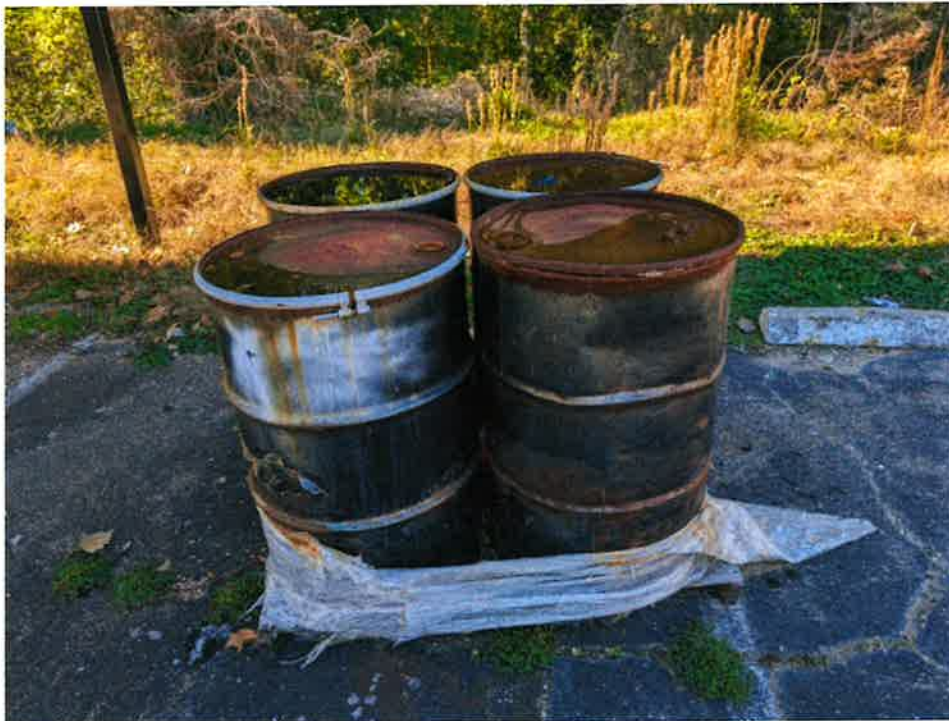
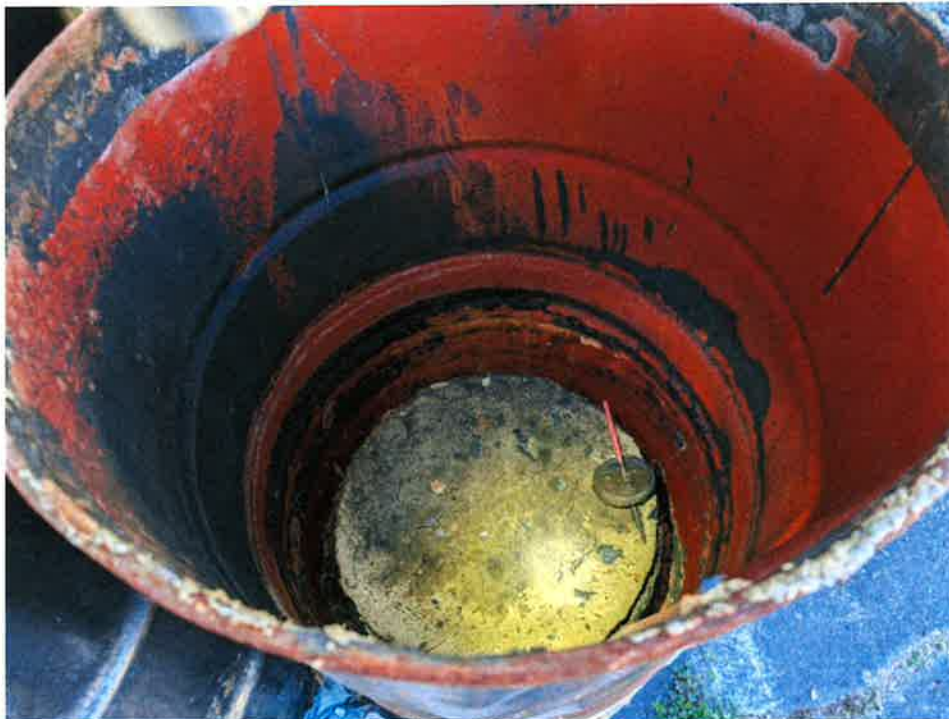
- KLG observed four 55-gallon unlabeled steel drums located northwest of the site building. Three of the drums were full and sealed. The fourth drum was unsealed, partially full, and contained waste solids, likely associated with waste from former restaurant operations.

**Photo 29:** Unlabeled drums northwest of building

**Photo 30:** Interior of unsealed drum

6. KLG observed four 55-gallon unlabeled steel drums located northwest of the site building. Three of the drums were full and sealed. The fourth drum was unsealed, partially full, and contained waste solids, likely associated with waste from former restaurant operations. The drum contents should be confirmed and the drums properly disposed.

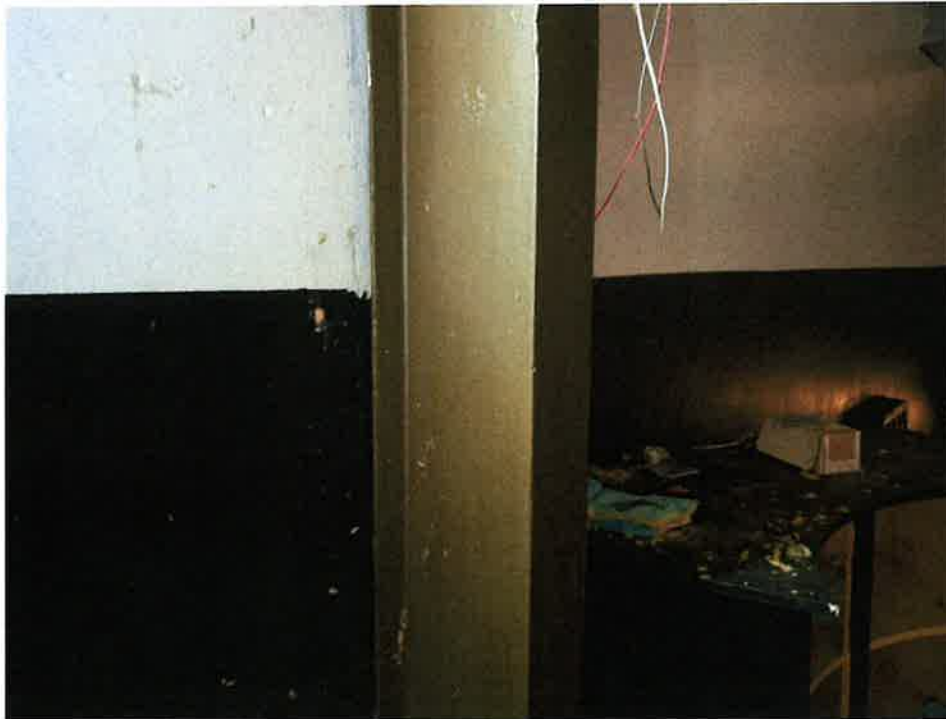
**Photo 2:** LBP on steel beam
