## MISSISSIPPI ASBESTOS DEMOLITION/RENOVATION NOTIFICATION FORM

Re: Asbestos Inspection, Lead-based Paint Sampling,  
and Hazardous Materials Evaluation  
Former Motel 6 Hotel  
4137 Interstate 20 Frontage Road  
Vicksburg, Mississippi

Re: Asbestos Inspection, Lead-based Paint Sampling,  
and Hazardous Materials Evaluation  
Former Battlefield Museum  
4139 Interstate 20 Frontage Road  
Vicksburg, Mississippi

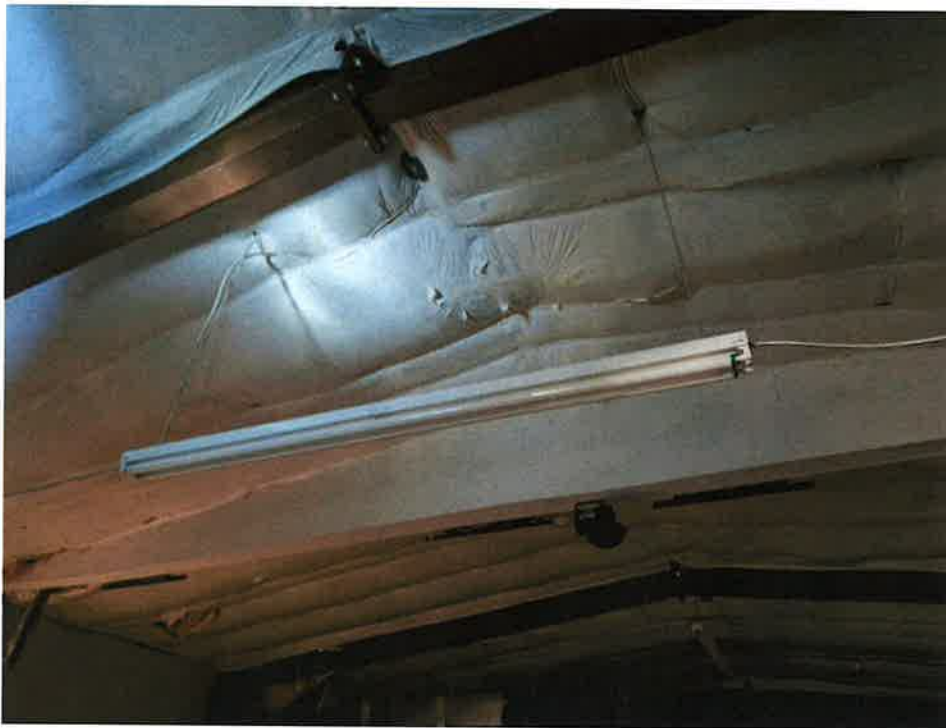
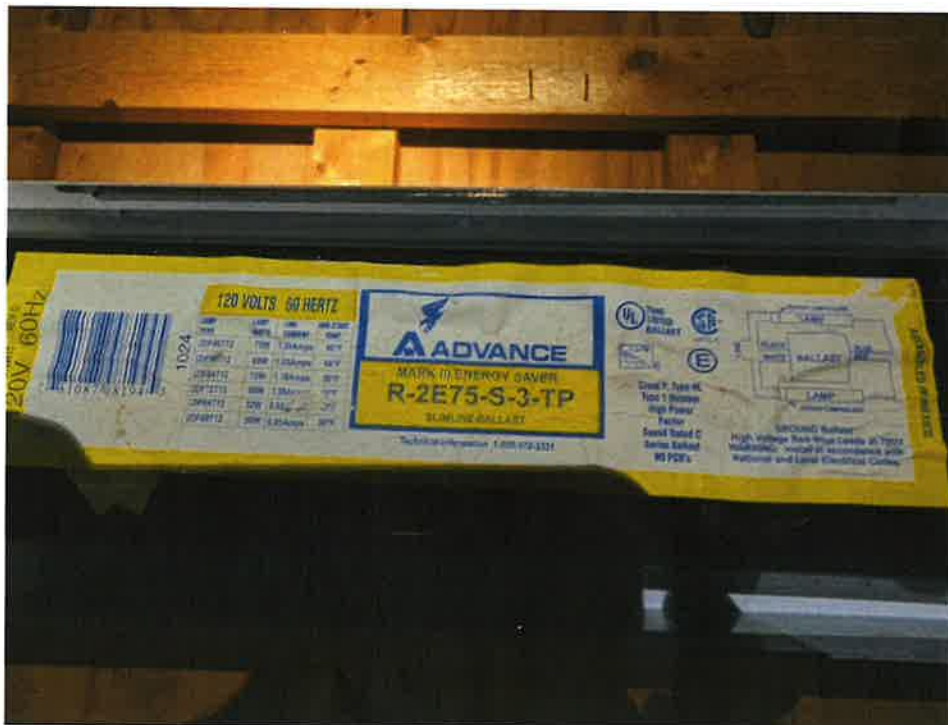
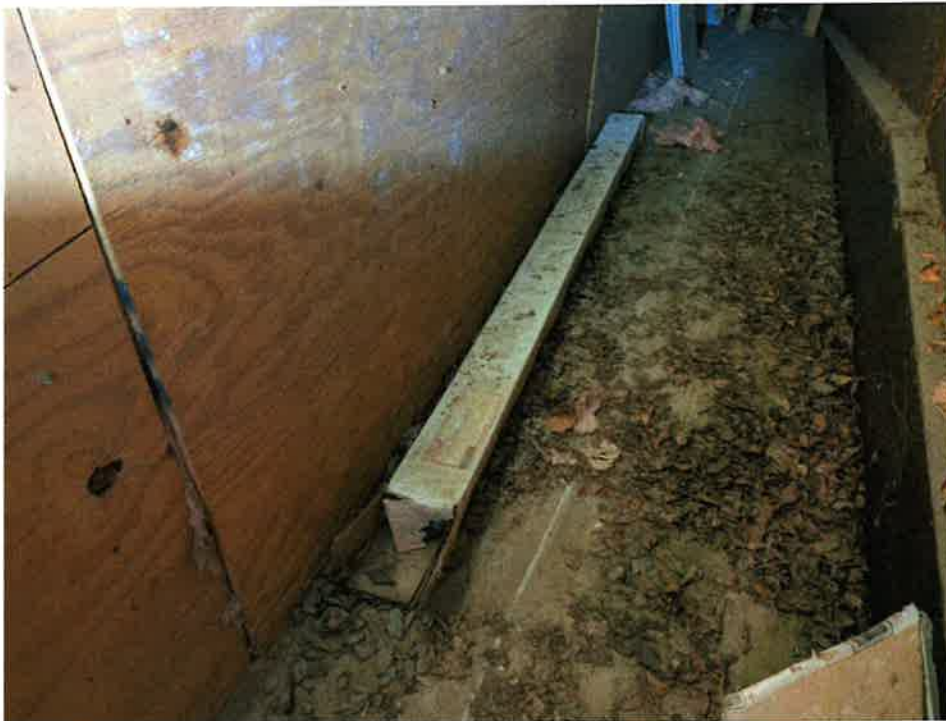
- Lighting in the building consist of fluorescent fixtures. Ballasts in the fluorescent fixtures were labelled as non-PCB containing. One box of fluorescent bulbs was observed in the second-floor level.

**Photo 3:** Representative fluorescent fixture inside building

**Photo 4:** Non-PCB ballast in fluorescent fixture

**Photo 5:** Box of fluorescent bulbs in second floor of building

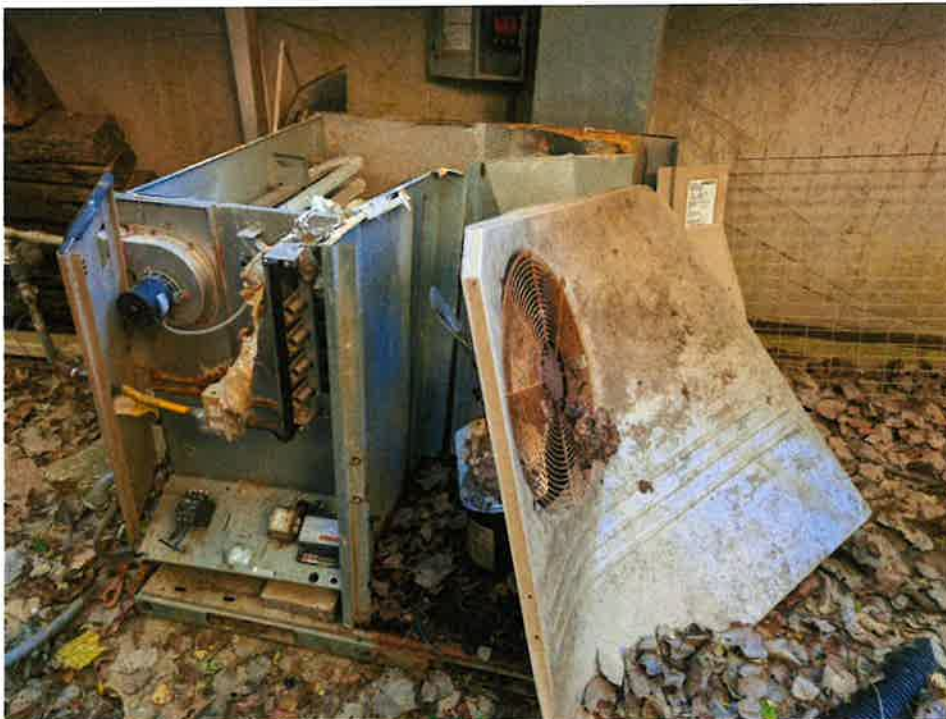
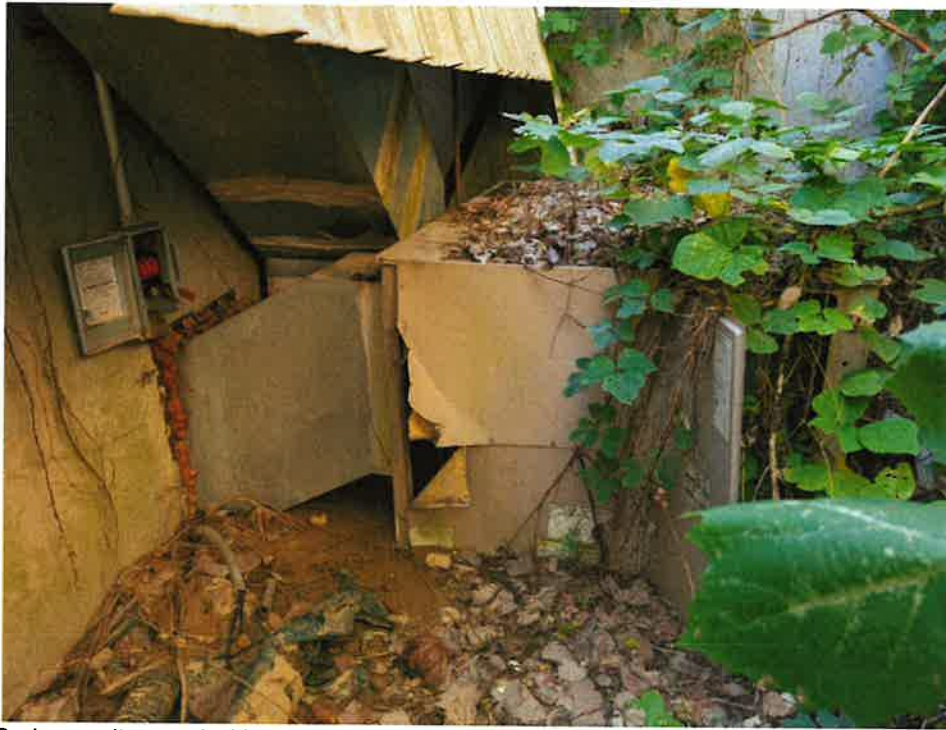
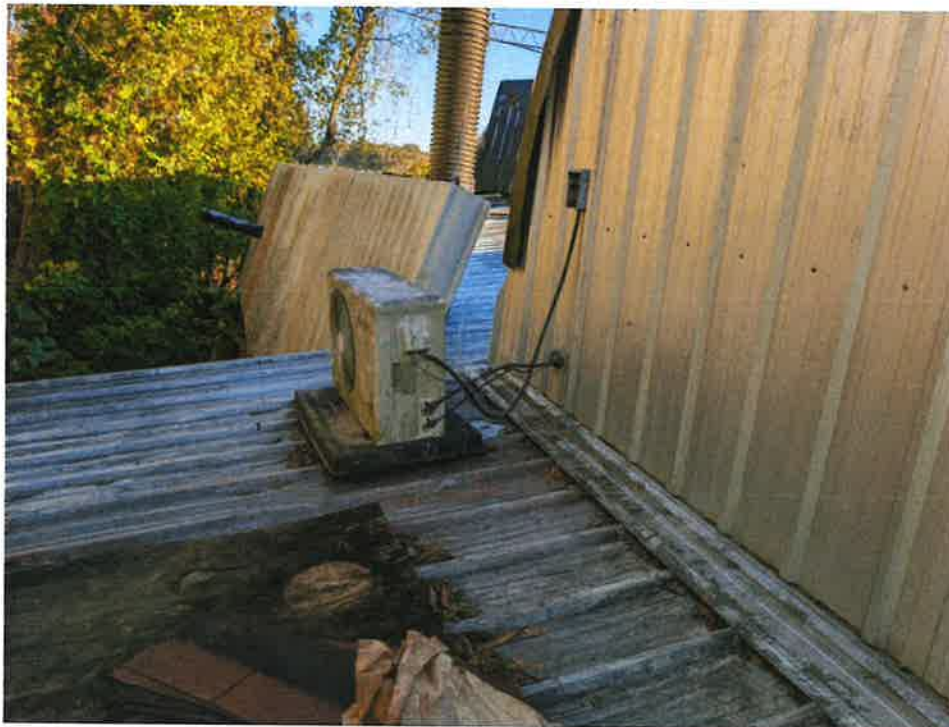
- Two package heating ventilating, and air conditioning (HVAC) units were observed on the north side of the building and one mini-split HVAC unit was observed on the roof.

**Photo 6:** Package unit on north side of building

**Photo 7:** Package unit on north side of building

**Photo 8:** Mini-split system on roof

4. Section 608 of the Clean Air Act (40 CFR Part 82, Subpart F) prohibits the intentional venting of ozone-depleting substances used as refrigerants into the atmosphere while maintaining, servicing, repairing, or disposing of air conditioning or refrigeration equipment. Refrigerants used in the package HVAC units and the mini-split HVAC unit should be recovered prior to equipment disposal.

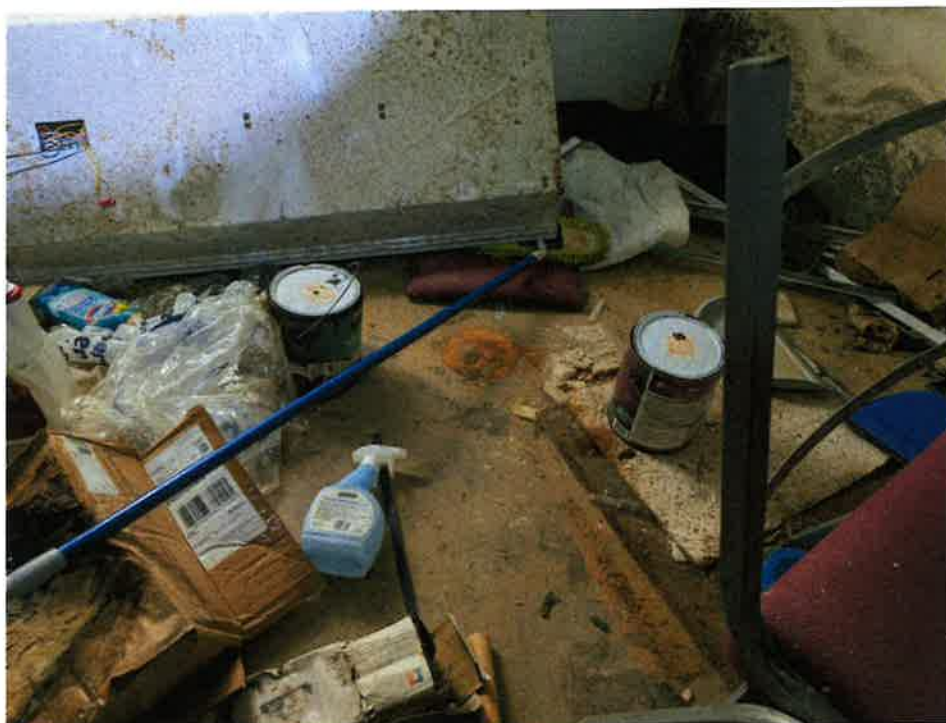
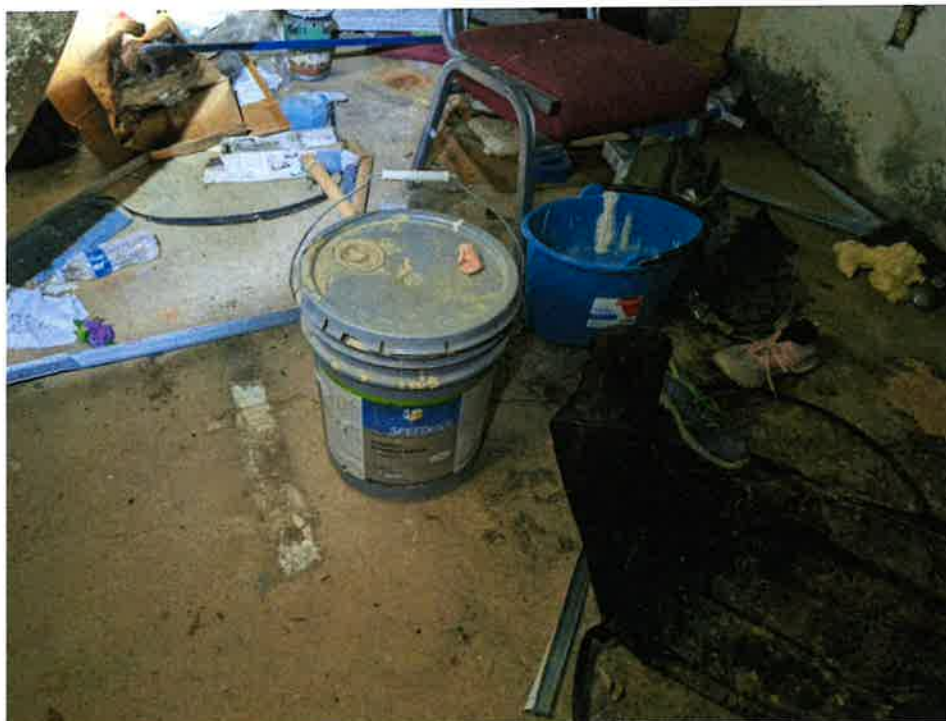
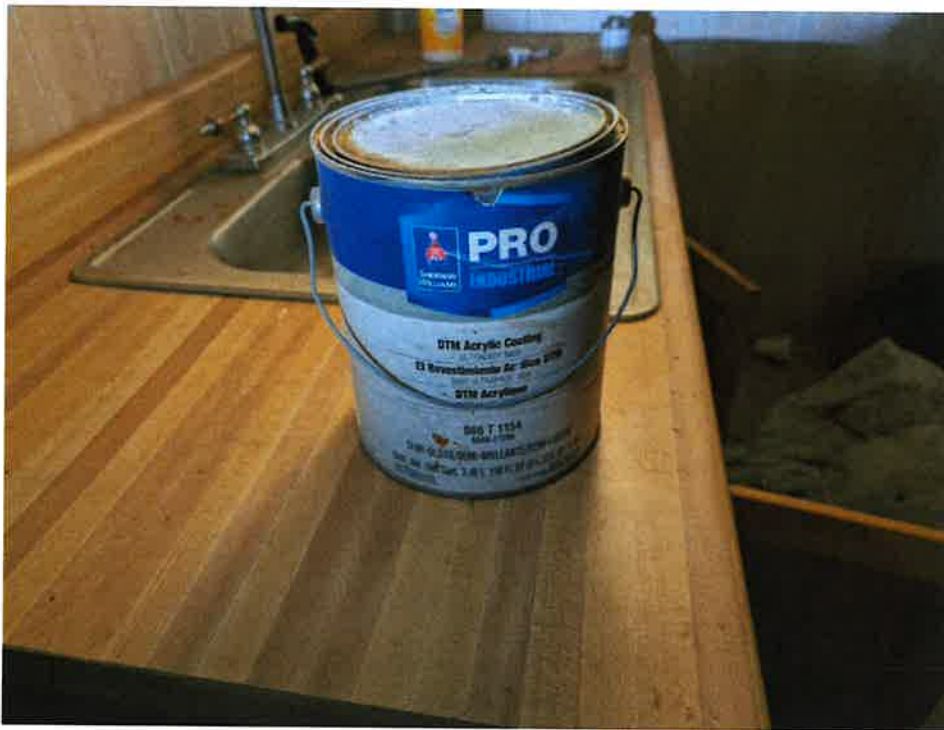
- KLK observed approximately four one-gallon paint containers and one five-gallon paint container inside the building.
- KLK observed one mercury-containing thermostat located on the north wall of the building.

**Photo 9:** Paint containers in first-floor storage room

**Photo 10:** Paint container in first-floor storage room

**Photo 11:** Paint container in second-floor

5. Approximately four one-gallon paint containers and one five-gallon paint container were observed inside the building. These products should be removed for proper disposal prior to building demolition.

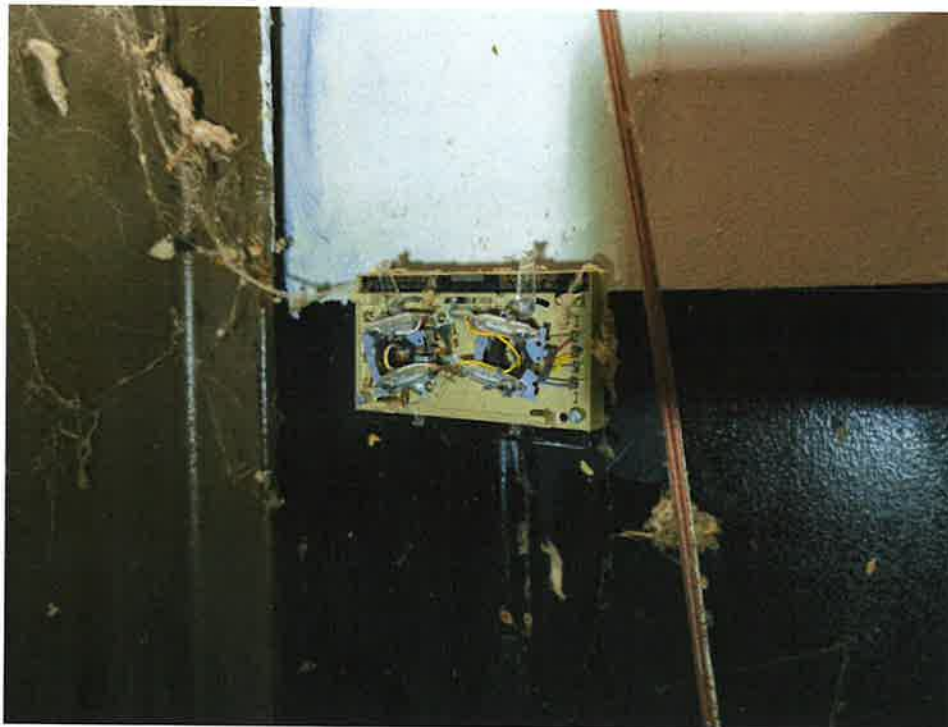
- One mercury-containing thermostat was observed on the north wall of the building.

**Photo 12:** Mercury-containing thermostat on the north wall
