MISSISSIPPI ASBESTOS DEMOLITION/RENOVATION NOTIFICATION FORM

ASBESTOS SURVEY

PROJECT
Melanie's Diner
2555 Goodman Road, W Horn Lake MS 38637

INSPECTION REPORT

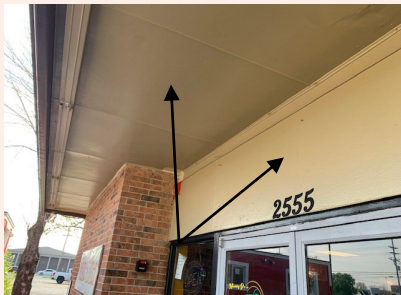
Front Transite Soffit

MD-13 – Ext. Soffit / MD-17 – Roof Parapet Wall – Transite Paneling

If this material is found anywhere else inside or outside the building. Treat and handle it as an asbestos contained material (ACM).

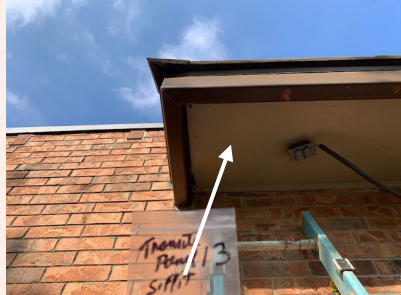
Side Transite Soffit

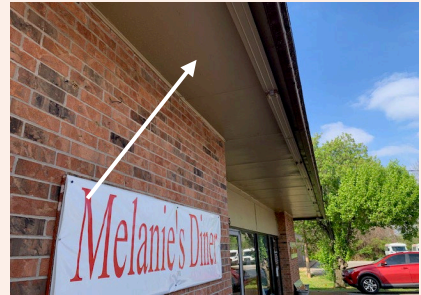
Front Transite Soffit

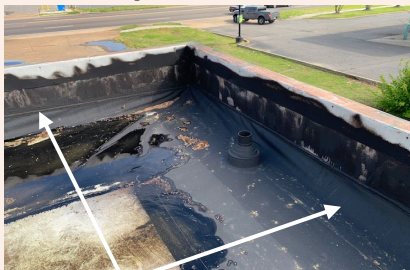
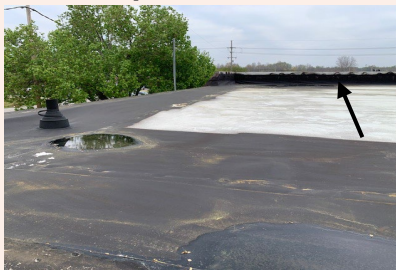
Parapet Wall MD-17

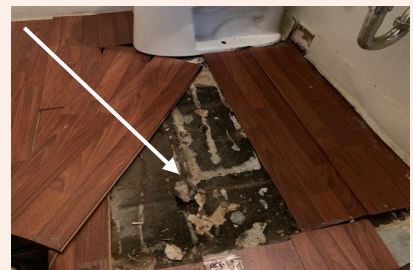
Bathroom Floor MD-7

MD-07 – Bathroom - Tan Floor tile / Black Floor Mastic

MD-07-Mastic 252401739-0007C	Bathroom - Floor tile/Mastic	Black Non-Fibrous Homogeneous		93% Non-fibrous (Other)	7% Chrysotile
MD-08 252401739-0008	Bathroom - Backing underlayment	Tan/Black Non-Fibrous Homogeneous		100% Non-fibrous (Other)	None Detected
MD-09-Cove Base 252401739-0009	Front storage room - Base vinyl	White Non-Fibrous Homogeneous		100% Non-fibrous (Other)	None Detected

If these materials are found anywhere else in the building. Treat and handle it as an asbestos contained material (ACM).
