Reference: Yandell Farms of Sheffield, Part 2  
Madison County, Mississippi

# **EROSION, SEDIMENT AND STORMWATER CONTROL PLAN**

## **YANDELL FARMS OF SHEFFIELD, PART 2**

RE: RPB Development, LLC  
Yandell Farms of Sheffield Development Phase II  
Madison County, Mississippi  
Regulatory Permit Review

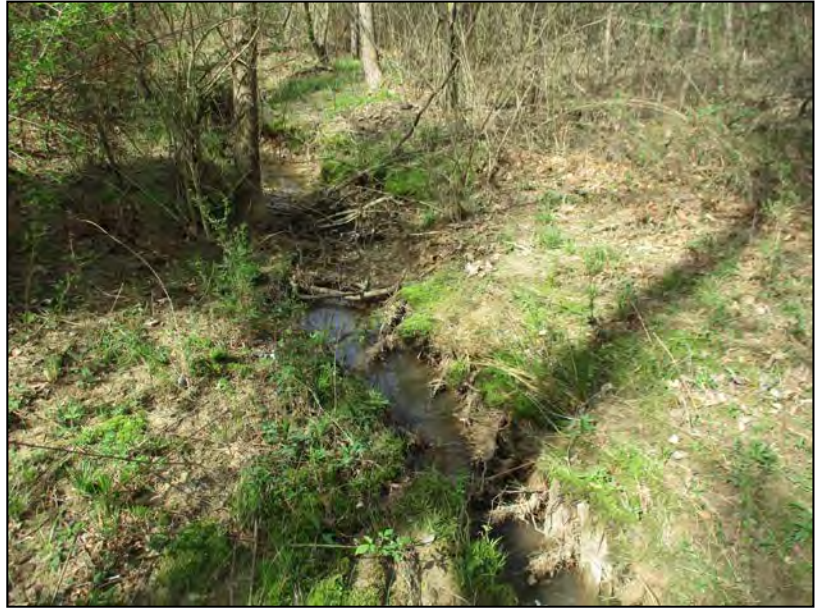
**PHOTOGRAPH #1**

**A downgradient view of the identified ephemeral stream channel that conveys storm water to the north across the subject property.**

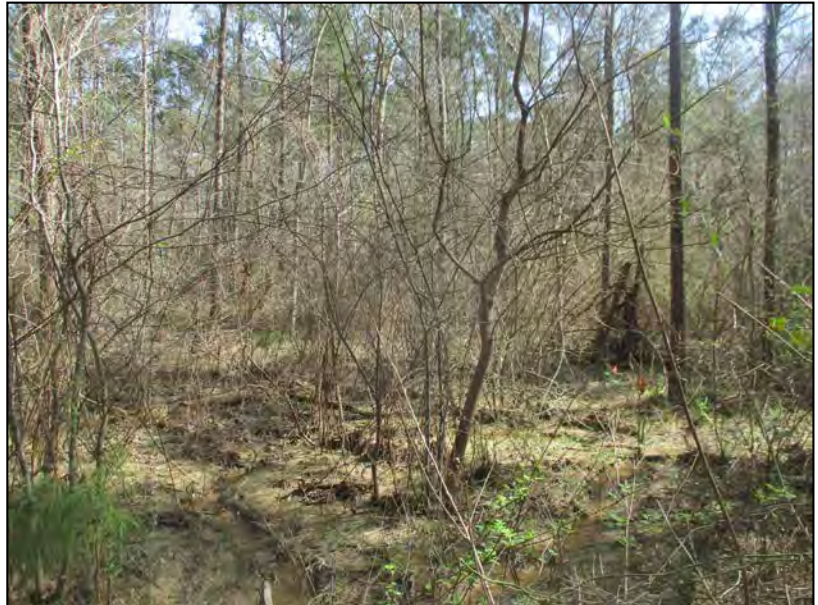
**PHOTOGRAPH #2**

The field investigations also discovered one (1) scrub-shrub wetland habitat that was identified within the southern portion of the property. The scrub-shrub wetland can be described as a naturally low-lying area that will collect and retain storm water before conveying it to the north via the identified ephemeral stream channel. The scrub-shrub wetland habitat exhibited hydrology indicators that include saturation at the surface, water-stained leaves, inundation in pools, sediment and drift deposits, and oxidized rhizospheres along living roots. The scrub-shrub wetland habitat contained vegetative components within the sapling/shrub and herbaceous strata and was without persistent overstory species. Vegetative species observed within the scrub-shrub wetland included sweet-gum (*Liquidambar styraciflua*), American elm (*Ulmus americana*), willow oak (*Quercus phellos*), cherry-bark oak (*Quercus pagoda*), water oak (*Quercus nigra*), red maple (*Acer rubrum*), cottongrass bulrush (*Scirpus cyperinus*), lamp rush (*Juncus effusus*), plume grass (*Saccharum giganteum*), bushy bluestem (*Andropogon glomeratus*), and *Carex* spp., among others.

The soils observed within the scrub-shrub wetland habitat were determined to range from a 5/1 (gray) to a 5/2 (grayish brown) on the 10YR page of the Munsell Soil Color Chart with a mottle color ranging from a 4/6 (strong brown) on the 7.5YR page to a 5/8 (yellowish brown) on the 10YR page.

**View of the identified scrub-shrub wetland habitat located within the southern portion of the subject property.**

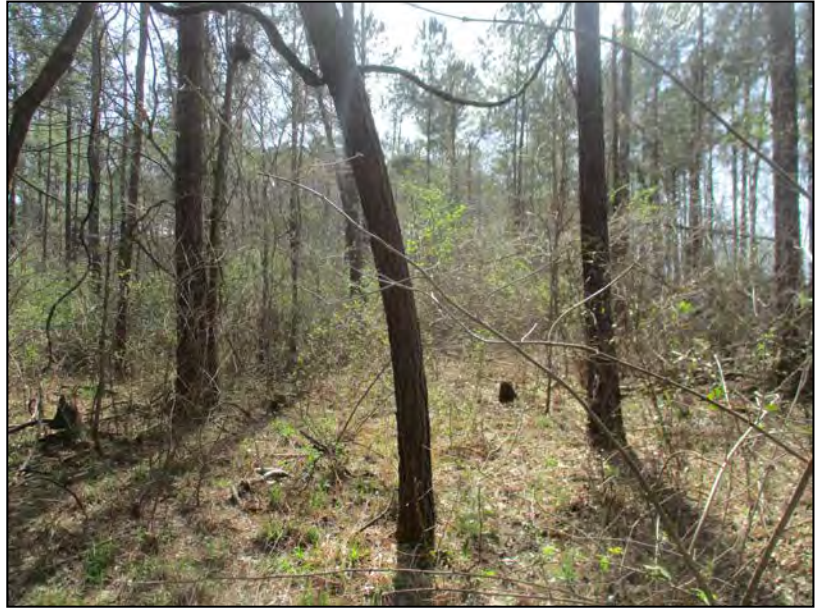
**PHOTOGRAPH #3**

The remaining portions of the subject property are contained within a forested upland (non-wetland) habitat type. Due to these upland habitats being present on higher elevations and hillslopes, the uplands were absent of any significant hydrology indicators or hydric characteristics. The primary vegetation observed within the upland habitats consist of loblolly pine (*Pinus taeda*), sweetgum (*Liquidambar styraciflua*), water oak (*Quercus nigra*), black cherry (*Prunus serotina*), cherry-bark oak (*Quercus pagoda*), American elm (*Ulmus americana*), hickory (*Carya spp.*), eastern red cedar (*Juniperus virginiana*), beauty berry (*Callicarpa americana*), dog-fennel (*Eupatorium capillifolium*), *Solidago spp.*, broomsedge (*Andropogon virginicus*), southern dewberry (*Rubus trivialis*), long-leaf wood-oats (*Chasmanthium sessiliflorum*), poison ivy (*Toxicodendron radicans*), and honeysuckle (*Lonicera japonica*), among others.

**View to the east depicting the forested upland habitat that was observed within the southern portion of the subject property.**

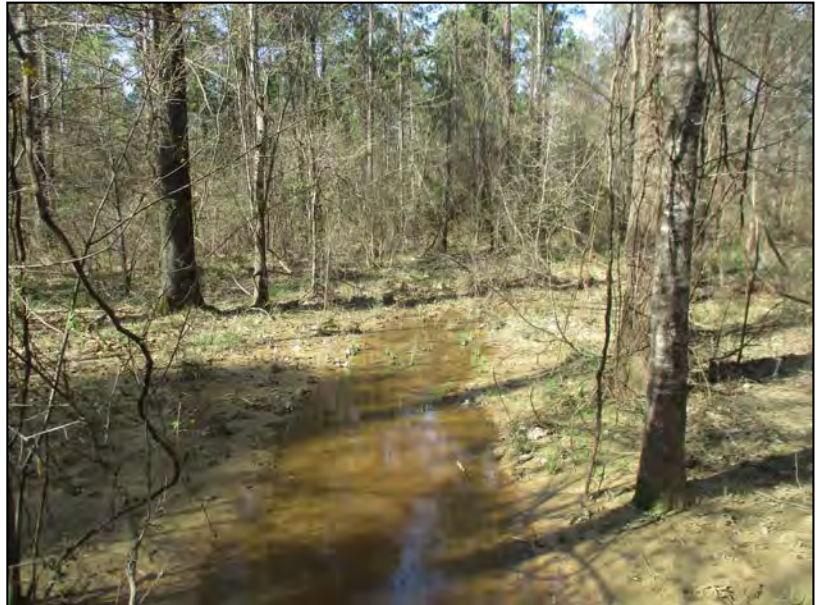
**PHOTOGRAPH #4**

**View to the north depicting the forested wetland habitat that was identified within the central portion of the subject property.**

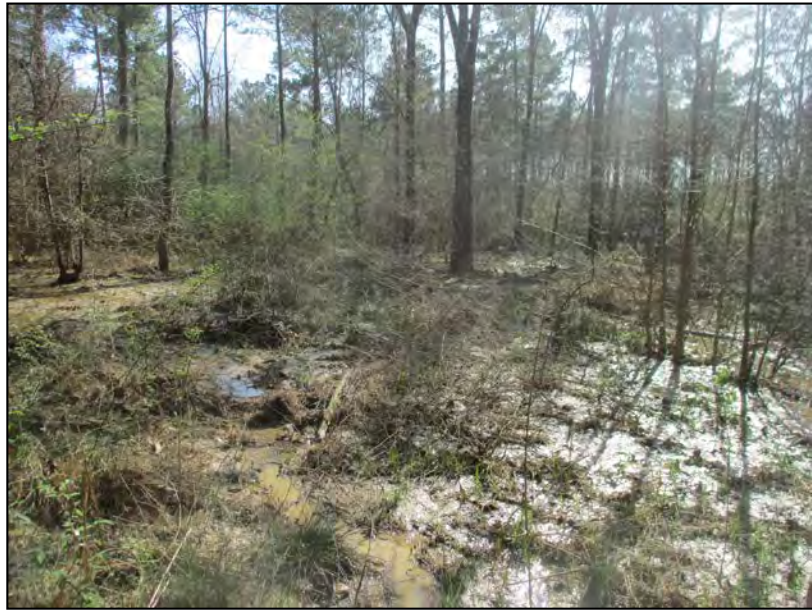
**PHOTOGRAPH #5**

**Photo shows the forested wetland habitat that was identified within the central portion of the property.**

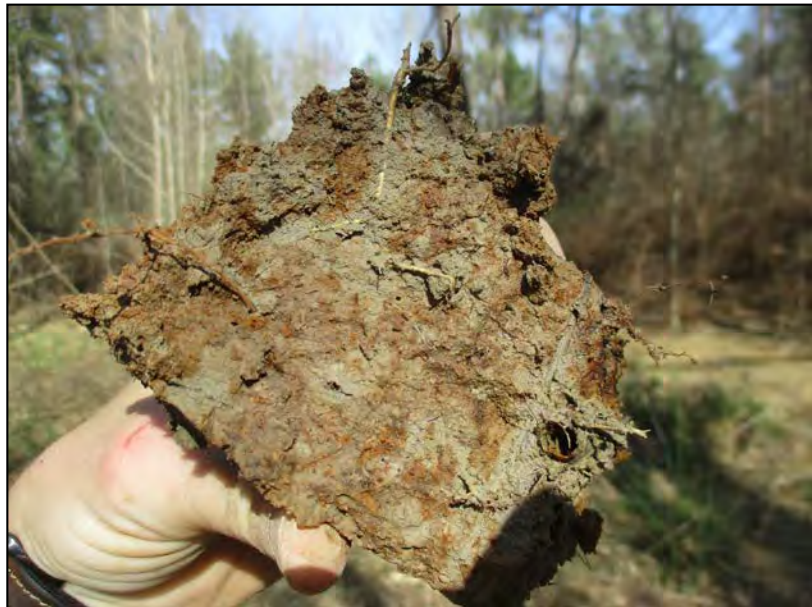
**PHOTOGRAPH #6**

The soils observed within the forested wetland habitats were determined to range from a 5/1 to a 6/1 (gray) and a 5/2 (grayish brown) to a 6/2 (light brownish gray) on the 10YR page of the Munsell Soil Color Chart with a mottle color ranging from a 4/6 (strong brown) on the 7.5YR page to a 5/8 (yellowish brown) on the 10YR page.

**Photo shows a hydric soil sample that was taken from within the forested wetland habitat.**

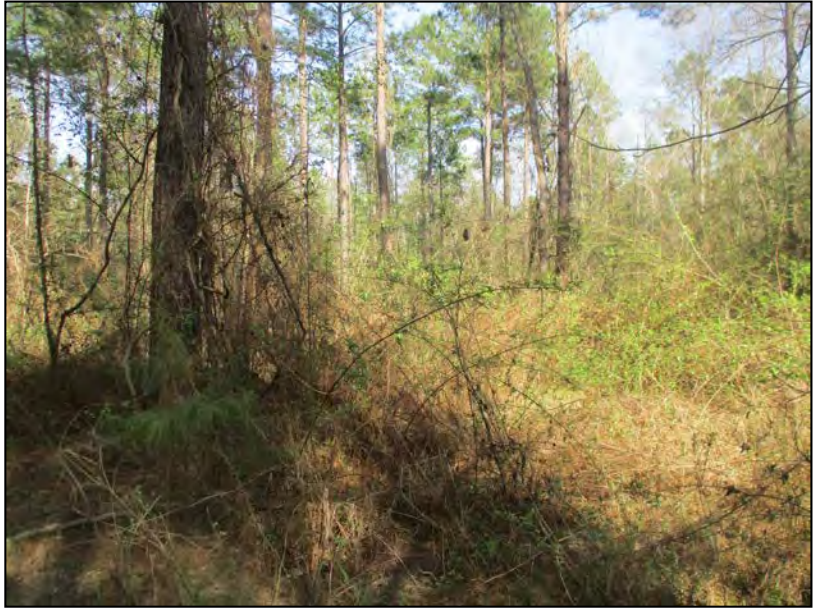
**PHOTOGRAPH #7**

**View to the east depicting the typical forested upland habitat that was observed within the northern portion of the subject property.**

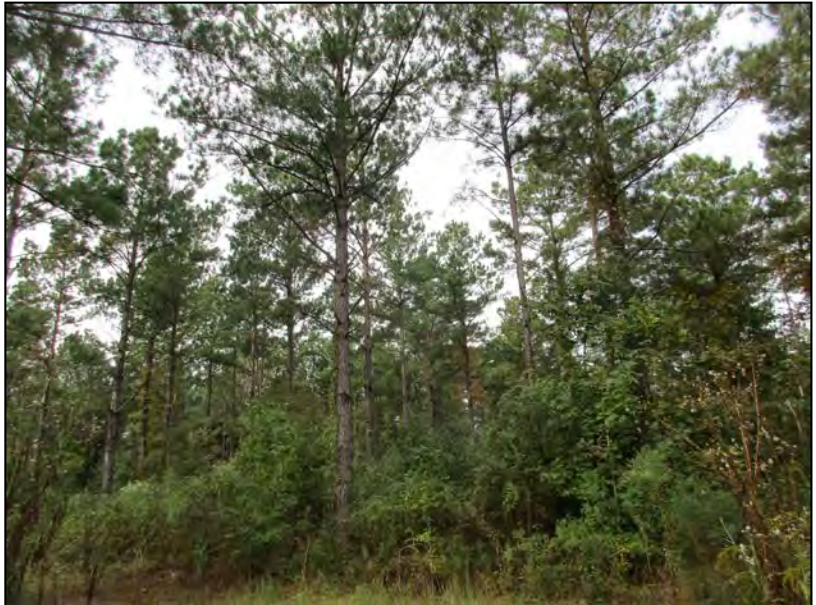
**PHOTOGRAPH #8**

**View to the east depicting the typical forested upland habitat that was observed within the west portion of the subject property.**

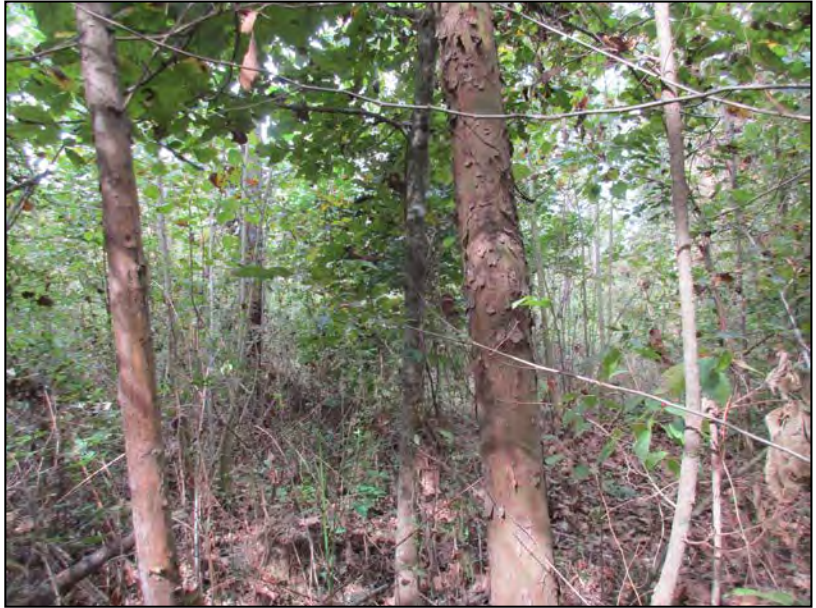
**PHOTOGRAPH #9**

**View of the forested wetland habitat that was identified in the north portion of the subject property.**
