# ASBESTOS SURVEY

PROPOSED DOLLAR GENERAL STORE

NORTHWEST CORNER OF HIGHWAY 11 AND W MICHIGAN STREET  
POPLARVILLE, MISSISSIPPI 39470

ECS PROJECT NO. 49:24405

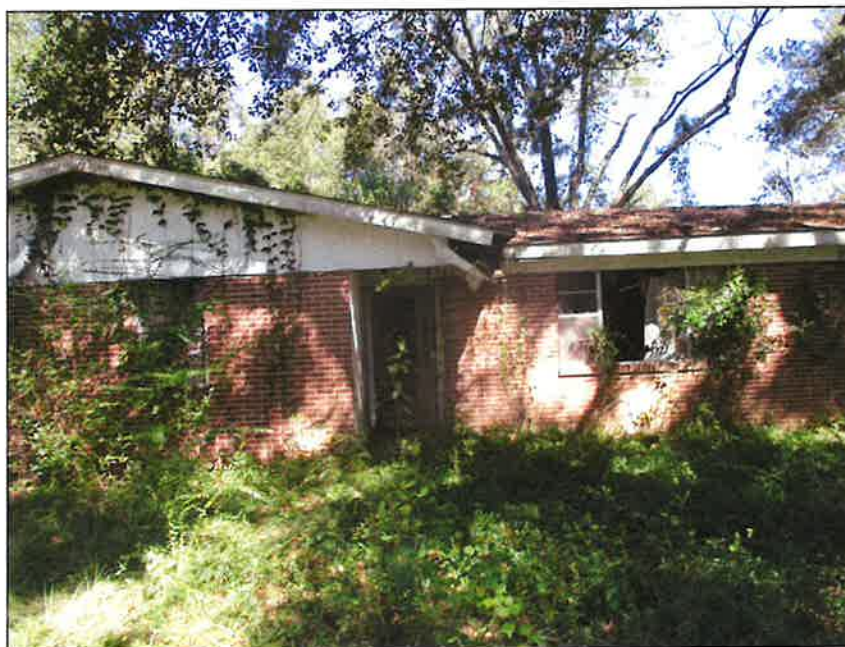
1 - Appearance of the residential structure on the subject property.

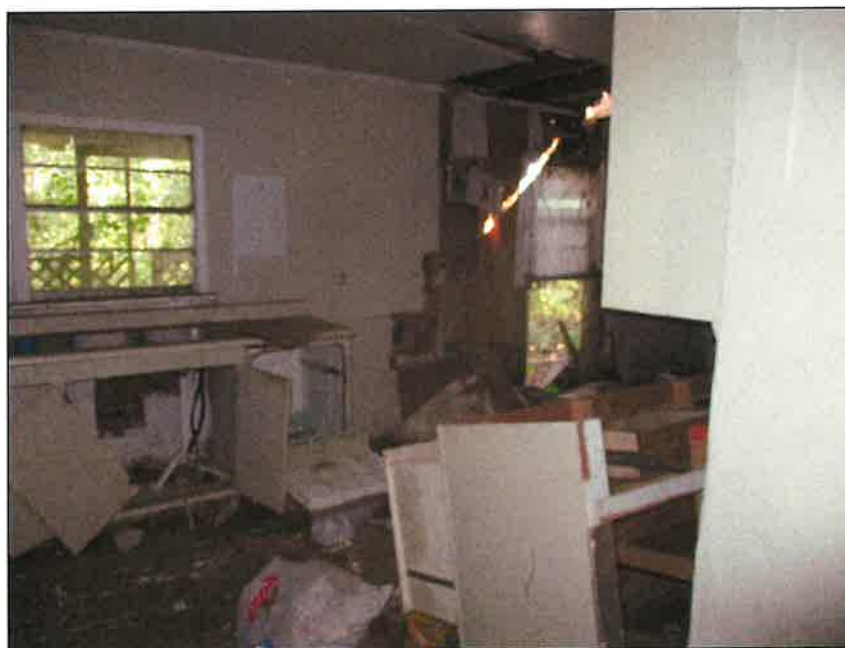
| <b>Sample ID</b> | <b>Material Location</b> | <b>Material Description</b> | <b>Analytical Results</b> | <b>Category</b> | <b>Estimated Quantity</b> |
|---|---|---|---|---|---|
| A - 1, 2, 3 | Kitchen | Brown and white floor tiles and yellow mastic | FT Non-detect-(ND)<br>Mastic-ND | Not Applicable (NA) | Approximately 300 square feet (SF) |

2 - View of the kitchen

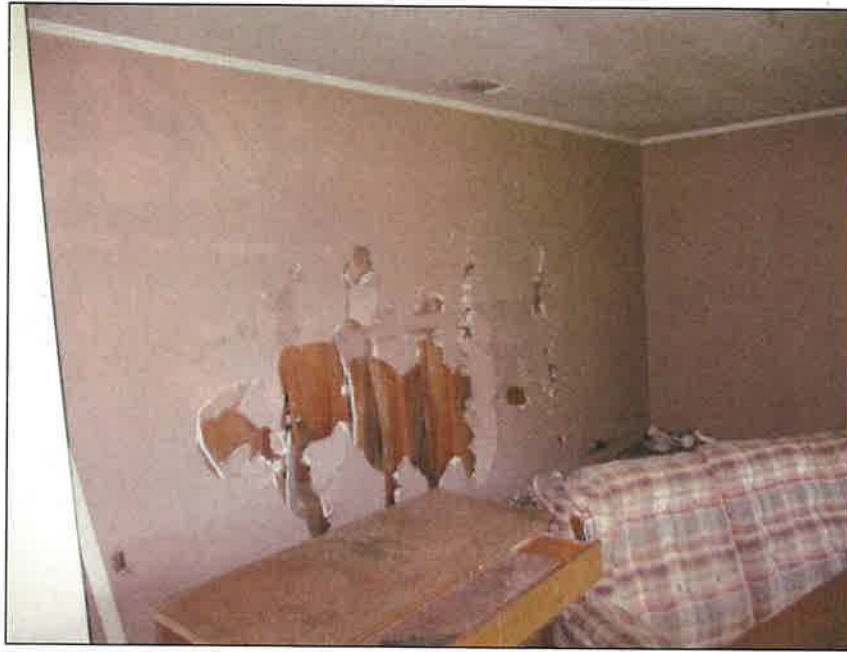
| <b>Sample ID</b> | <b>Material Location</b> | <b>Material Description</b> | <b>Analytical Results</b> | <b>Category</b> | <b>Estimated Quantity</b> |
|---|---|---|---|---|---|
| <b>A - 17, 18, 19</b> | Living room | Gray drywall and <b>tan joint-compound</b> | Drywall - ND<br><b>JC - 3% Chrysotile</b> | Category II | <b>Approximately 400 SF</b> |

3 - View of the living room (ACM drywall)

ECS recommends where a material type has been identified as asbestos-containing that, other materials with similar color, texture, age, and size throughout the building's interior and exterior be assumed to contain asbestos. Please refer to Section 4.1 for a complete list of building materials reported positive for asbestos and Section 4.2 for materials assumed to contain asbestos. Identified ACMs must be removed, encapsulated, or enclosed before disturbance of the materials.

If ACMs are to be removed, an accredited asbestos abatement contractor should perform the removal. It is recommended that an industrial hygienist monitor the project. This involves collecting air samples from within and outside abatement work areas to monitor the asbestos abatement contractor's work practices throughout the project. The industrial hygienist should evaluate if the asbestos abatement work is in accordance with project specifications, U.S. EPA regulation 40 CFR Part 61-NESHAP Subpart M: National Emission Standard for Asbestos, and OSHA regulation 29 CFR 1926.1101 – Asbestos in Construction. The industrial hygienist should assess each work area to monitor the removal of ACMs. Only after the industrial hygienist has determined the identified ACMs have been removed should final clearance air samples be collected (if necessary).

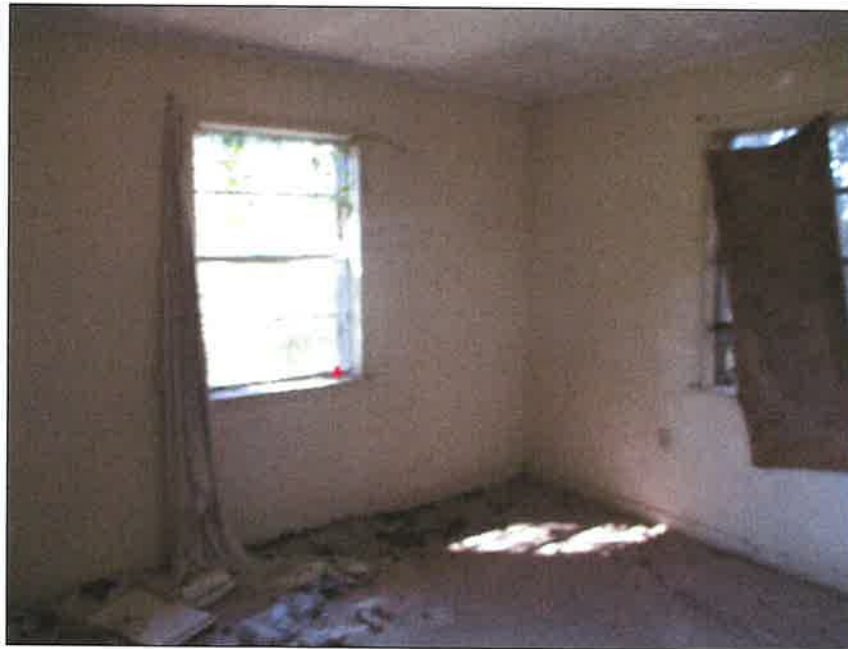
4 - View of a typical bedroom

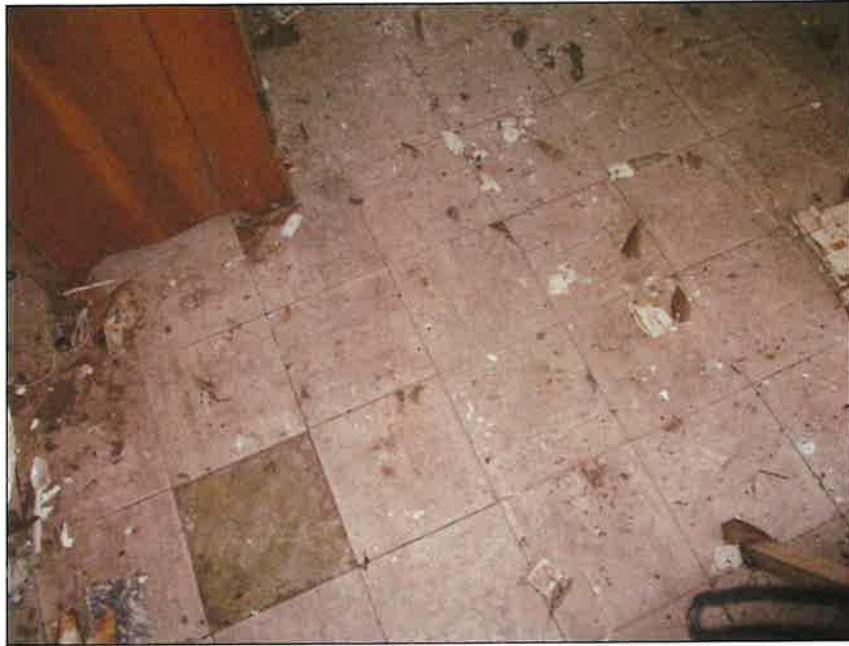
| <b>Sample ID</b> | <b>Material Location</b> | <b>Material Description</b> | <b>Analytical Results</b> | <b>Category</b> | <b>Estimated Quantity</b> |
|---|---|---|---|---|---|
| <b>A - 4, 5, 6, 7, 8</b> | Living room, kitchen, and bedrooms | <b>Tan 9" x 9" floor tiles and yellow mastic</b> | <b>FT - 2% Chrysotile</b><br>Mastic - ND | Category 1 | <b>Approximately 1,500 SF</b> |

5 - View of the tan 9" x 9" floor tiles (ACM)

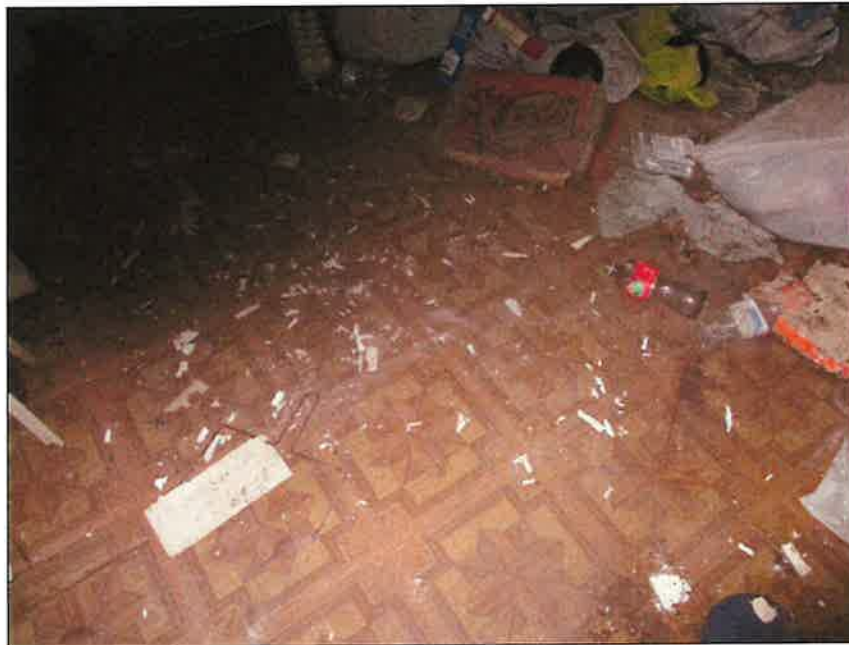
| <b>Sample ID</b> | <b>Material Location</b> | <b>Material Description</b> | <b>Analytical Results</b> | <b>Category</b> | <b>Estimated Quantity</b> |
|---|---|---|---|---|---|
| A - 9, 10, 11 | Utility room | Brown linoleum and yellow mastic | Linoleum - ND<br>mastic - ND | NA | Approximately 150 SF |

6 - View of the brown linoleum

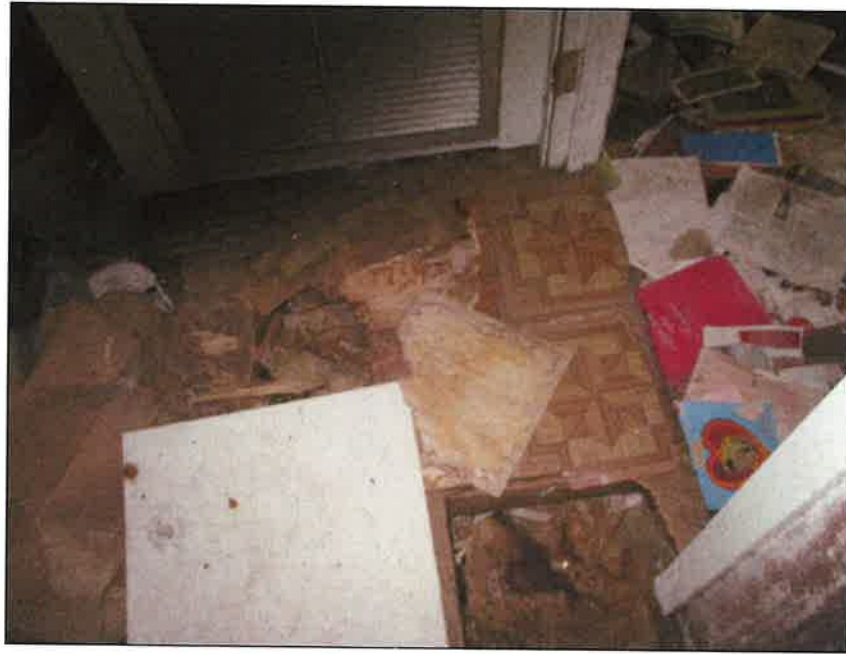
7 - View of the of brown linoleum

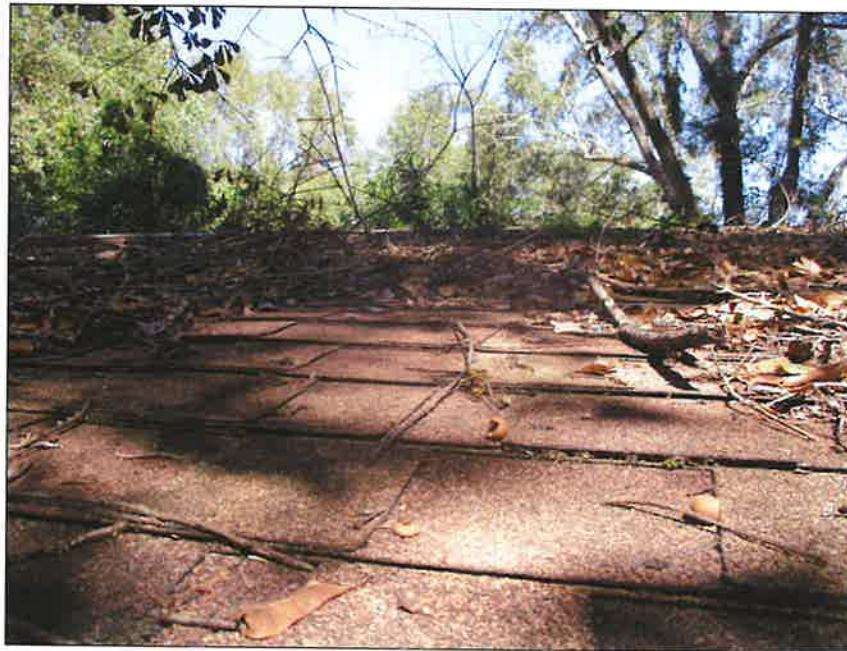
| <b>Sample ID</b> | <b>Material Location</b> | <b>Material Description</b> | <b>Analytical Results</b> | <b>Category</b> | <b>Estimated Quantity</b> |
|---|---|---|---|---|---|
| R - 1, 2, 3, 4, 5 | Roof | Brown and black shingles, black tar, and black felt paper | Shingles -ND<br>Tar - ND<br>Felt - ND | NA | Approximately 2,350 SF |

8 - View of the roof
