Asbestos Containing Material Survey

Three Houses Located
At
732 North Church Street
414 & 502 Barnes Street

Tupelo, MS
April 24, 2025

EAC Environmental is pleased to submit the Asbestos Containing Building Material Surveys conducted on behalf of three vacant houses located at 732 North Church Street, 414 and 502 Barnes Street, Tupelo, Mississippi.

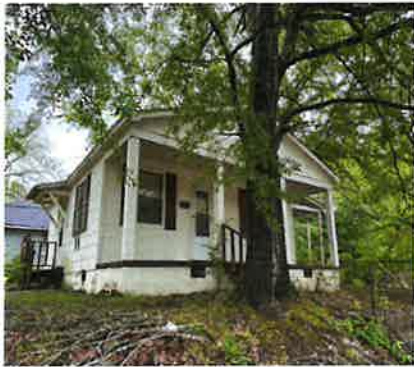
732 North Church

- 1) 732 Church ST.** 18% Chrysotile Asbestos in exterior transite siding and 4% in bathroom VCT
- 2) 414 Barnes -** Exterior Shingles Contain 16% Chrysotile Asbestos
- 3) 502 Barnes -** Exterior Shingles contain 16% Chrysotile Abestos

In accordance with State Regulations, ACM will require removal by an MDEQ Licensed Asbestos Contractor and properly disposed of in a National Emission Standards for Hazardous Air Pollutants (NESHAP) Approved Landfill.
