NESHAP ASBESTOS-CONTAINING MATERIALS SURVEY REPORT

**Merit Health River Region, West Campus
Site Specific Asbestos Survey
1111 North Frontage Rd.
Vicksburg, MS 39180**

GHP Project No. 230046.01

**Survey Date: July 8-11, 2024
Final Report Date: July 30, 2024**

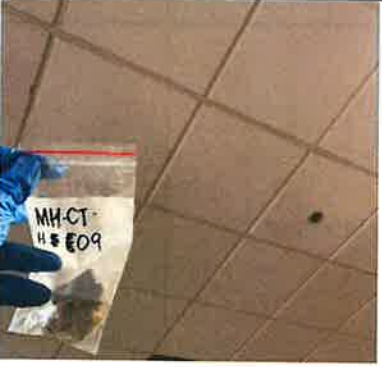
None Detected	2' x 4' Pinhole Ceiling Tile

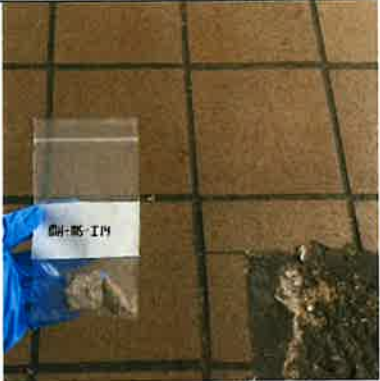
None Detected	6" x 6" Dark Brown Ceramic Floor Tile & Grout
J

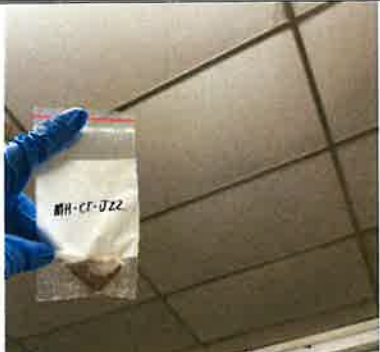
None Detected	2' x 4' Flat, No-Texture Ceiling Tile
K

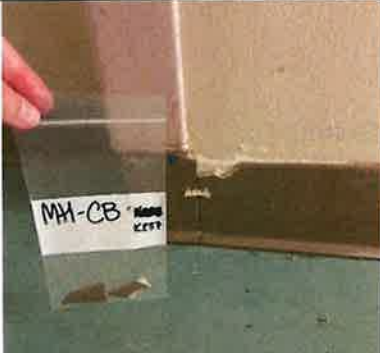
None Detected	Light Brown Cove Base
L

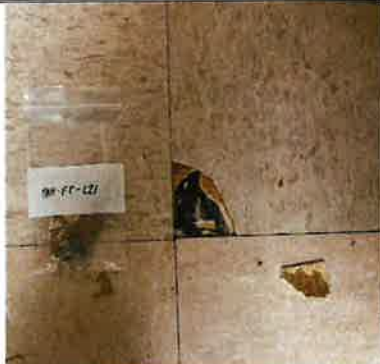
2 % Chrysotile – Tile 5% Chrysotile - Mastic	12" x 12" Beige Vinyl Floor Tile

Based on the site investigation and sample results, GHP would recommend that any regulated materials identified within this report be removed and disposed by properly licensed and trained personnel based prior to any demolition or development of the site/facility.

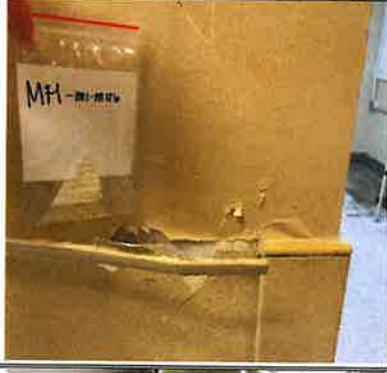
None Detected	Beige Textured FRP & Mastic
N

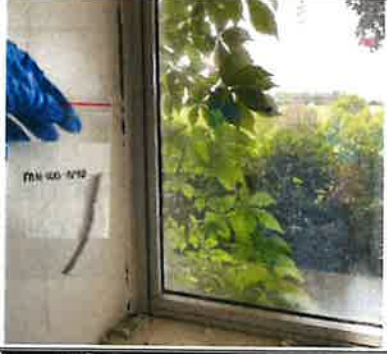
None Detected	White Chalky Window Caulking
O

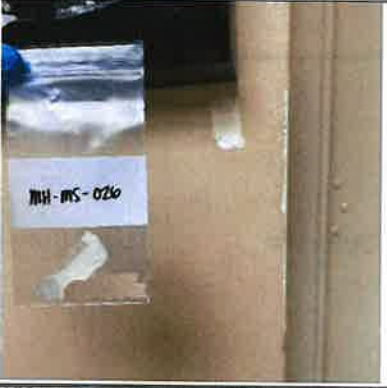
None Detected	Beige Textured Wallpaper
P

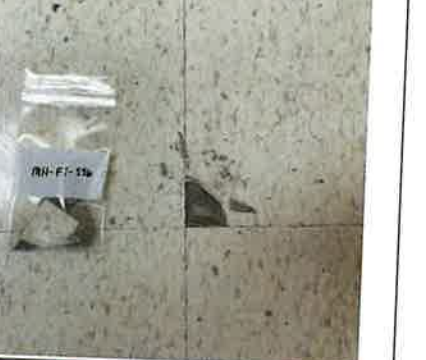
<p>None Detected</p>	<p>12" x 12" White with Grey Specks, Vinyl Floor Tile</p>
T

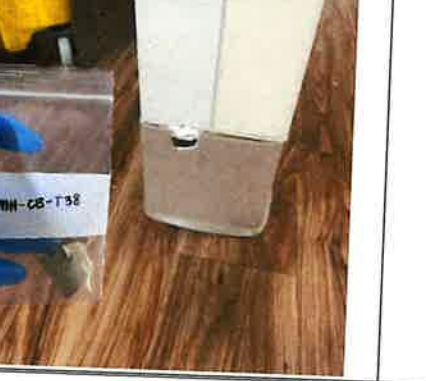
<p>None Detected</p>	<p>Tall Gray Cove Base</p>

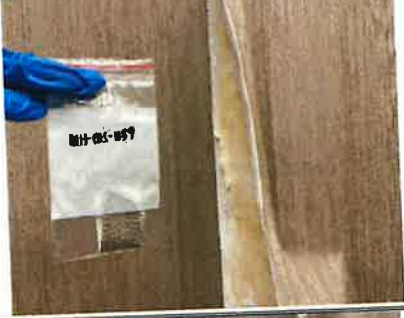
None Detected	Brown/Black Threaded Wallpaper
V

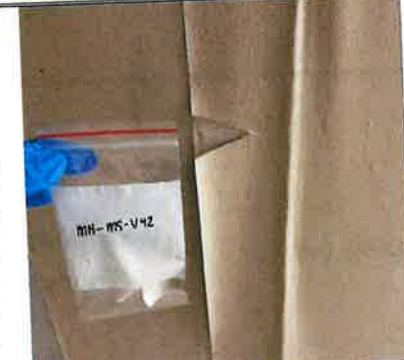
None Detected	Beige Textured Wallpaper
W

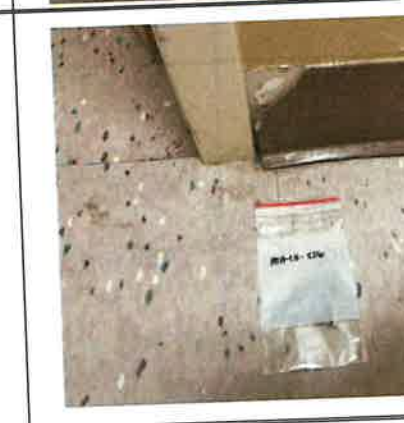
None Detected	Dark Brown Cove Base

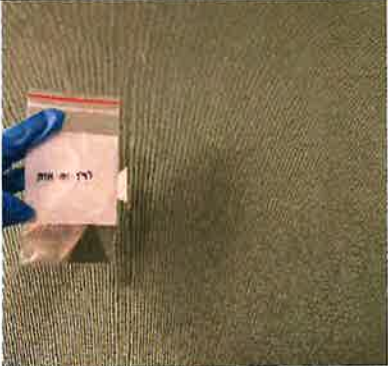
None Detected	Dark Green Wallpaper
Z

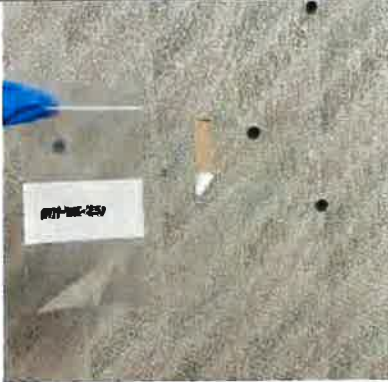
None Detected	Gray/Blue Zigzag Wallpaper
AA

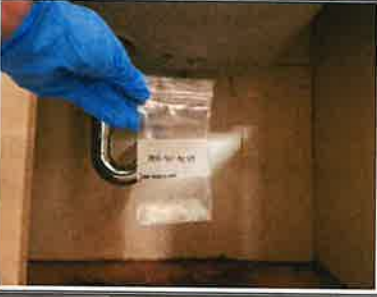
<p>3-4% Chrysotile</p>	<p>Grey Sink Undercoat</p>
AD

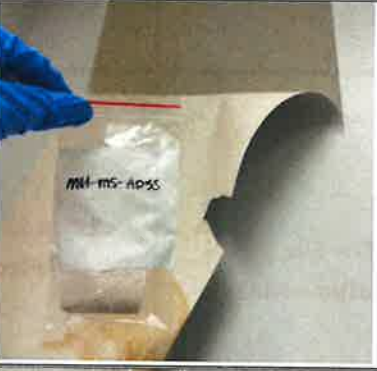
<p>None Detected</p>	<p>White Textured Wallpaper</p>
AE

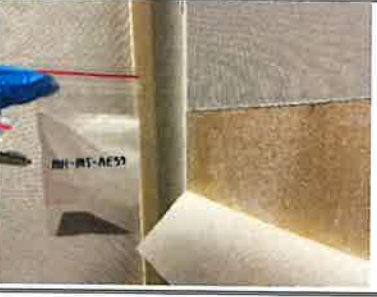
<p>None Detected</p>	<p>White Textured Wallpaper</p>

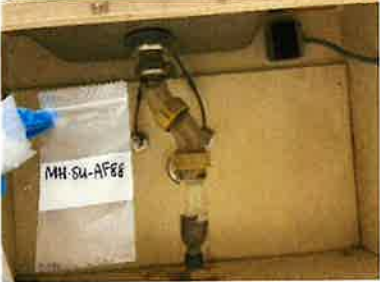
<p>2% Chrysotile</p>	<p>Brown Sink Undercoat</p>
AG

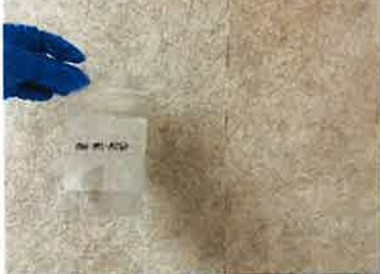
<p>None Detected</p>	<p>Beige Textured/Marbled Wallpaper</p>

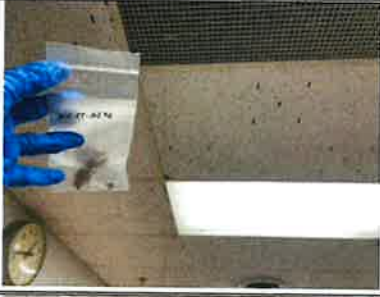
None Detected	2' x 4' Pinhole with Perforation Ceiling Tile
AK

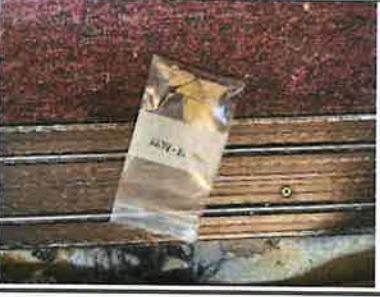
NAD – Tile 2% Chrysotile – Mastic	12" x 12" Grey/Beige Vinyl Floor Tile
AM

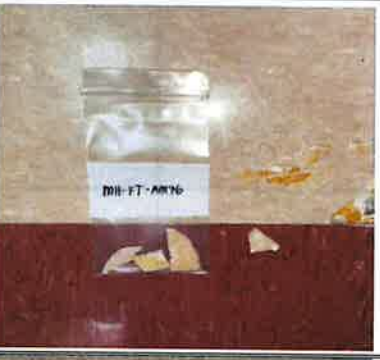
2% Chrysotile – Bottom Tile 5% Chrysotile – Mastic	12" x 12" Peach with Spots Vinyl Floor Tile
AN

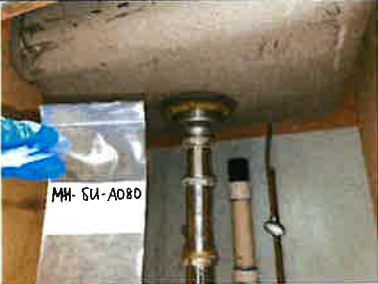
2% Chrysotile	Grey Sink Undercoat
AP

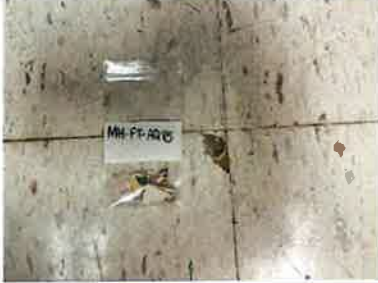
2% Chrysotile – Bottom Tile 5% Chrysotile – Mastic	12" x 12" Blue Speckled Vinyl Floor Tile
AR	 	None Detected	Grey Cove Base
AS

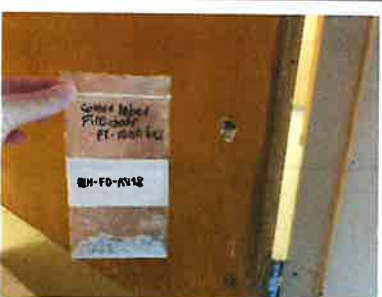
AV	MH-FD-AV98	Fire Door Core, Green Label	1 st Floor	Corridor O/S Sleep Center	2% Chrysotile 8% Amosite
AV	MH-FD-AV351	Fire Door Core, Green Label	4 th Floor	Fire Exit by Comm.	5% Chrysotile 5% Amosite
AV	MH-FD-AV356	Fire Door Core	4 th Floor	Eastern Stairwell	5% Chrysotile 5% Amosite
BD	MH-PW-BD127	4" Pipe Wrap, Tan	1 st Floor	Cafeteria, Above Ceiling	None Detected (Assume Positive)
BD	MH-PW-BD129	4" Pipe Wrap, Tan	1 st Floor	Central Storage	None Detected (Assume Positive)
BD	MH-PW-BD210	4" Pipe Wrap, Tan	1 st Floor	Lobby	None Detected (Assume Positive)
BD	MH-PW-BD215	4" Pipe Wrap, Tan	1 st Floor	Physical Therapy Admin	None Detected (Assume Positive)

2% Chrysotile 8% Amosite	Fire Door Core (Green Label)
AW

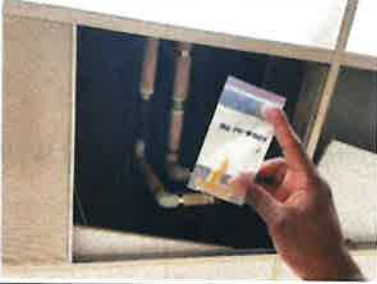
<p style="color: red;">NAD – Insulation 2% Chrysotile – Grey Gummy Layer</p>	<p style="color: red;">4" Pipe Wrap, Tan</p>
BE

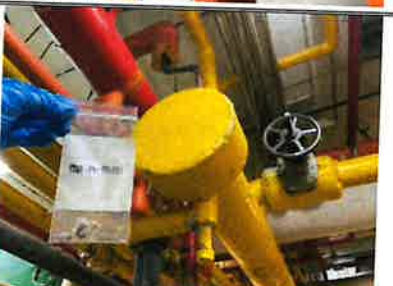
20% Chrysotile	12" Steam Line End Cap
BH

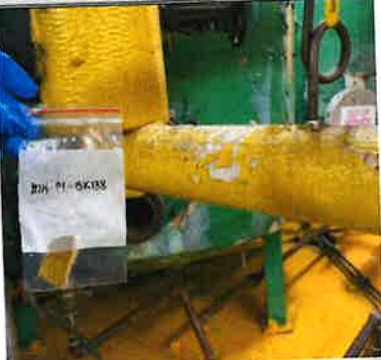
TABLE 2: SUMMARY OF MATERIALS WITH >1% ASBESTOS CONCENTRATIONS					
HA	Sample ID	Material Description	Material Location	Sample Location	Results
BH	MH-PI-BH397	8" Teal Elbow	2 nd Floor, Roof	Mech. Room 5	5% Chrysotile
BI	MH-PI-BI135	12" Blue Pipe Insulation, CWS	1 st Floor	Plant Ops, Mech. Shop	None Detected (Assume Positive)
BI	MH-PI-BI135	12" Blue Pipe Insulation, CWS	1 st Floor	Plant Ops, Mech. Shop	None Detected (Assume Positive)
BI	MH-PI-BI399	12" Blue Pipe Insulation, CWS	2 nd Floor, Roof	Mech. Room 5	None Detected (Assume Positive)
BI	MH-PI-BI400	12" Blue Pipe Insulation, CWS	2 nd Floor, Roof	Mech. Room 5	5% Chrysotile
BK	MH-PI-BK138	4" Steam Line Yellow Pipe Insulation	1 st Floor	Plant Ops, Mech. Shop	None Detected (Assume Positive)
BK	MH-PI-BK144	4" Steam Line Yellow Pipe Insulation	1 st Floor	Plant Ops, Mech. Shop	5% Chrysotile 5% Amosite
BK	MH-PI-BK146	4" Steam Line Yellow Pipe Insulation	1 st Floor	Plant Ops, Mech. Shop	5% Chrysotile 5% Amosite

<p>5% Chrysotile 5% Amosite</p>	<p>4" Steam Line, Yellow Pipe Insulation</p>
BL

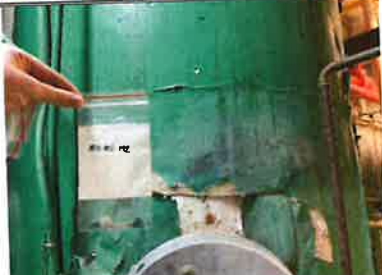
<p>20% Chrysotile</p>	<p>Teal Boiler/Steam Tank Insulation</p>
BN

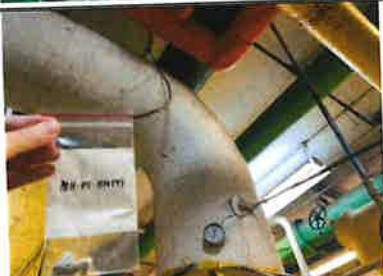
<p>20% Chrysotile</p>	<p>12" White Hard Pipe Insulation</p>
BO

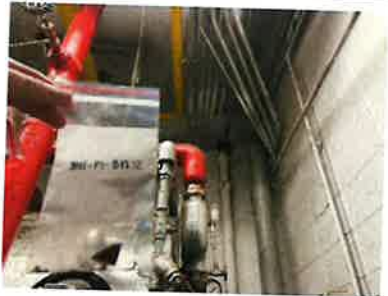
<p>5% Chrysotile 5% Amosite</p>	<p>Red Hard Pipe Elbow</p>
BQ

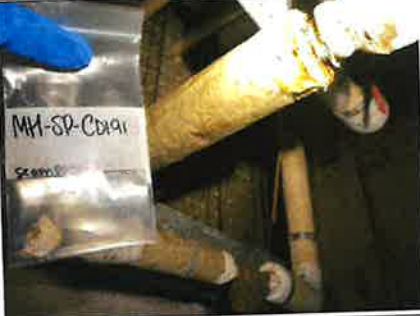
<p>4% Chrysotile</p>	<p>White Seam Paste on Fiberglass Pipe</p>
CE

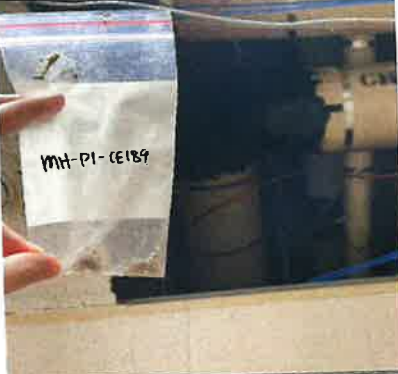
<p>None Detected</p>	<p>12" Hard Pipe Elbow</p>
CF

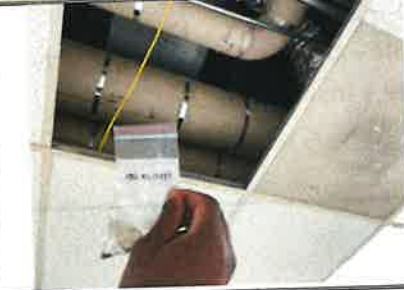
<p>None Detected</p>	<p>12" Pipe Insulation</p>

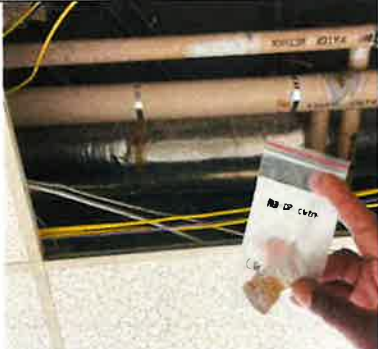
None Detected	Yellow Duct Paste on Soft Duct
CH

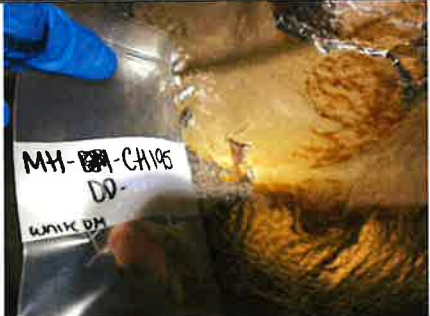
None Detected	White Duct Paste on Soft Duct
CI

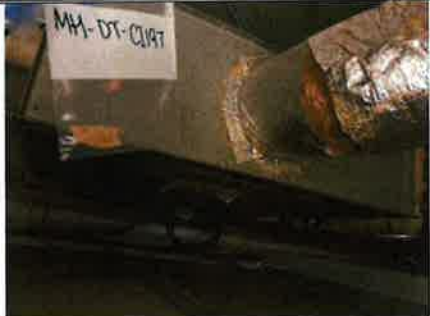
None Detected	Brown Duct Tape on Soft Duct
CI

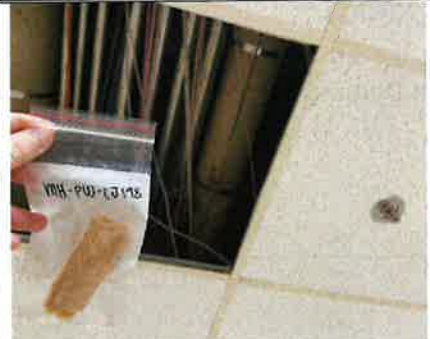
None Detected	8" Pipe Wrap, Tan Over Fiberglass

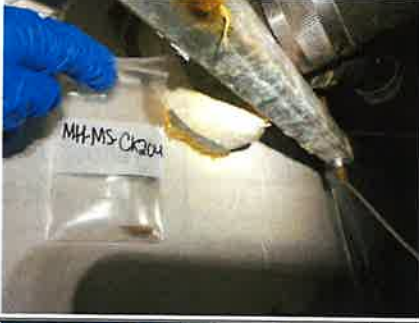
None Detected	Yellow Fire Stop
CL

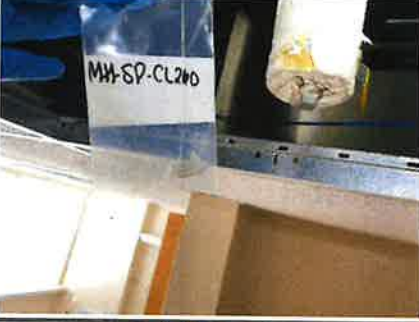
3% Chrysotile	White Seam Paste
CM

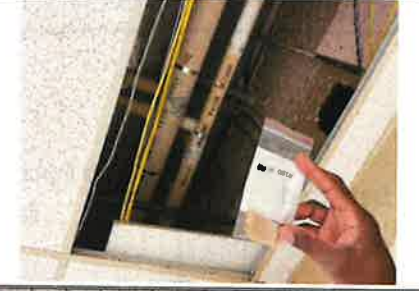
None Detected	6" Pipe Insulation
CN

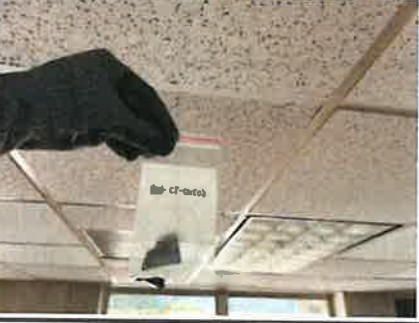
None Detected	2' x 2' Textured Ceiling Tile

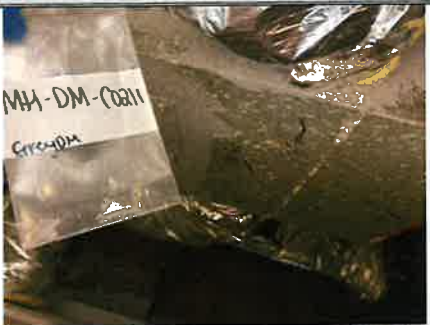
None Detected	Grey Duct Mastic
CP

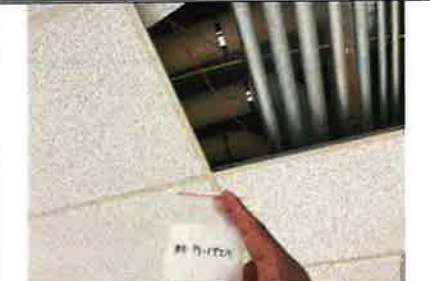
None Detected	8" Pipe Elbow
CQ

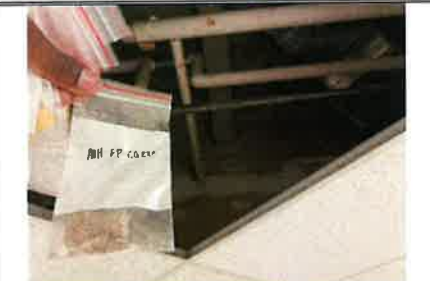
None Detected	Beige/Gray Fireproofing
CR

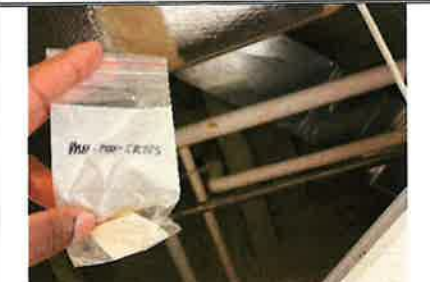
None Detected	8" Pipe Wrap, White

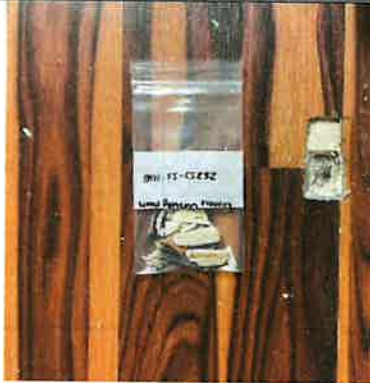
None Detected	Light & Dark Wood Pattern Floor Sheeting
CT

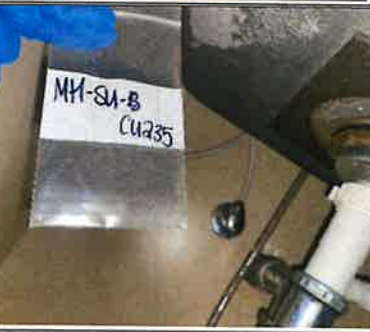
None Detected	Dark Grey Sink Undercoat
CV

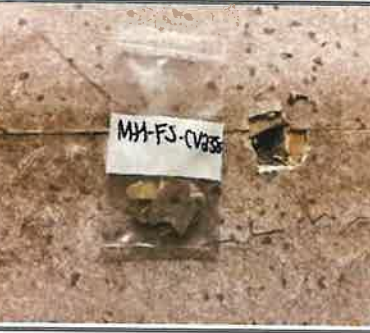
<p style="color: red;">NAD – Linoleum 2% Chrysotile – Tile 5% Chrysotile – Mastic</p>	<p style="color: red;">Pink with Teal Speck Patterned Floor Sheeting</p>

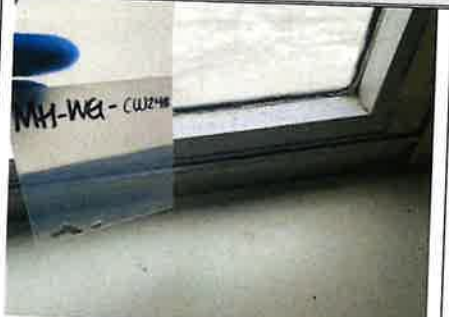
None Detected	Window Glazing
CX

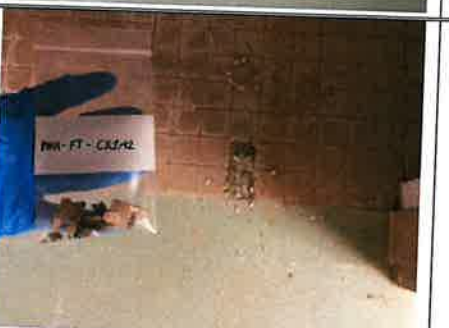
None Detected	Brown Ceramic Floor Tile
CY

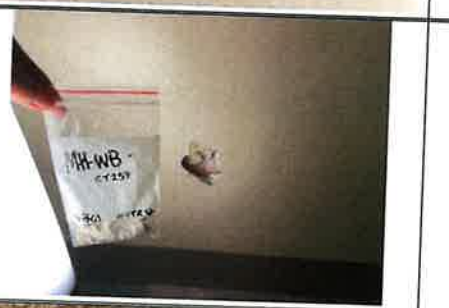
None Detected	Wallboard, Tape & Mud
CZ

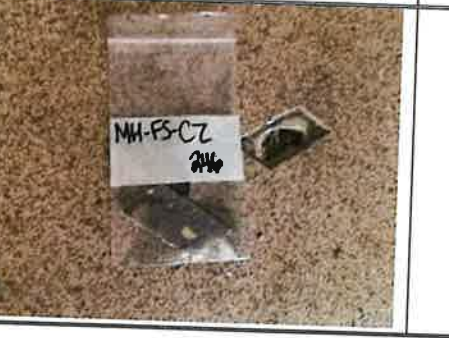
None Detected	Blue, Grey Speckle Floor Sheeting

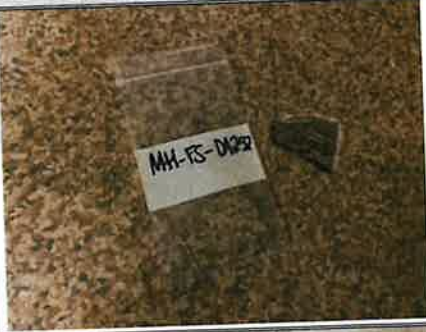
None Detected	Brown & Yellow Floor Sheetting
DB

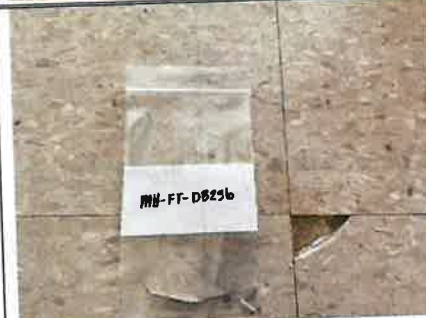
<p style="color: red;">NAD – Tile 2% Chrysotile Mastic</p>	<p style="color: red;">12" x 12" Light Grey with Dark Streak Vinyl Floor Tile</p>
DC

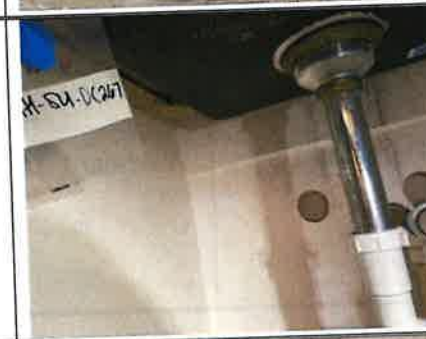
None Detected	Black Tar Sink Undercoat
DD

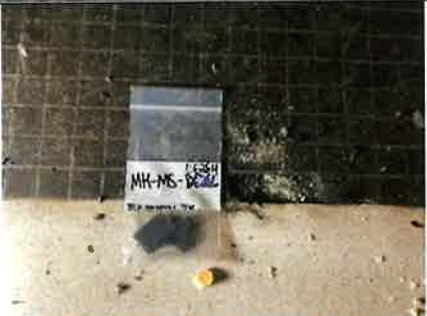
None Detected	Black Ceramic Tile
DF

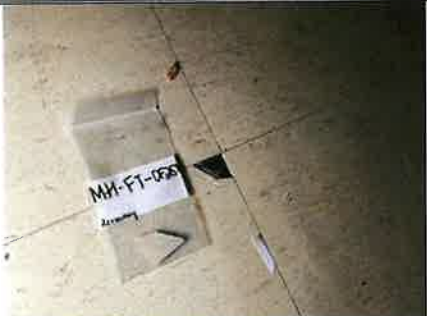
2% Chrysotile – Tile 5% Chrysotile – Mastic	12" x 12" Beige Floor Tile
DG

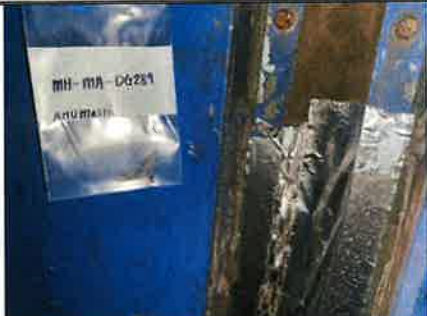
None Detected	AHU Mastic
DH

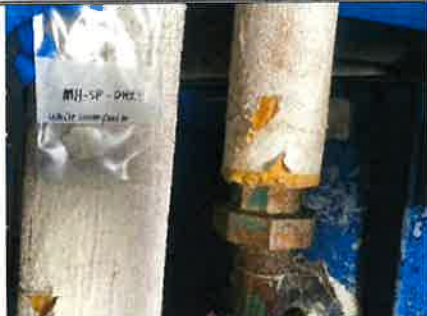
None Detected	White Seam Paste

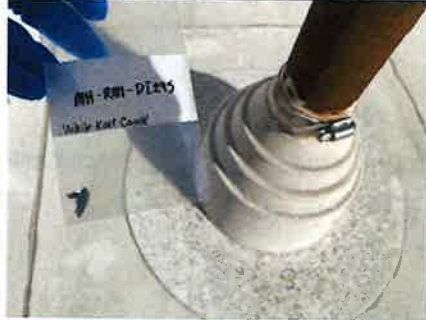
None Detected	White Roof Caulk
DJ

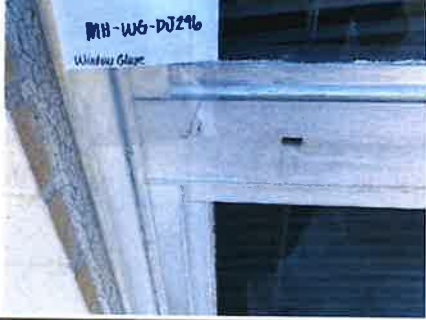
None Detected	Window Glazing
DK

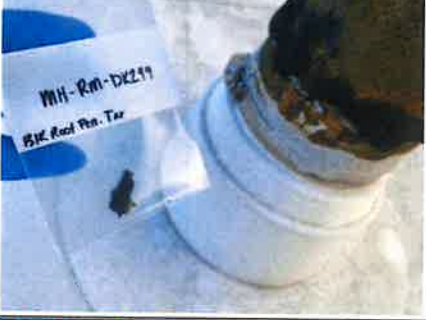
None Detected	Black Roof Penetration Tar
DL

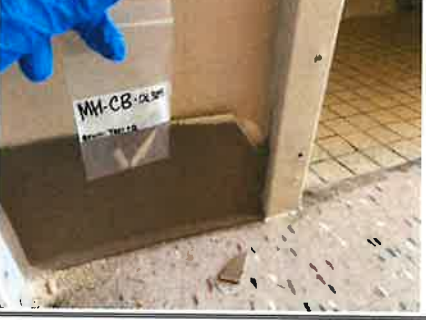
None Detected	Tall Brown Cove Base

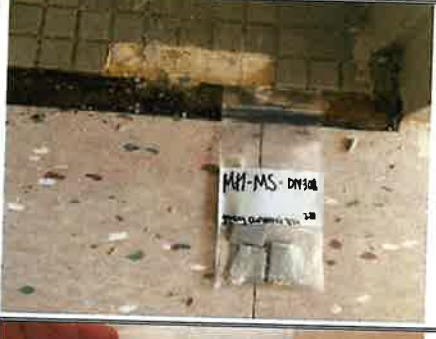
<p>None Detected</p>	<p>Grey Ceramic Floor Tile</p>
DO

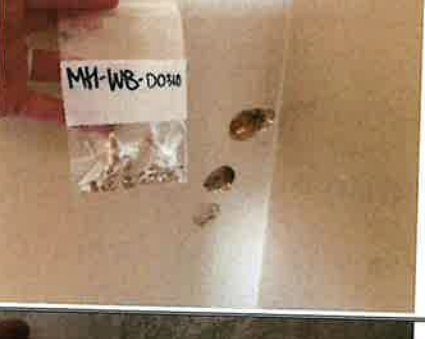
<p>None Detected</p>	<p>Wallboard, Tape & Mud</p>
DP

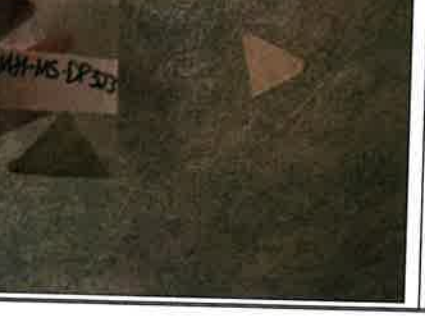
<p>None Detected</p>	<p>Grey Swirl Wallpaper</p>

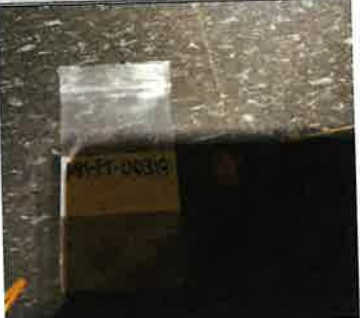
None Detected	12" x 12" Black with White Streak Vinyl Floor Tile
DR

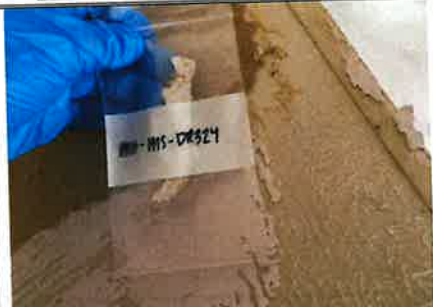
None Detected	White FRP & Mastic
DS

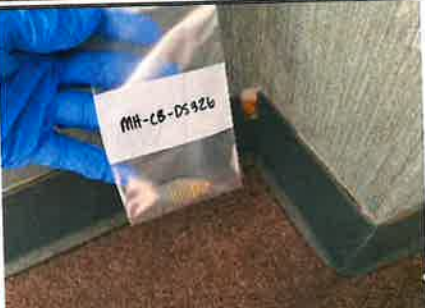
None Detected	Green Cove Base
DT

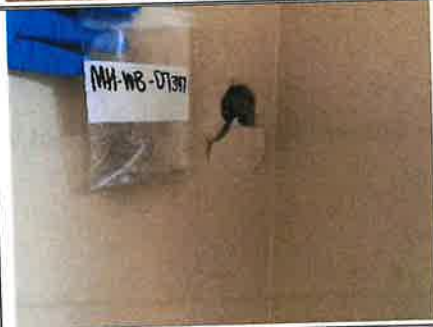
None Detected	Wallboard, Tape & Mud

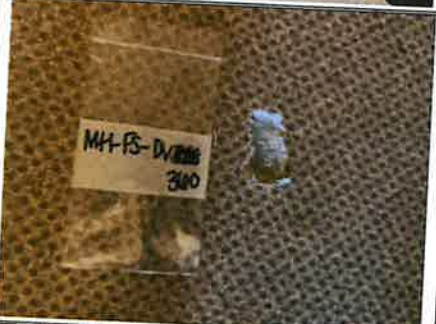
<p>None Detected</p>	<p>Brown Textured Floor Sheeting</p>
DW

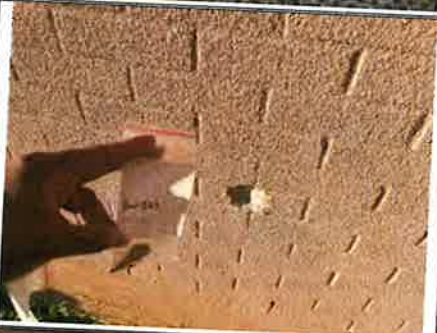
<p>None Detected</p>	<p>Exterior Brink</p>
DX

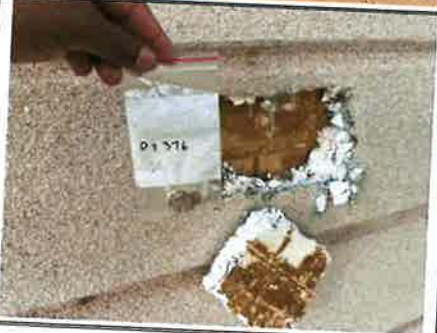
<p>None Detected</p>	<p>Exterior Mortar</p>

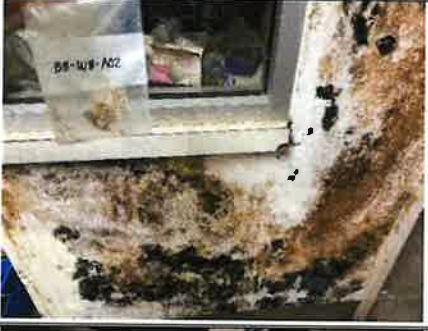
None Detected	Wallboard, Tape & Mud
B

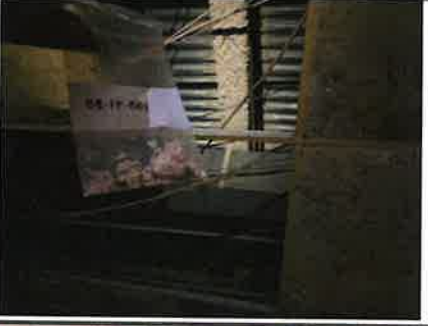
5% Chrysotile	Tan Fireproofing
C

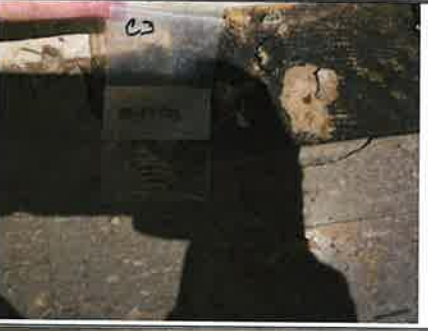
2% Chrysotile – Tile 5% Chrysotile – Mastic	12" x 12" Cream Floor Tile
D

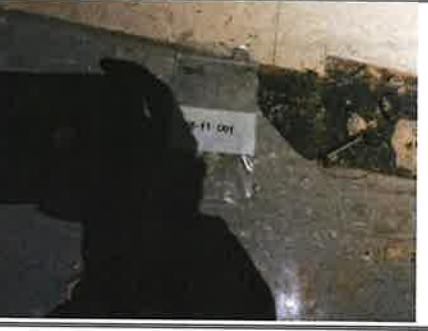
NAD – Tile 5% Chrysotile – Mastic	12" x 12" Grey Floor Tile

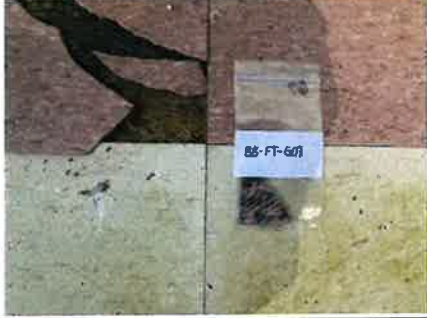
<p style="text-align: center;">NAD – Tile 5% Chrysotile – Mastic</p>	<p style="text-align: center;">12" x 12" Mauve Floor Tile</p>
H

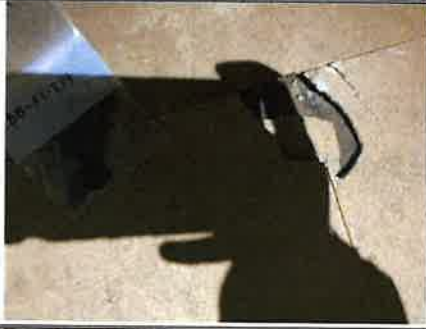
<p>NAD – Tile 5% Chrysotile – Mastic</p>	<p>12" x 12" Brown Floor Tile</p>
J

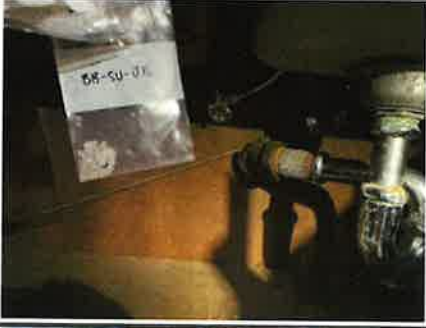
<p>4% Chrysotile</p>	<p>Grey Sink Undercoat</p>
K

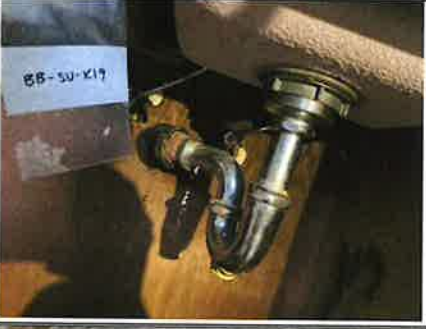
<p>5% Chrysotile</p>	<p>Pink Sink Undercoat</p>
L

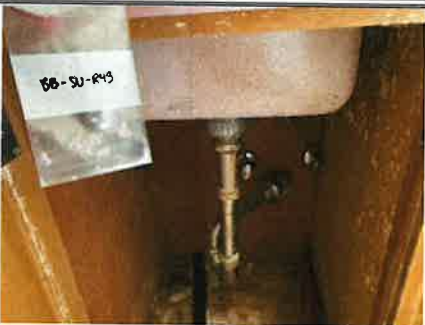
3% Chrysotile	White Sink Undercoat
S

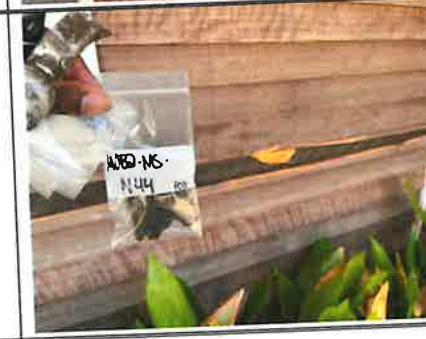
None Detected	Exterior Felt Behind Wood
Maintenance Building			
A

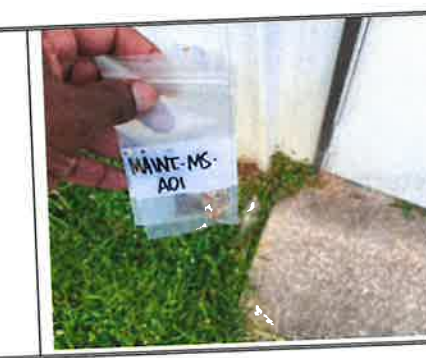
None Detected	Concrete Slab

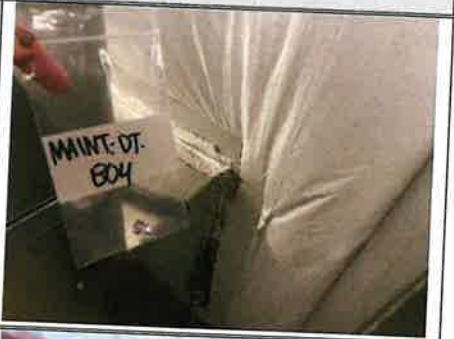
None Detected	Silver Duct Tape
C

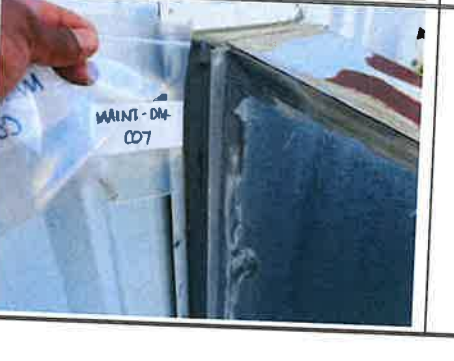
None Detected	Grey Duct Mastic
